# Flow Assurance Intelligence Report

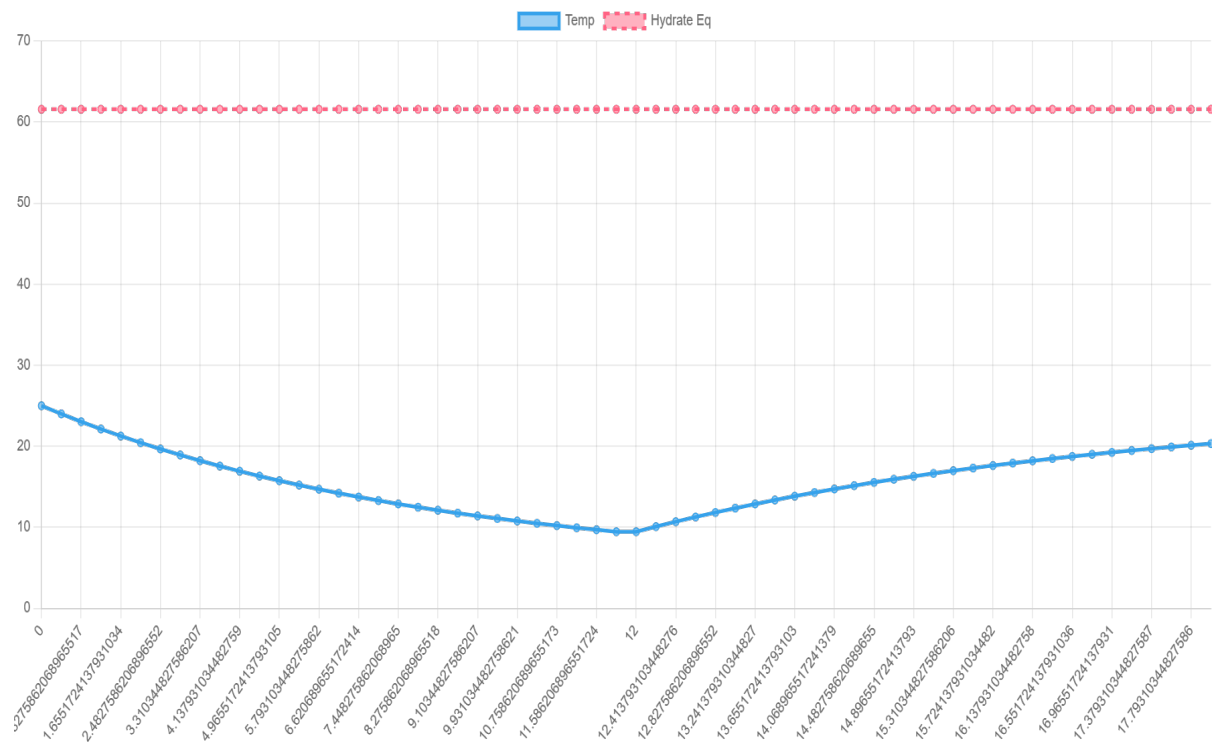
Risk Level: HIGH  
Max Subcooling: 52.11  
Minimum Temperature: 9.46 °C

Severe hydrate formation risk detected during shutdown conditions.

- Immediate hydrate inhibitor injection required
- Minimize shutdown duration
- Enhance pipeline insulation
- Controlled restart procedure mandatory
