## RESIN CASTING: A COLLECTION OF HYPOTHESES

Eric Paul Marvets  
John Paul's Jewelers  
Columbus, GA USA

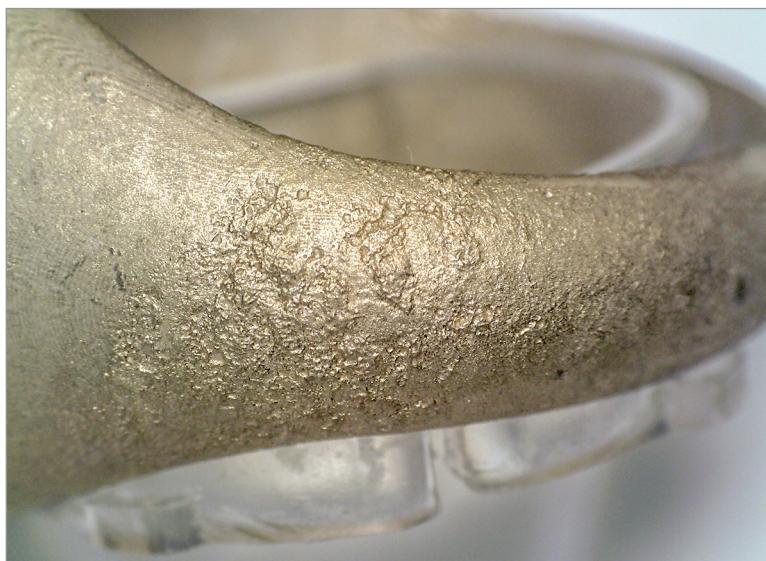
It appeared the only solution to ash was prevention. The goal of further testing was to minimize the duration of pyrolysis prior to combustion. Again, the results varied considerably. Sometimes the castings were flawless. At other times, ash created severe surface defects. The defects were usually located on prongs or at the mid-shank position of a ring (Figure 1). The defects formed in bands running parallel to the flask wall.

*Figure 1 Ash banding defect on an otherwise clean casting*

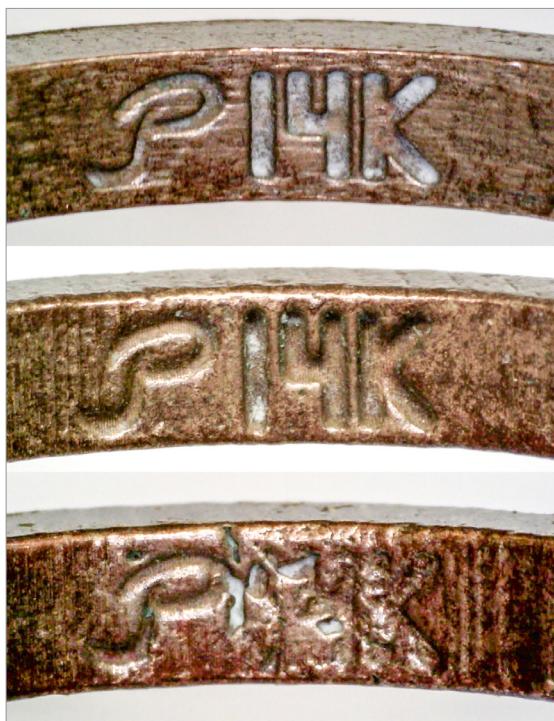
Again, the initial results were promising but became inconclusive. Each method worked well on some part geometries but produced consistent defects on others. More interestingly, the uncured resin controls began to perform better with age, surpassing each treatment and ultimately resulting in perfect castings by week three (Figure 3).

*Figure 3 Top: Solidscape control; middle: aged B9v1.2 Emerald control; bottom: B9v1.2 Emerald 12-hour UV test*

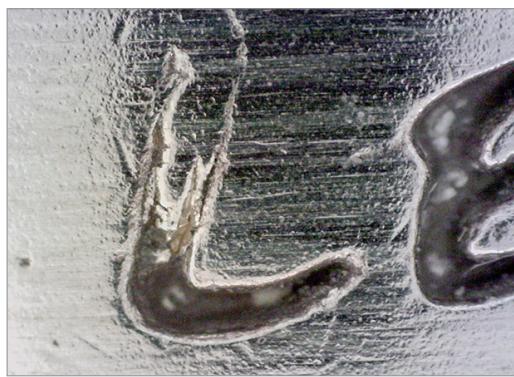
Evidence for non-uniform deformations was found experimentally, and a conceptual model was derived (Figure 5). Features that were castable at cardinal positions (red and blue) became prone to investment breakout as they approached intercardinal positions (purple). Lettering defects provided additional insight. Letters with horizontal channels seemed to relieve the force responsible for the defects (Figure 6).

*Figure 6 "L" located at an intercardinal position*

Heat-curing treatments were shown to resolve these investment breakout defects. This pre-shrinks and stabilizes the geometry prior to entering the mold. Parts are reduced in volume by 1–2% (depending on resin and printer exposure), becoming denser through polymerization and the volatilization of constituent components. However, shrinkage was not the cause of investment breakout. Full-sized versions of these same troublesome geometries were cast successfully once aged (Figure 3).

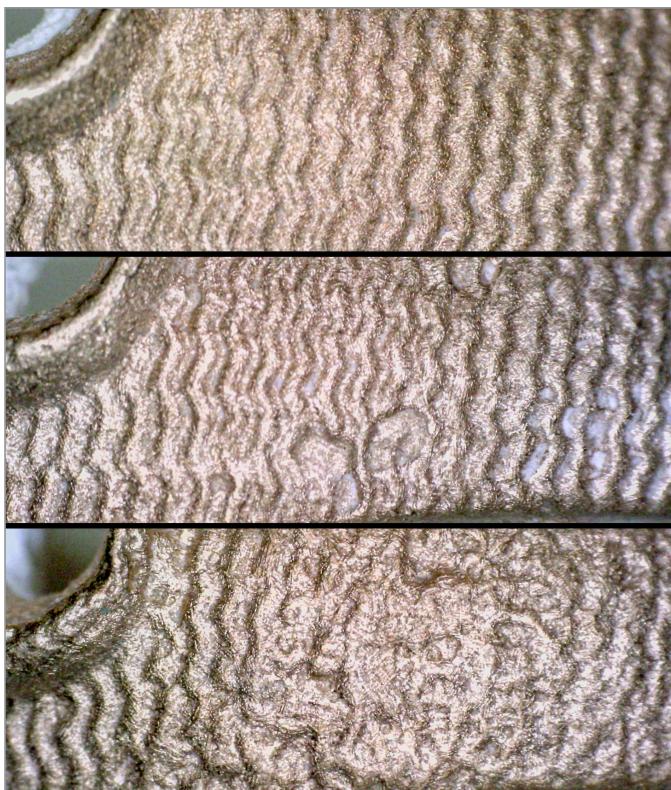
defect. The other two flasks were vacuumed, which increased the working time to eight minutes. When the pressure was released slowly via the needle valve, the defects were minimal. The quick-release flask showed a complete disruption of the pattern.

**Figure 12** Top: no vacuum; middle: slow release; and bottom: fast release of vacuum

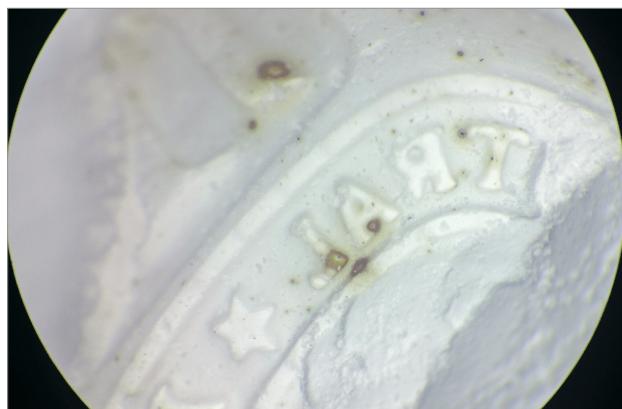
Some ash deposits were also seen to adhere to the mold. In a ceramic clay dish, there would be a single globular deposit left with the ash skeleton. This bonded with the clay, and a grinding wheel was required for removal. When the ash body is broken into many small pieces in the mold, the same color deposits were found in the investment (Figure 13).

*Figure 13 Stain surrounding possible globular residue on the mold wall*

In short, ash is permanent. Once created, it cannot be removed. The only solution is to prevent ash by minimizing the time spent under pyrolysis. We must proceed from 400°F (204°C) to 800°F (427°C) as quickly as possible. Unfortunately, water makes this a complicated task.
