Keep Stability Individual Film Process On LSSG Product

Team : All In

By : Heri Wahyu Setyawan

Date : Dec 13, 2024

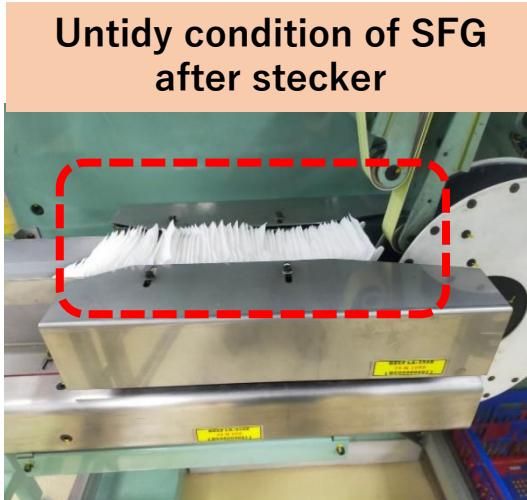
SFG pouch caught by stacker propeller.

SFG rate is unstable after stecker due to belt slig rotation and rocking

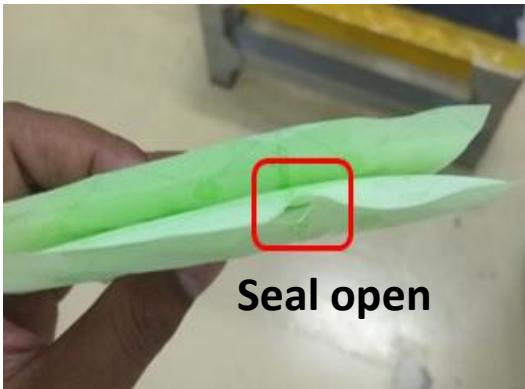
Seal pattern easily get dirty from green ink, and it cause seal open.
MC need to frequently stop to clean seal pattern.

**After change to green IF, appear pouch seal open issue.
Frequency & stop time of KI 22 increase significantly.**

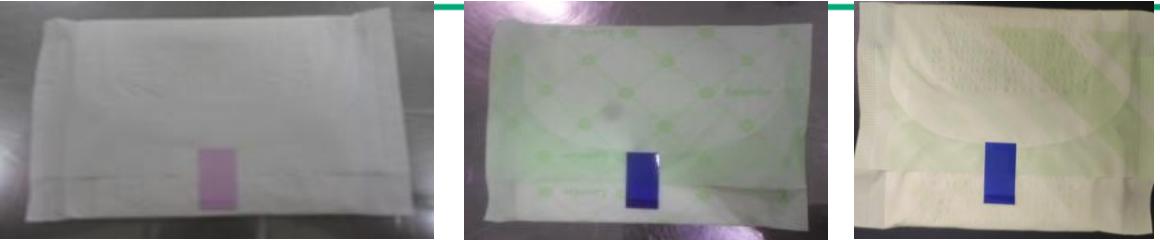
Replacement Unit Pouch Seal

Based on data above, after change green I/F, stop time, frequency (pouch seal open) and Replacement unit **more higher** than white I/F

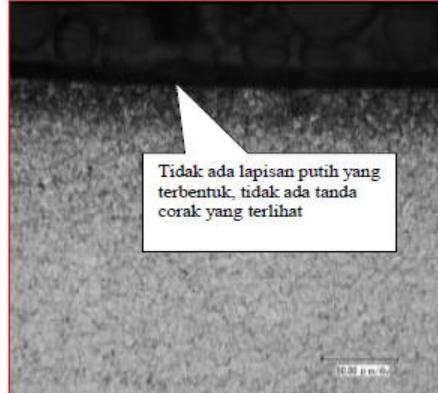
1. Kanuc Treatment Hardening

*minimal Harden standard. 62 HRC

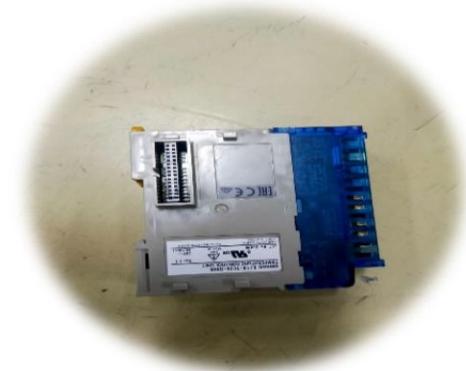
4. Replace temp Control

From these activities, the results obtained are still not maximized.
Next we do a more analysis deeply

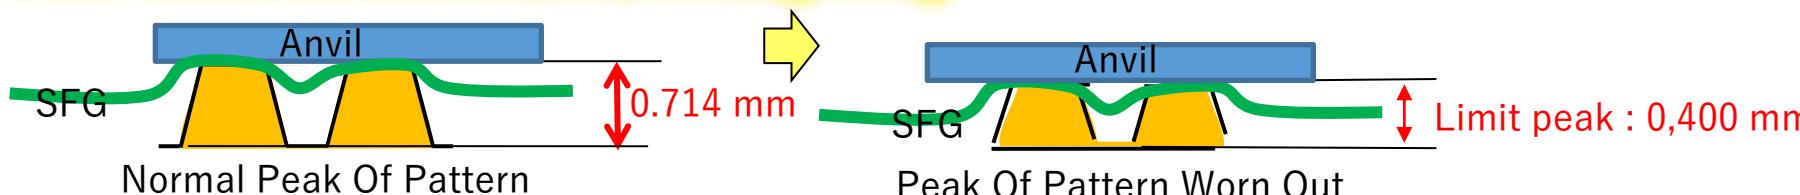
Diameter P/S

Peak Pattern decrease 0.03mm/month/grinding

Peak Pattern Pouch Seal wears out quickly(lifetime ± 40 days) , causing the pouch seal to not maximally seal the SFG.(Seal Weak)

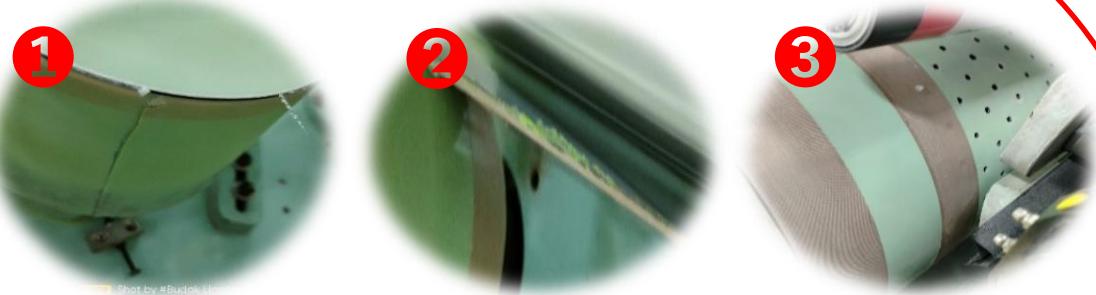
**HM body not center attached to SFG,
the effect is:**

HM Sticking roll
folding IF

HM Sticking Plate
folding IF

HM Sticking in Transfer
Drum B

**Pouch torn cause of
pull by HM**

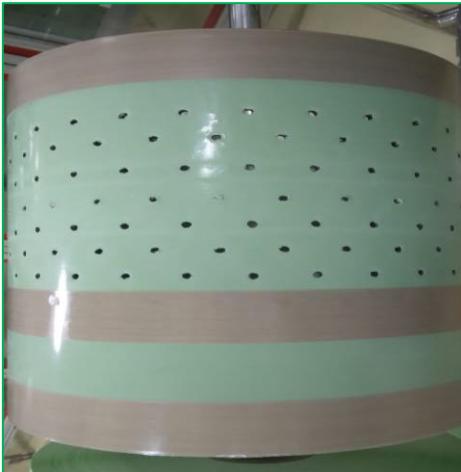
Maximize Vacuum System Repitch Drum

New Condition : 7 line

Previous : 8 line of vacuum holes

- 1** Reduce the vacuum hole to make the vacuum suction stronger

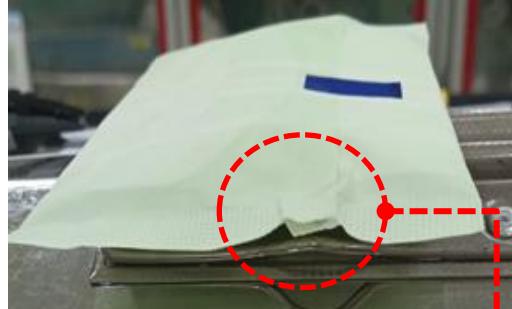
Clearence Belt Transfer SFG Over Press

Conveyor belt design with press belt type has no clearance (0) when SFG through the turn roll SFG get the over press, the effect is in pouch seal torn

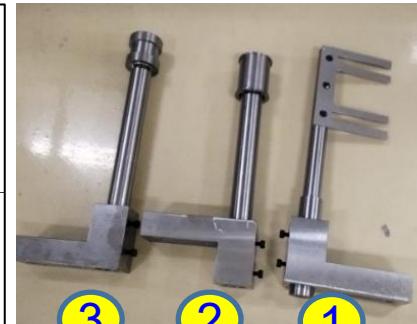
Setting Clearance belt for minimize friction of SFG

After setting Clearance belt a & b = 3mm,
 We can reduce trouble Pouch Torn cause friction of belt

Trial Setting Clearance Press Belt			
Clearance (a)	Clearance (b)	Hasil	Keterangan
5 mm	5 mm	NG	Laju SFG berantakan
4 mm	4 mm	NG	Laju SFG berantakan
3 mm	3 mm	OK	Laju SFG stabil
2 mm	2 mm	OK	Laju SFG stabil
1 mm	1 mm	NG	Indikasi SFG lemah

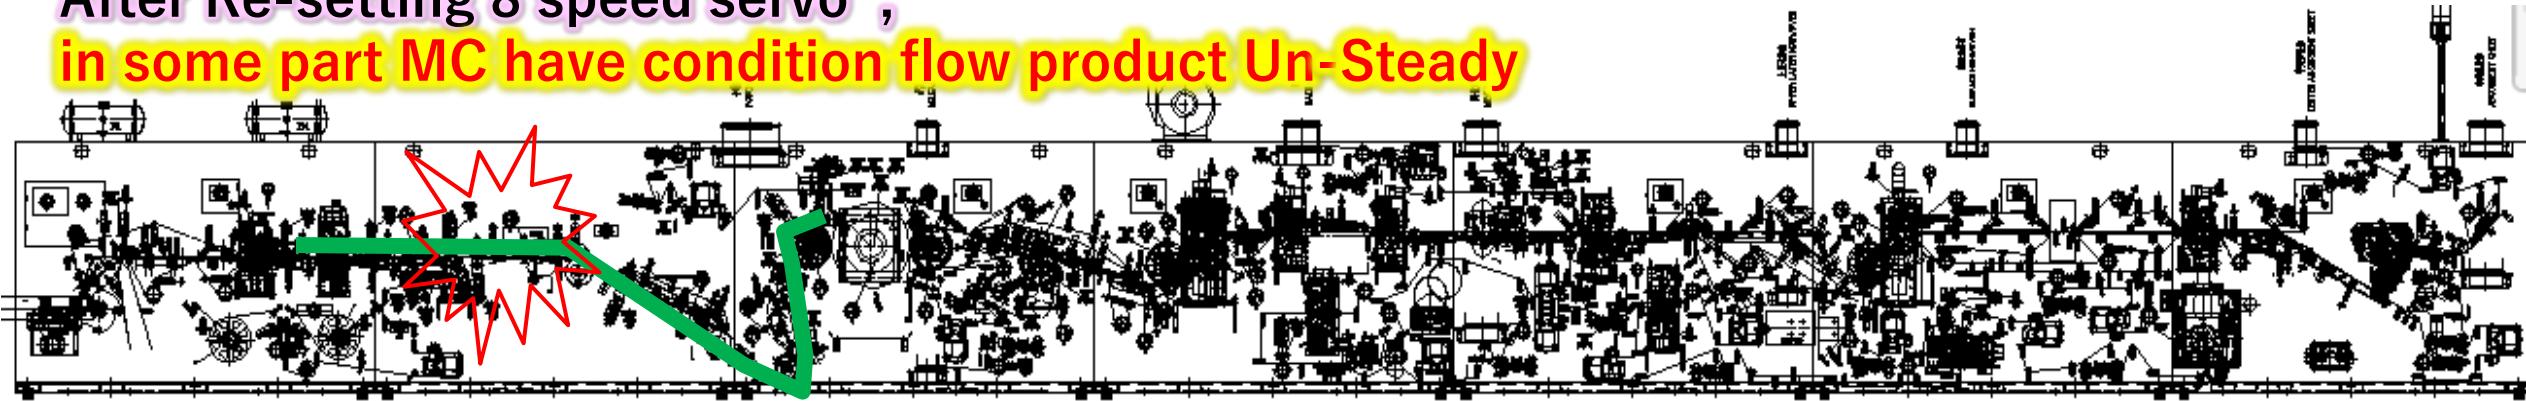
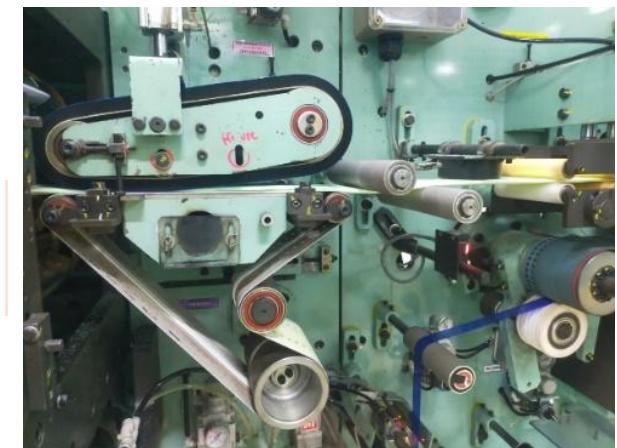
Additional Roll Before Pouch Seal

After Re-setting 8 speed servo ,
 in some part MC have condition flow product Un-Steady

with Additional Roll
The Flow SFG is more stable
