Nessus Vulnerability Scan

I performed a vulnerability scan of a LAN using Nessus. First, I identified all the hosts on the network, then I analyzed the most consequential vulnerabilities found for a single host (which was the router). Lastly, I remediated one of the more significant vulnerabilities.

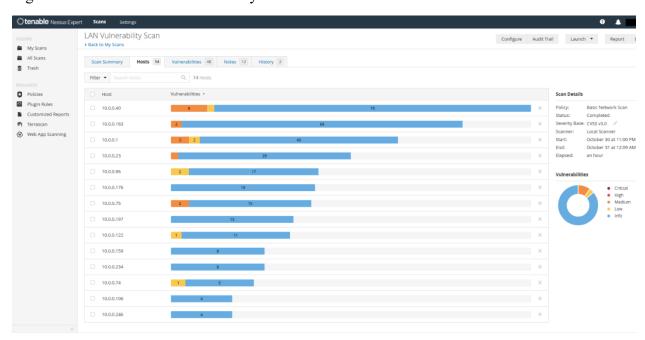
I identified 14 hosts on the LAN, with a total of 48 vulnerabilities detailed in Figure 1.

Figure 1: All LAN Hosts Identified by the Nessus

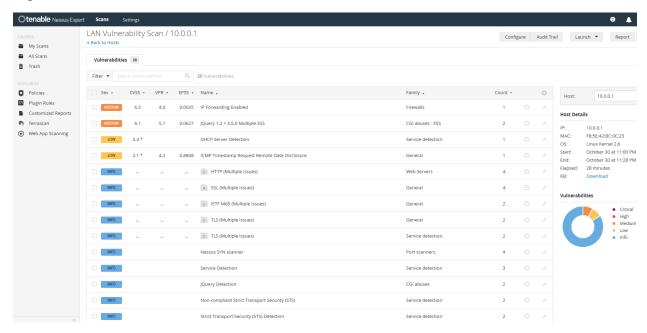
Figure 2: Vulnerabilities for Host 10.0.0.1

The most significant vulnerability detected in the router was <u>CVE-1999-0511</u>, with a CVSS rating of 6.5. However, this vulnerability describes a remote host (other than a router or firewall) having IP forwarding enabled. Since the device in question is a router, the vulnerability can be categorized as a false positive.

The next most serious vulnerability identified in the router was CVE-2020-11023, with a CVSS rating of 6.1. CVE-2020-11023 is a JQuery-related vulnerability that allows for multiple types of XSS attacks. While a patch is available that would eliminate this vulnerability, it has not been incorporated by the ISP; and I do not have access to the firmware to update the device myself. Since the router in question was rented from an ISP, and a software update was not offered for the product, my choices were to accept the risk or purchase a new router; I chose to buy a new router. After its installation, I performed another vulnerability scan to see if the JQuery-related vulnerability was still present on the new device.

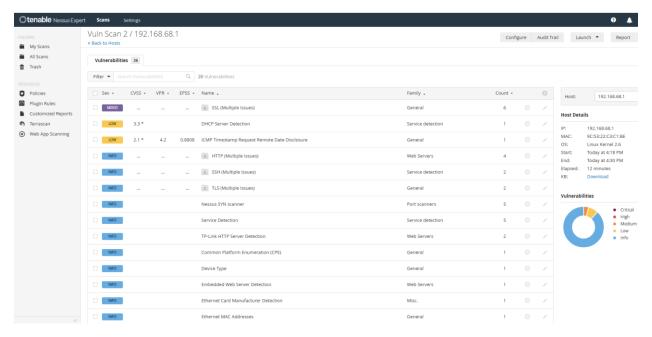
Since this is a new router, the internal IP address scheme of the LAN has changed, and that is reflected in the most recent vulnerability scan. To that point, the new router is identified as 192.168.68.1, shown in Figure 3. Finally, as you can see in Figure 3, this device does not have the JQuery-related vulnerability present, therefore CVE-2020-11023 has been effectively remediated.

Figure 3: Nessus Scan of New Router (192.168.68.1)
