4<sup>th</sup> May 2026.**MINUTES FOR SITE MEETING HELD ON 4<sup>th</sup> MAY 2026 FOR GARDEN DEVELOPMENT, MABUSHI, ABUJA FCT.**

**Location:** Mabushi  
**Project:** Event Center at Plot 2030 Mabushi  
**Facilitator:** Arc. Chike

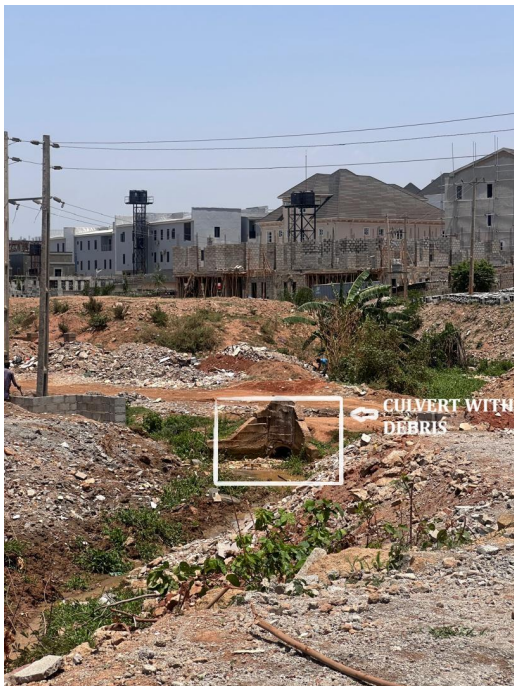
| ITEM | DESCRIPTION | ACTION |
|---|---|---|
| 1 | <p><b><u>Drainage:</u></b></p> <p>The surveyor requested a plan for the drainage, particularly for the culvert, as the existing rings are undersized (see Fig. 1).</p> <p>Engr. Kanabe stated that he has been informed that the contract for the access road has been awarded. His intention is to wait for the road contractor to mobilize to site, as the cost of constructing a box culvert is significant.</p> <p>The surveyor advised that the size of the culvert rings should be increased as soon as possible to prevent future drainage issues.</p> <p>Arc. Chike recommended that work should commence on site, particularly in establishing levels. This will help reduce debris and litter currently obstruct the drainage path, allowing water to flow more freely. He added that by the time this is achieved, the road contractor may have mobilized, after which the replacement of the culvert rings can be properly considered.</p> | Consultant Engineer |

Fig. 1 Culvert with debris in water path

All debris and litter within the existing drainage channel should be cleared immediately to restore free flow of water.

Following this, the drainage system should be observed under normal flow conditions to assess its performance. The decision to upgrade or redesign the culvert should be based on this assessment, alongside considerations of the proposed finished floor levels.

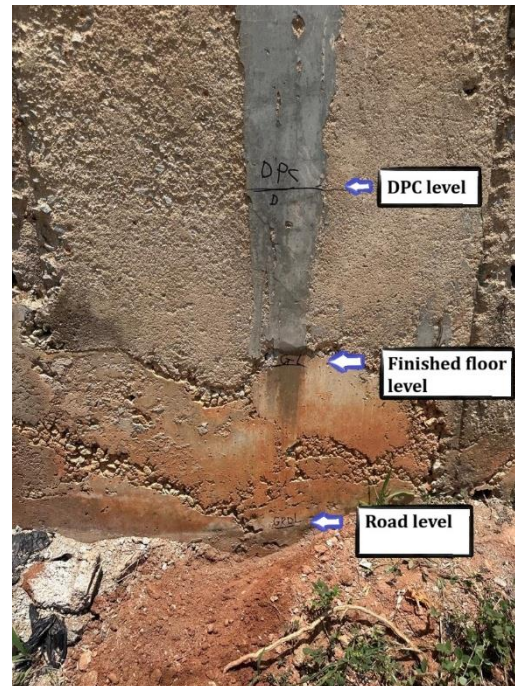
Fig. 2 Site levels as given by surveyor

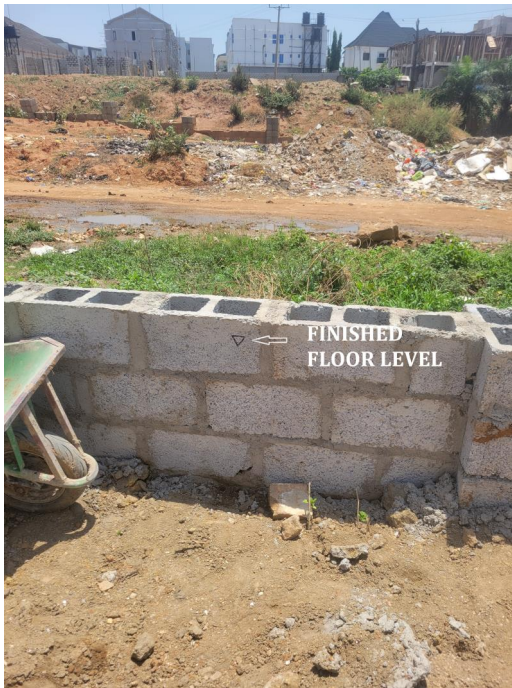
| 2 | <p><b><u>Site Levels and Perimeter Wall:</u></b></p> <p>The surveyors marked the DPC level and the grade level of the site (see Fig. 2).</p> <p>The marked level is nearly the same height as the existing perimeter wall at the entrance (see Fig. 3).</p> <p>The surveyor raised concerns about the load that the proposed filling may impose on the perimeter wall. In response, Engr. Kanabe stated that the perimeter walls are intended to be filled with weak concrete to improve their load bearing capacity.</p> | Consultant Engineer |

Fig 3. Finished floor level

The height of the perimeter wall should be increased by a minimum of three courses above the currently proposed level and be made into a double wall. This adjustment is necessary to accommodate the anticipated final ground levels and to ensure adequate containment of the filled material within the site.
