# St. John, USVI - Post-Hurricane Irma Community Survey

Buildings & Civic Property · 2026-09-30

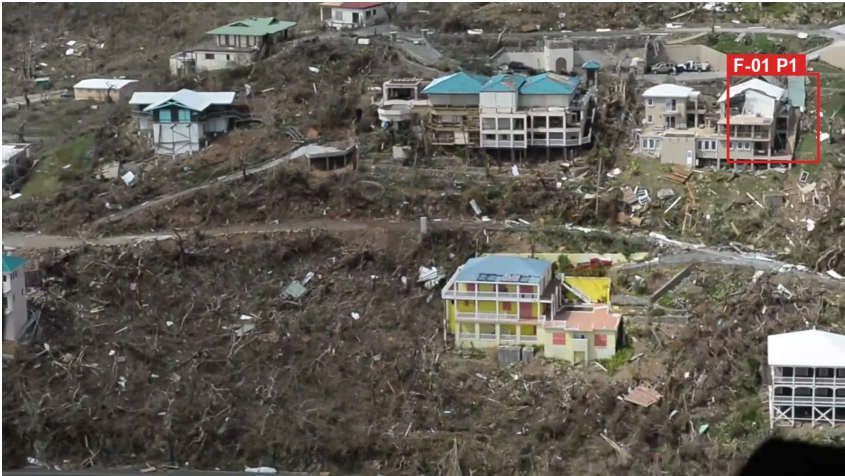
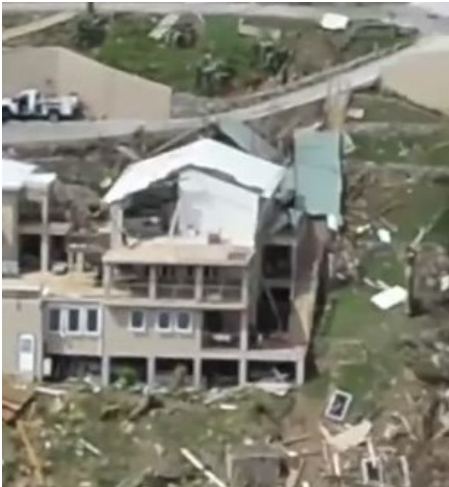
F-01 House with roof and upper structure torn open

| Severity | Critical, score 3.95 / 4 |

A multi-storey house has lost part of its roof and upper walls, leaving the upper floor open to the weather.

*Visual evidence:* Missing roof sections and exposed interior on the top floor, debris spilling down the slope below.

**For this finding:** Tarp the opening to stop rain getting in, keep people out of the top floor until an engineer checks the roof framing, then re-roof with hurricane-rated fixings.

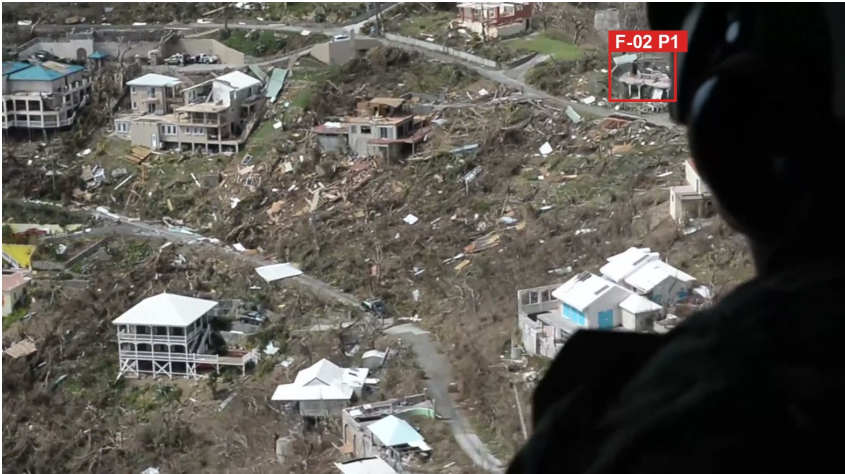
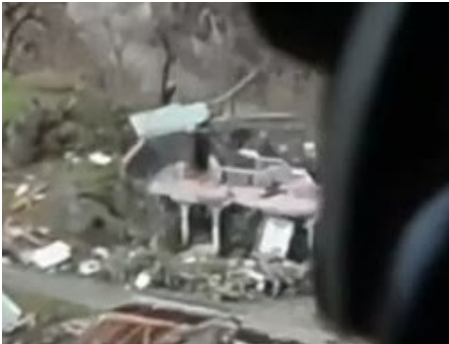
F-02 House largely destroyed

| Severity | Critical, score 4.00 / 4 |

A house at the top right has lost its roof and most of its upper structure.  
*Visual evidence:* Only parts of walls and a platform remain; debris around it.

**For this finding:** Placard the building unsafe and keep people out until a structural engineer assesses it; plan demolition if beyond repair.

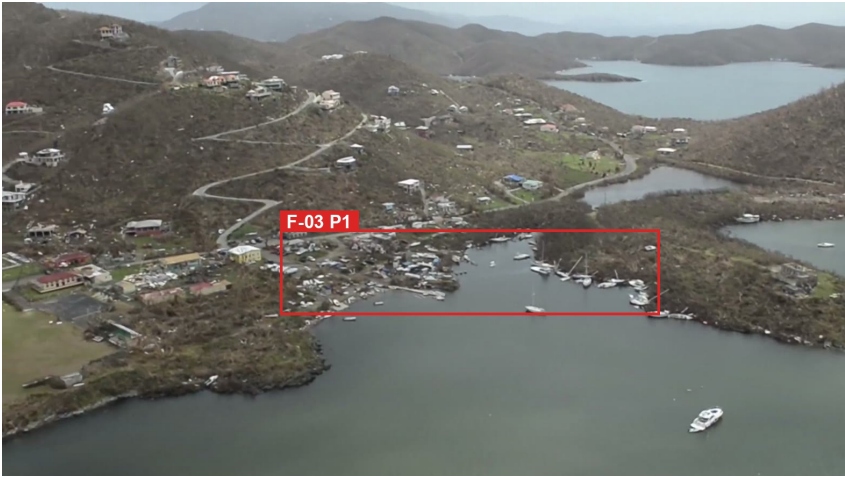
F-03 Boats wrecked and piled up along the harbour shoreP1 · Immediate (within 24-72 h)

Dozens of boats have been driven ashore, sunk or piled together along the harbour edge and in the boatyard. Wrecked boats leak fuel and oil and block the waterfront.

For this finding: Boom off leaking vessels, survey the harbour for sunken hazards, and organise vessel salvage before reopening the waterfront.

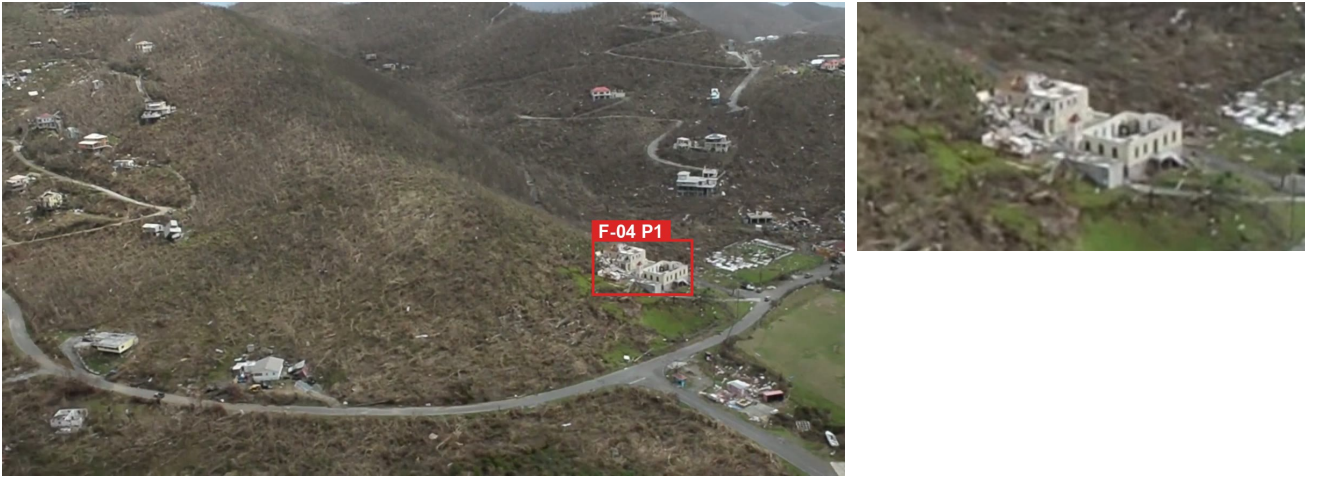
F-04 Large building reduced to roofless walls

| Category | structural damage (53% confidence) |

- 1 Cordon off a fall zone around the structure (at least its height) and post it as unsafe.
- 2 Get a structural engineer's rapid safety evaluation (inspected / restricted use / unsafe placard).
- 3 Shore or brace if the structure is to be saved; otherwise plan a controlled demolition.
- 4 Do not let anyone climb or enter until the engineer clears it.

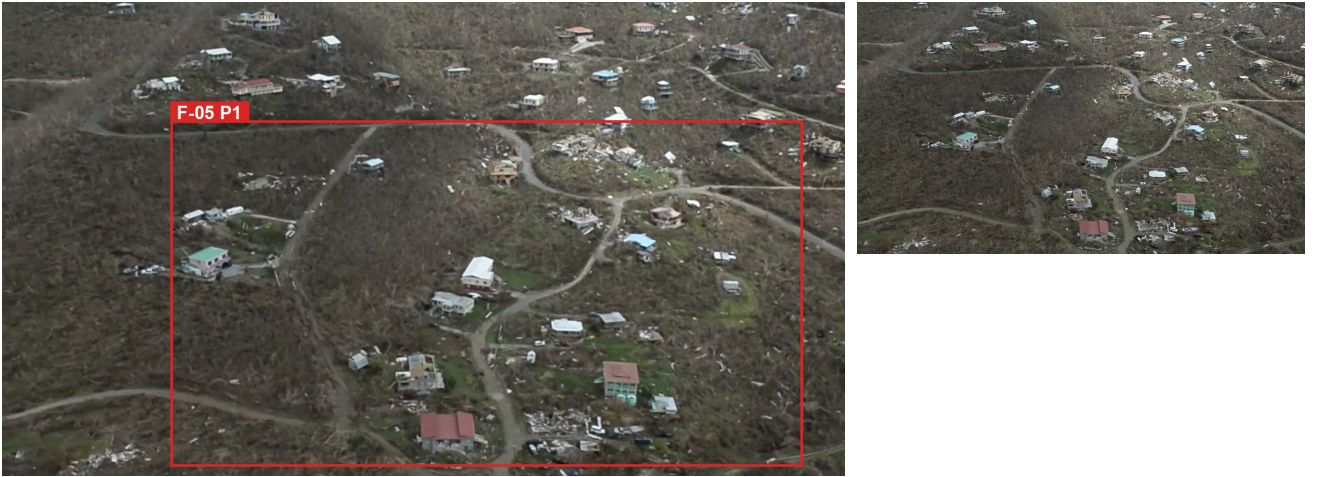
F-05    Widespread damage across hillside neighbourhood

Across this neighbourhood many homes show missing roofs and debris fields around them; the damage is spread over the whole area, not just a few houses.

**For this finding:** Do a house-by-house rapid safety evaluation (ATC-45 style) to find unsafe homes and people needing shelter.

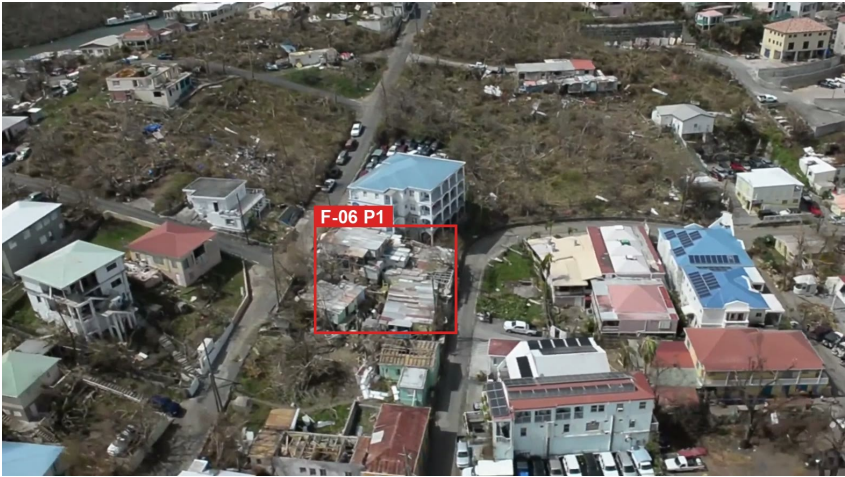
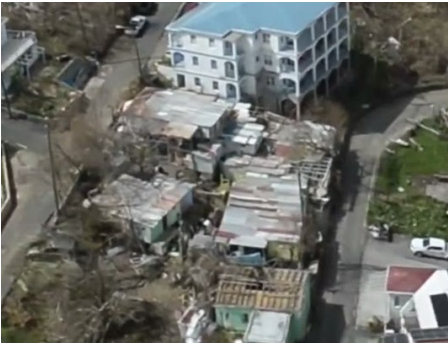
F-06 Cluster of small structures collapsedP1 · Immediate (within 24-72 h)

Visual evidence: Tangle of roof sheets, timber and broken walls between two larger buildings.

- 1 Cordon off a fall zone around the structure (at least its height) and post it as unsafe.
- 2 Get a structural engineer's rapid safety evaluation (inspected / restricted use / unsafe placard).
- 3 Shore or brace if the structure is to be saved; otherwise plan a controlled demolition.
- 4 Do not let anyone climb or enter until the engineer clears it.

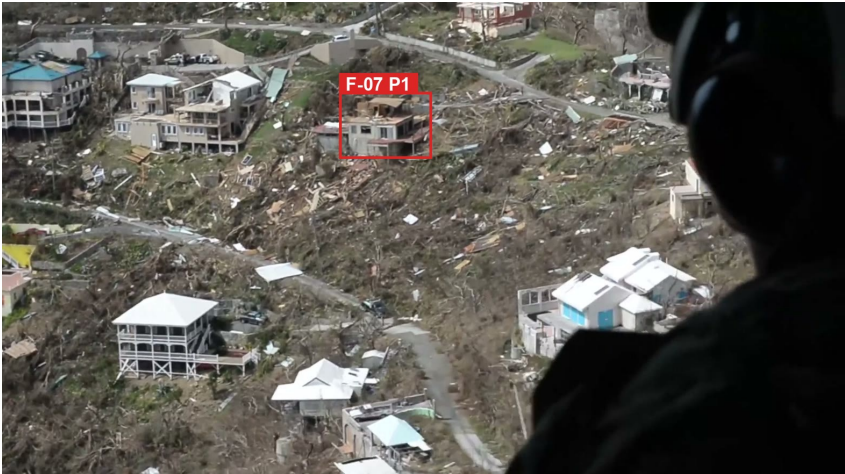
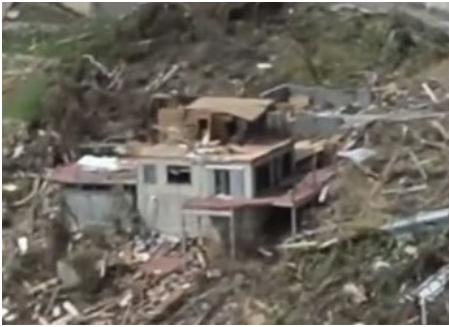
F-07 Roof blown off, top-floor framing exposed

| Category | roof damage (100% confidence) |

- 1 Keep people out of rooms under the damaged roof until an engineer or building official has checked it.
- 2 Make it weather-tight: cover openings with secured tarps or temporary sheeting (fixed to the structure, not weighed down loosely).
- 3 Have a structural engineer check rafters, trusses and connections under the damaged area before repair.
- 4 Replace damaged decking and roofing; upgrade fixings to current wind-load requirements.
- 5 Roof work needs fall protection (harness, anchors or edge protection).

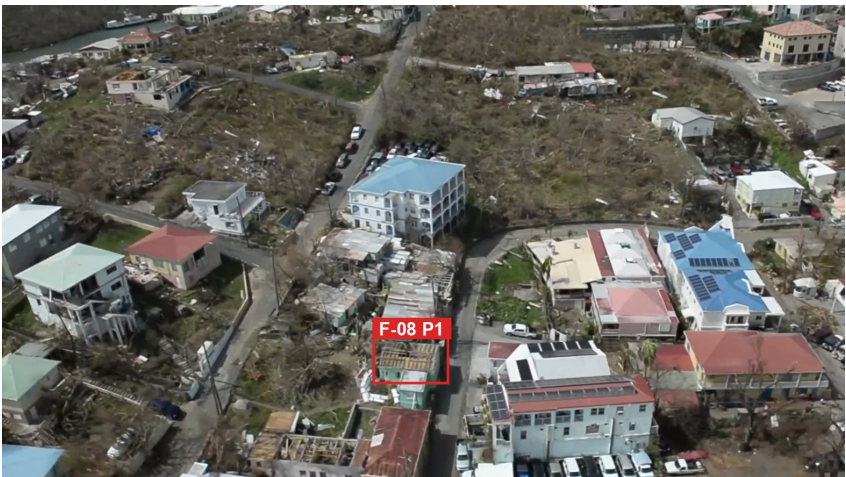
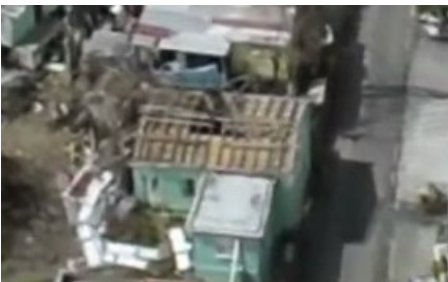
F-08    Roof stripped to exposed rafters

| Category | roof damage (100% confidence) |

- 1 Keep people out of rooms under the damaged roof until an engineer or building official has checked it.
- 2 Make it weather-tight: cover openings with secured tarps or temporary sheeting (fixed to the structure, not weighed down loosely).
- 3 Have a structural engineer check rafters, trusses and connections under the damaged area before repair.
- 4 Replace damaged decking and roofing; upgrade fixings to current wind-load requirements.
- 5 Roof work needs fall protection (harness, anchors or edge protection).

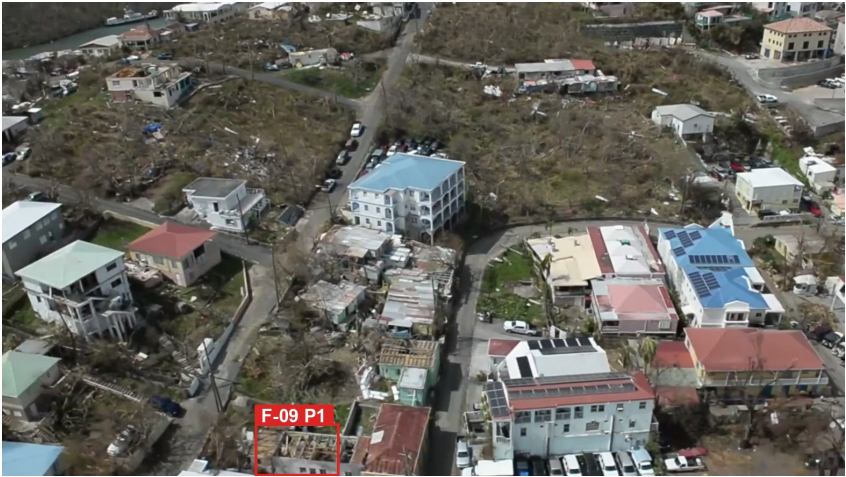
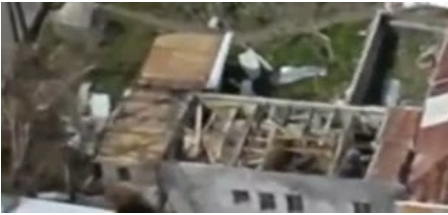
F-09    Roof stripped to exposed rafters

| Category | roof damage (100% confidence) |

- 1 Keep people out of rooms under the damaged roof until an engineer or building official has checked it.
- 2 Make it weather-tight: cover openings with secured tarps or temporary sheeting (fixed to the structure, not weighed down loosely).
- 3 Have a structural engineer check rafters, trusses and connections under the damaged area before repair.
- 4 Replace damaged decking and roofing; upgrade fixings to current wind-load requirements.
- 5 Roof work needs fall protection (harness, anchors or edge protection).

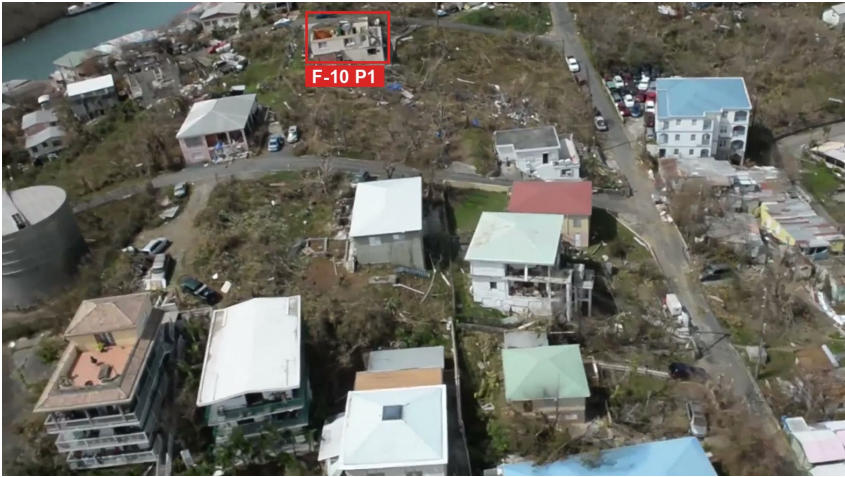
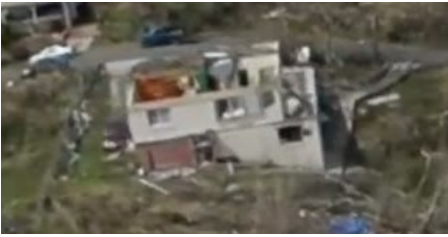
F-10 Building roof gone, interior exposed

| Category | roof damage (100% confidence) |

- 1 Keep people out of rooms under the damaged roof until an engineer or building official has checked it.
- 2 Make it weather-tight: cover openings with secured tarps or temporary sheeting (fixed to the structure, not weighed down loosely).
- 3 Have a structural engineer check rafters, trusses and connections under the damaged area before repair.
- 4 Replace damaged decking and roofing; upgrade fixings to current wind-load requirements.
- 5 Roof work needs fall protection (harness, anchors or edge protection).

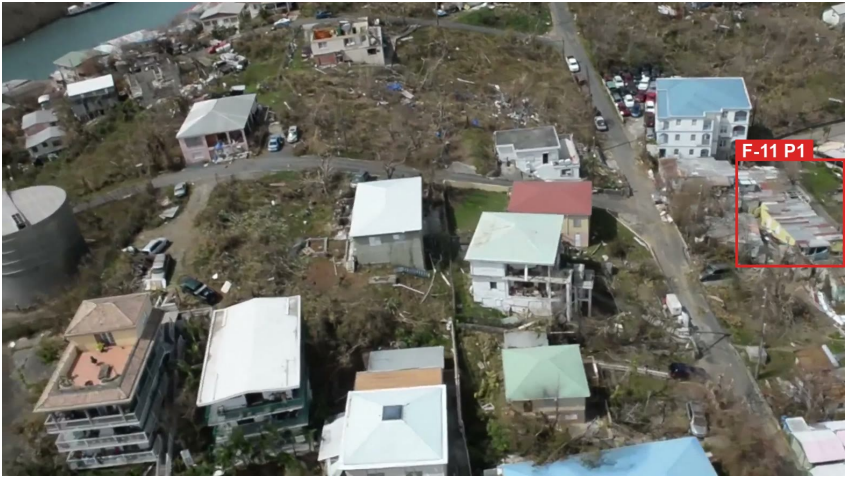
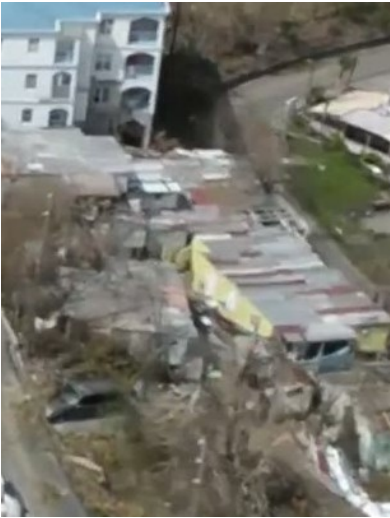
F-11 Informal structures with damaged roofs

A row of small informal buildings on the right has damaged or missing roofing.  
*Visual evidence:* Crumpled and missing roof sheets on low structures.

- 1 Keep people out of rooms under the damaged roof until an engineer or building official has checked it.
- 2 Make it weather-tight: cover openings with secured tarps or temporary sheeting (fixed to the structure, not weighed down loosely).
- 3 Have a structural engineer check rafters, trusses and connections under the damaged area before repair.
- 4 Replace damaged decking and roofing; upgrade fixings to current wind-load requirements.
- 5 Roof work needs fall protection (harness, anchors or edge protection).

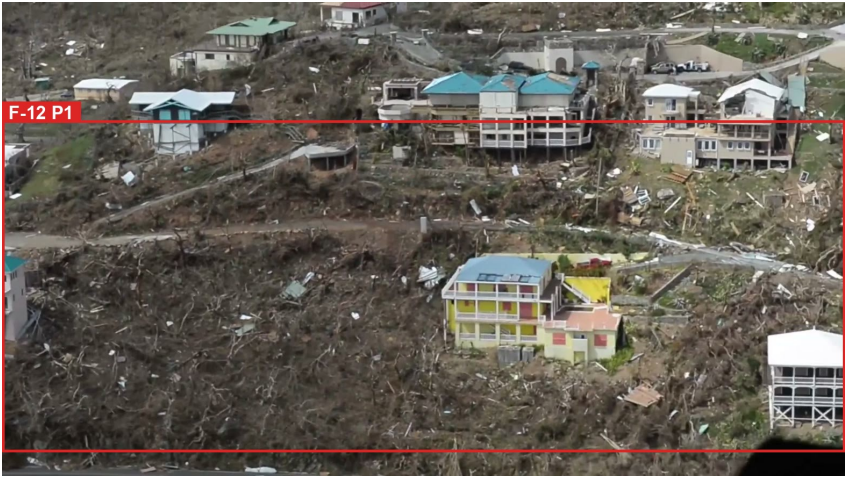
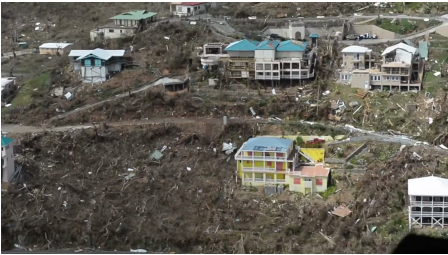
F-12 Hurricane debris field across hillside homes

Visual evidence: Hundreds of white and grey fragments and broken timber spread over the brown slope and along the road.

For this finding: Clear loose roofing sheets, timber and debris from around occupied homes and roads first; separate hazardous material for proper disposal.

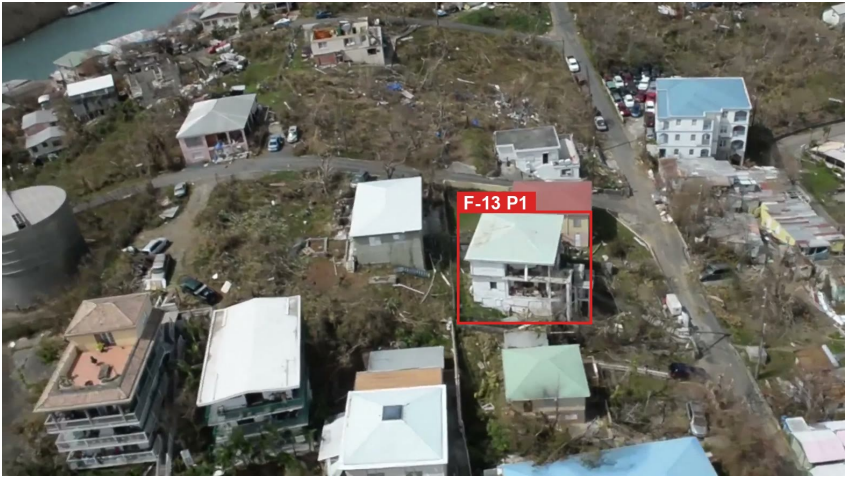
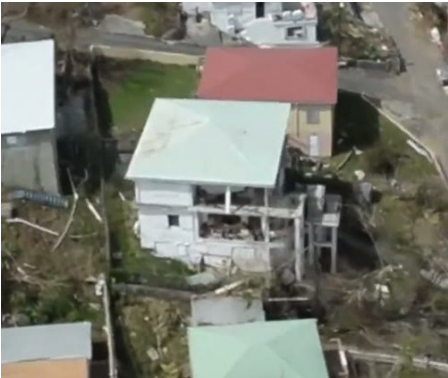
F-13 House damaged with debris around the lower floorP1 · Immediate (within 24-72 h)

The lower part of this house is damaged and debris is piled around it.  
*Visual evidence:* Broken lower walls and a heap of debris beside the house.

**For this finding:** Clear loose roofing sheets, timber and debris from around occupied homes and roads first; separate hazardous material for proper disposal.

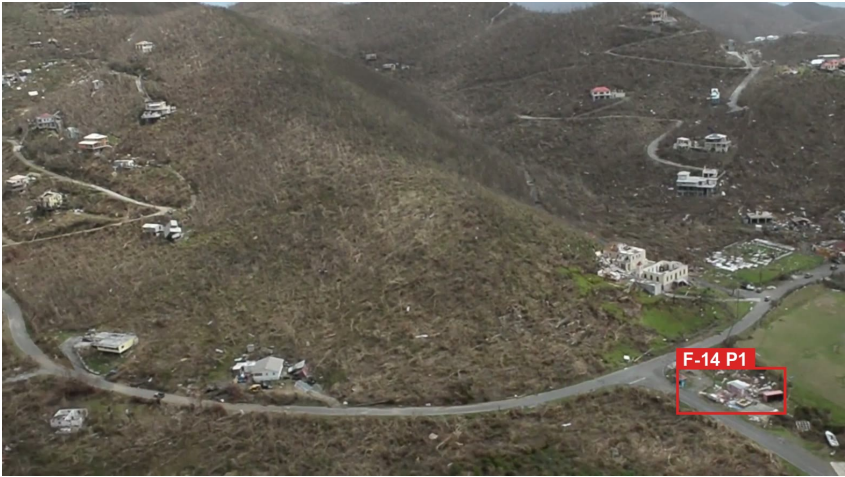
F-14 Homes destroyed beside the main road

A group of buildings by the road is largely destroyed, with debris spread onto the verge.  
*Visual evidence:* Broken structures and a scatter of coloured debris next to the road.

- 1 Secure or remove loose sheet metal and debris that wind can pick up.
- 2 Clear debris from access routes, drains and around buildings.
- 3 Separate hazardous debris (asbestos-cement sheets, treated wood, chemicals) for proper disposal.

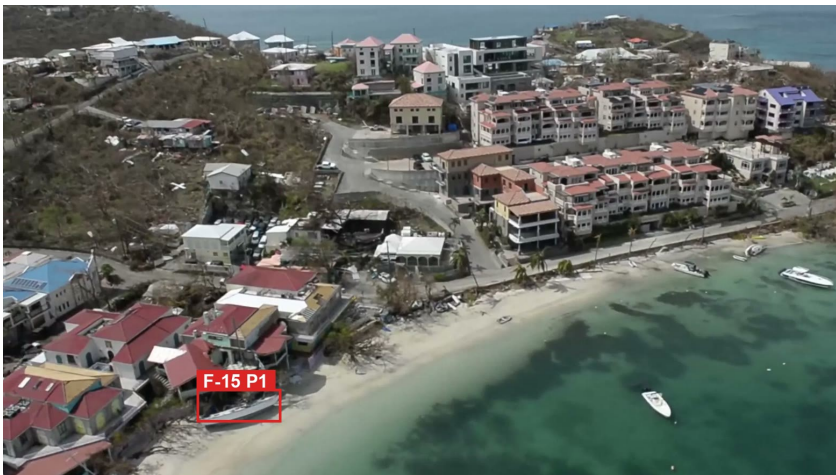
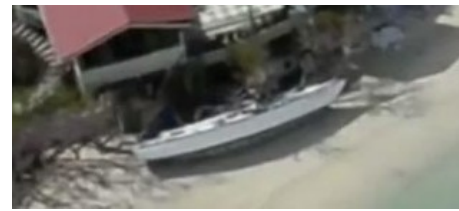
**F-15 Boat stranded on the beach****P1 · Immediate (within 24-72 h)**

| Category | debris and loose material (78% confidence) |

**For this finding:** Check the hull for fuel leaks and have it salvaged.

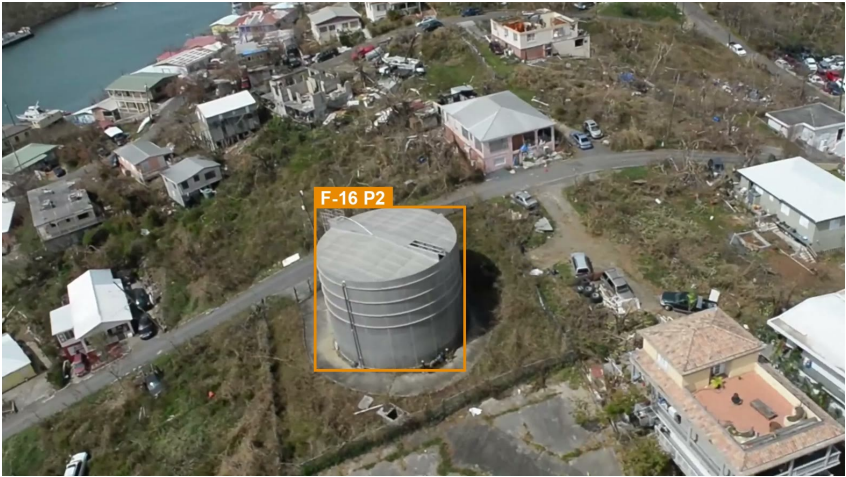
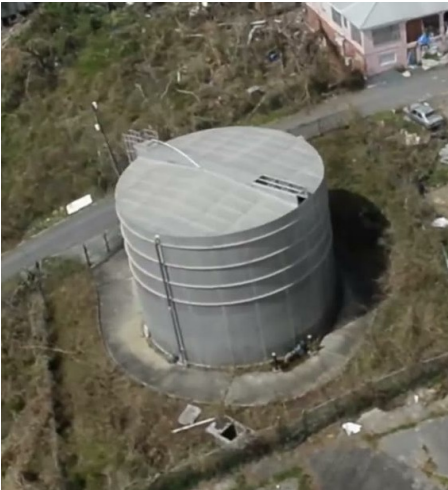
F-16 Public water storage tank needs post-storm inspectionP2 · Planned (within 30 days)

The large steel water tank that supplies the area has no obvious damage to its shell from the air, but the handrail or equipment on its roof looks bent, and debris lies around its base. Hurricane winds can damage tank roofs and vents where contamination gets in.

- 1 Treat all downed or leaning lines as live; keep people away and call the utility.
  - 2 Have the utility or a licensed electrician make safe and restore service.
  - 3 Inspect water tanks for shell, roof and foundation damage before refilling.
- References: NFPA 70 (National Electrical Code); AWWA D100 / D103 (water storage tanks)

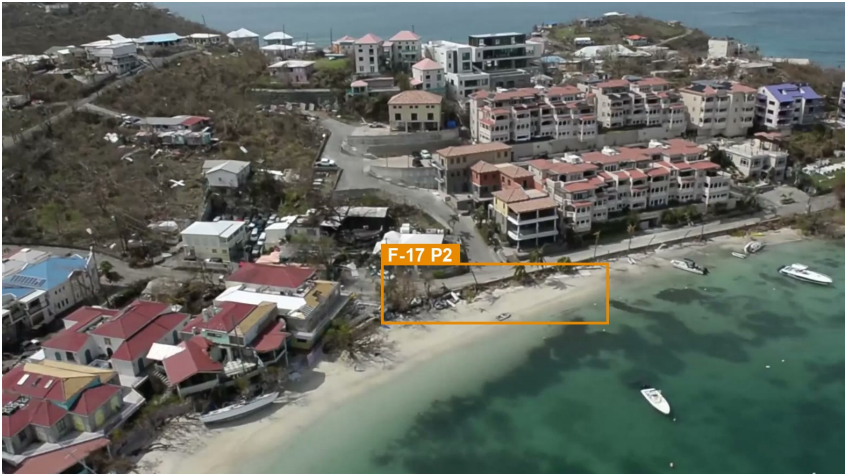
F-17 Debris washed up along the beach and waterfrontP2 · Planned (within 30 days)

| Category | debris and loose material (100% confidence) |

For this finding: Clear loose roofing sheets, timber and debris from around occupied homes and roads first; separate hazardous material for proper disposal.
