# Francis Scott Key Bridge, Baltimore - Collapse (Mar 2024)

Civil Infrastructure & Construction · 2026-09-30

# 1. Executive summary

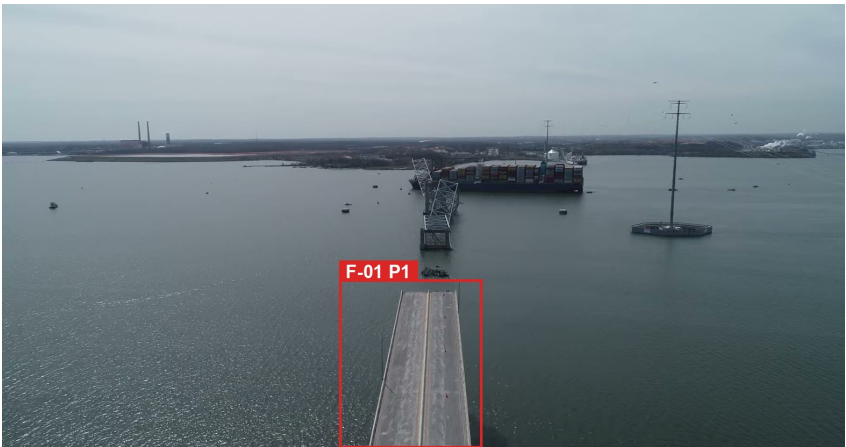
F-01 Approach roadway ends abruptly at the collapse

The approach road deck stops abruptly where the main spans have fallen. Anyone driving onto the bridge would drive straight into the gap.

*Visual evidence:* Road deck with lane markings ending in a clean cut over open water.

**For this finding:** Keep road closures at both ends with physical barriers well back from the gap; assess the remaining approach spans and piers.

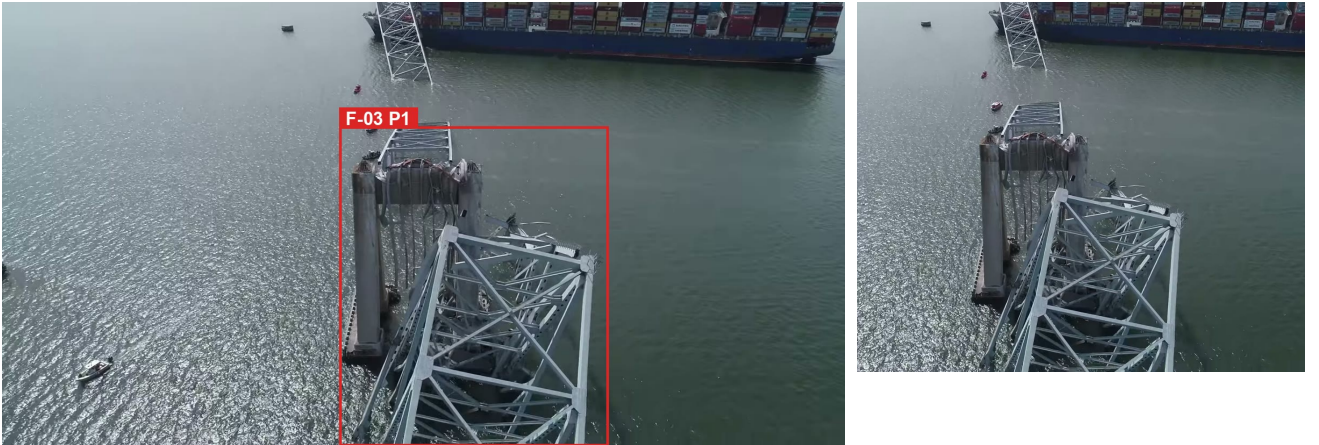
F-03 Truss section draped against a damaged pier

A large truss section has fallen against this pier and is tangled around it. The pier cap is damaged and the wreckage is unstable.

*Visual evidence:* Twisted steel truss leaning against a concrete pier column; bent and broken members.

**For this finding:** Keep the bridge closed and the waterway below restricted; engineers must assess the remaining piers and approach spans before any salvage work starts.

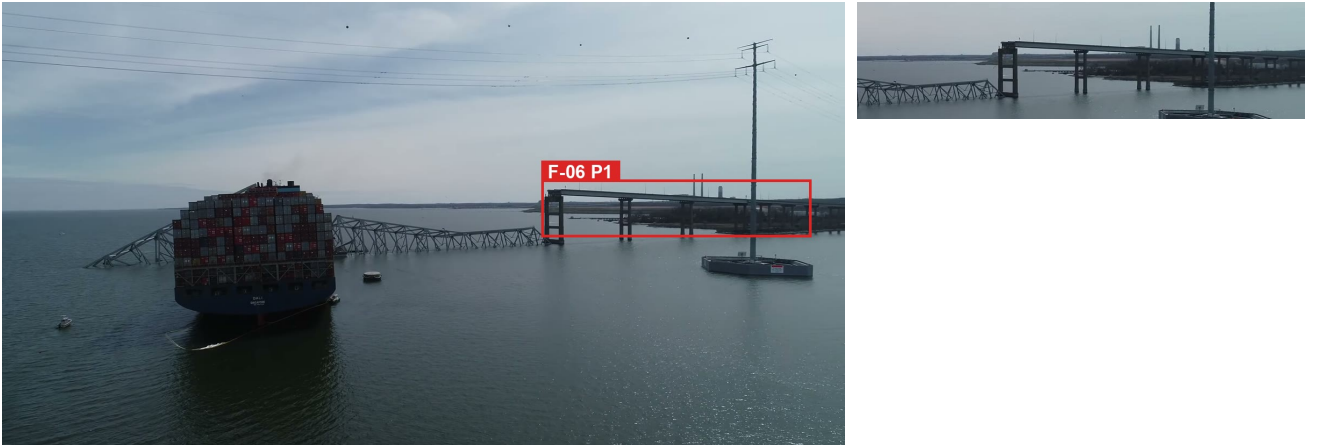
F-06 Far-side approach span ends over open water

On the far side the approach span also ends over open water.  
*Visual evidence:* Road deck on piers ending at the gap, truss wreckage in the water next to it.

**For this finding:** Keep the far-side closure in place and assess the remaining piers.

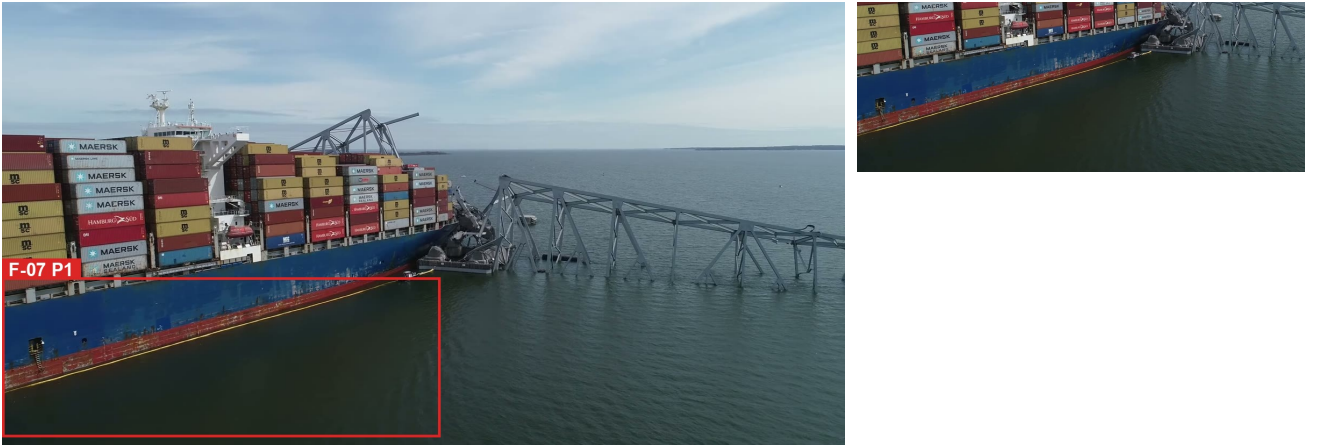
F-07 Containment boom along the hull (possible fuel release)P1 · Immediate (within 24-72 h)

A yellow containment boom has been laid in the water along the ship's hull, which suggests fuel or oil may be leaking. The sheen itself can't be seen at this distance.  
*Visual evidence:* Continuous yellow floating boom following the hull toward the bow.

- For this finding:** Keep booms in place and monitored; sample the water; check the ship's fuel tanks for damage.
- Standard procedure**
- 1 Have a qualified engineer review the frame and decide on an inspection or repair.

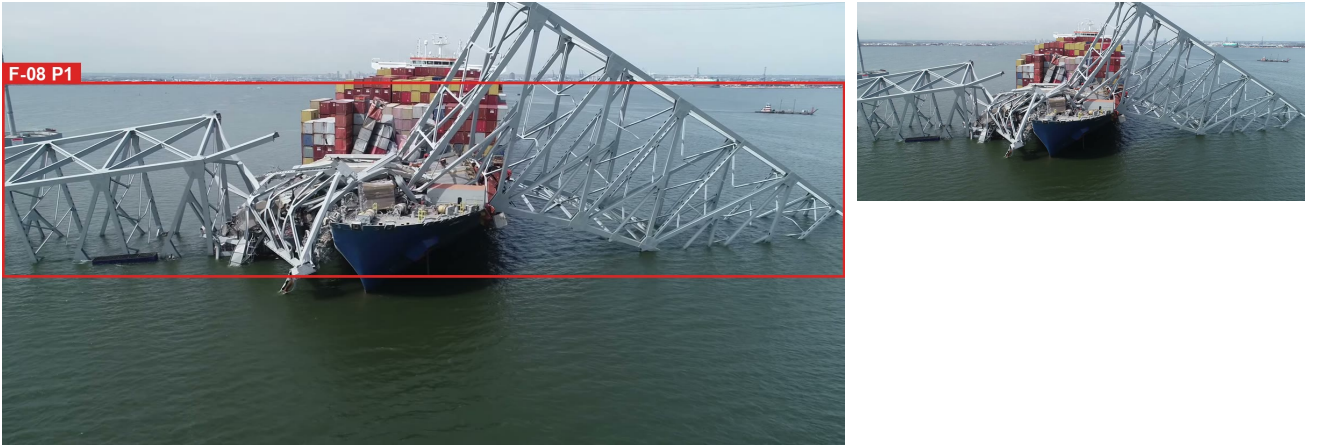
F-08 Wreckage blocking the shipping channel

Collapsed truss spans lie across the channel on both sides of the ship, closing the shipping channel into the port.  
*Visual evidence:* Truss sections sticking up out of the water across the channel width.

**For this finding:** Keep the channel closed; mark wreckage with buoys; open temporary alternate channels once surveyed; plan wreck removal.
