# Oroville Dam, CA - Spillway Emergency (Feb 2017)

Civil Infrastructure & Construction · 2026-09-30

# 1. Executive summary

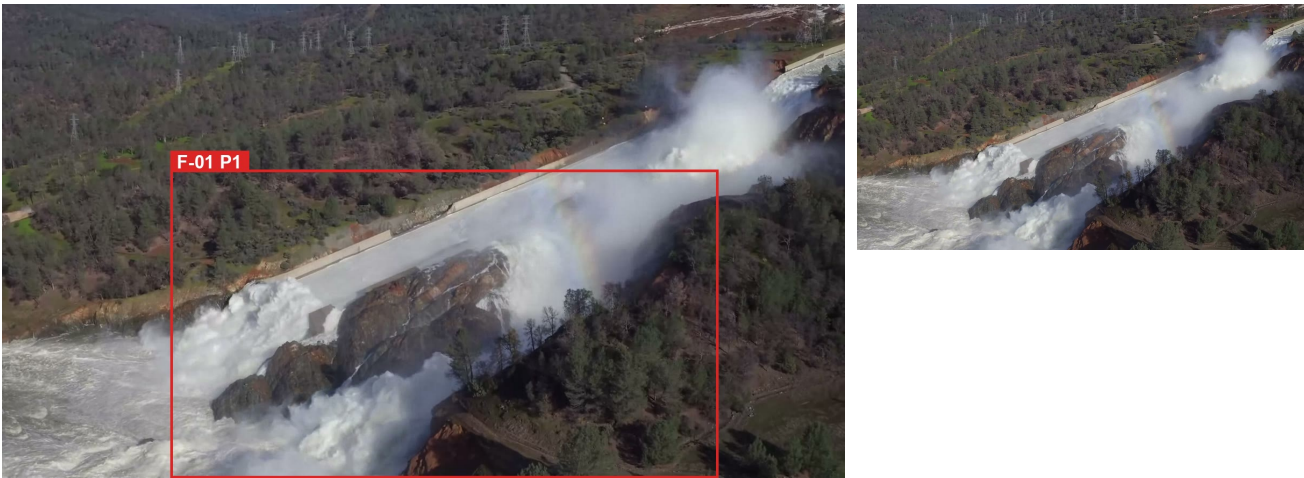
F-01 Main spillway chute broken mid-slope

| Extent | Crater many tens of metres across |

Clear side view of the break: the chute is intact above, and below it water is scouring a deep crater into the rock beside the chute.

*Visual evidence:* Smooth chute flow up to the break, then white water plunging into an eroded rock hole with red-brown exposed rock.

**For this finding:** Keep everyone out of the spillway area and downstream channel; reduce releases where possible, and have dam-safety engineers assess the chute and foundation before any repair.

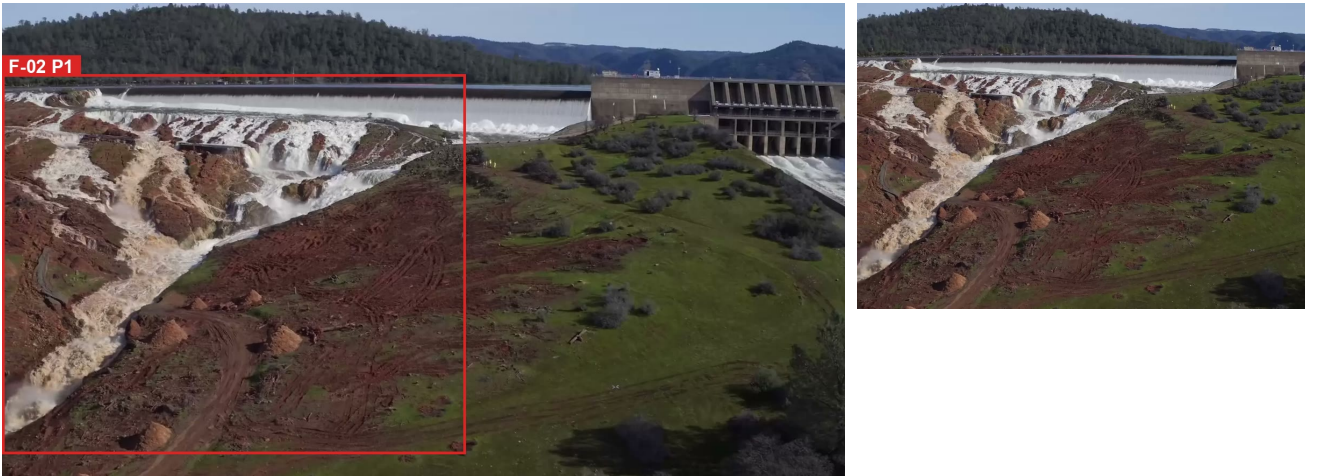
F-02 Emergency spillway overtopping and eroding the hillside

| Extent | Full weir length, hundreds of metres |

Water is pouring over the emergency spillway weir onto the unlined hillside below it. The flow is cutting deep channels into the soil and rock directly downslope of the concrete weir.

*Visual evidence:* Water spilling along the weir crest, white flow down bare red ground, eroded gullies starting just below the weir.

**For this finding:** Order evacuation downstream if erosion keeps moving toward the weir; increase main spillway releases to lower the lake below the weir crest; armour the eroding slope with rock as soon as it's safe.

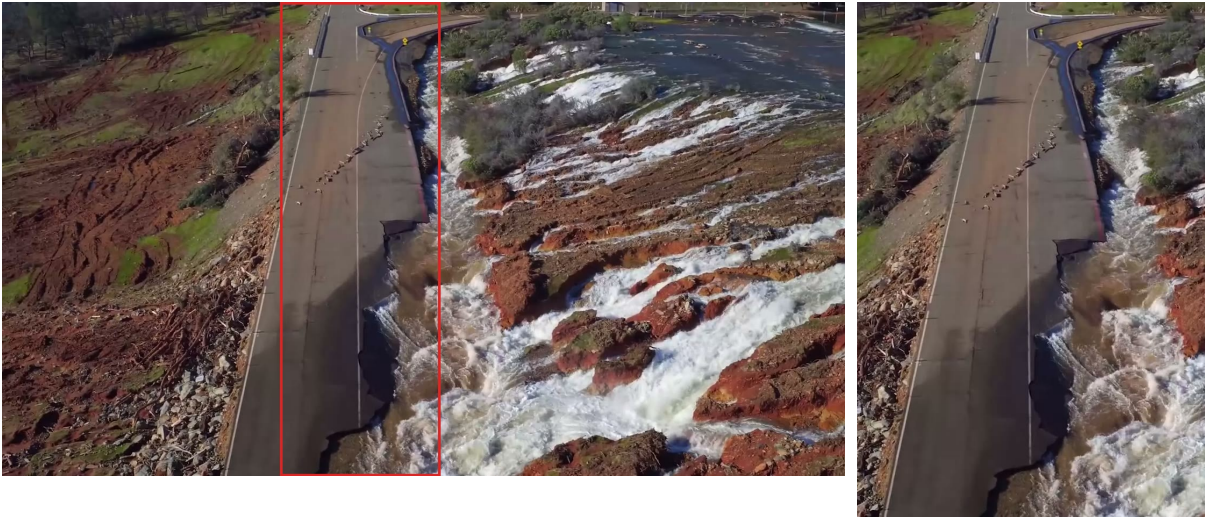
F-03 Road edge undermined by spillway flow

| Extent | ~100 m of road edge |

The water running beside the access road has eroded the ground next to it, and the pavement edge looks broken, with rocks and debris washed onto the road.

Visual evidence: Irregular dark broken edge along the right side of the road, rocks scattered on the pavement, fast water right beside it.

**For this finding:** Close the road to traffic; inspect the pavement and embankment once flow stops and rebuild the edge with erosion protection.

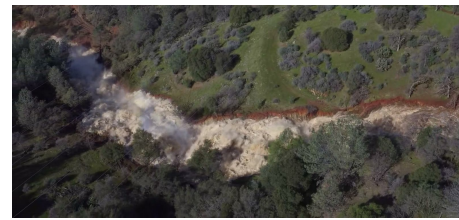
**F-05 Heavy erosion and sediment in the downstream channel****P2 · Planned (within 30 days)**

| Extent | Hundreds of metres of channel |

The flow below the spillway is carrying large amounts of eroded soil and rock. Its banks are freshly cut and red, and sediment will build up further downstream.

*Visual evidence:* Brown turbulent water filling a ravine; bare red earth scars along the banks.

**For this finding:** Survey the downstream channel and river for sediment deposits and bank failures once flows drop; plan debris removal.

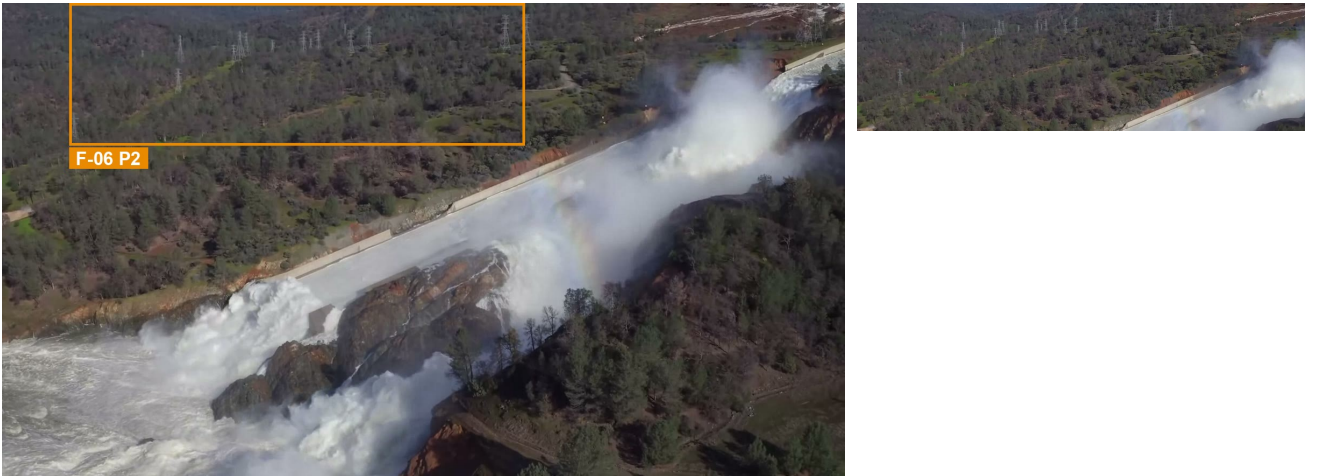
F-06 Transmission towers on the hillside near the eroding spillway

| Extent | 3-4 towers |

Several high-voltage transmission towers stand on the hillside above the spillway. If erosion spreads, their foundations could be at risk.

*Visual evidence:* Lattice towers along the ridge above the chute.

**For this finding:** Have the utility assess the towers' distance from the erosion and plan to de-energise or reroute if it spreads.
