# Mosier, OR - Oil Train Derailment

Oil & Gas Facility · 2026-09-30

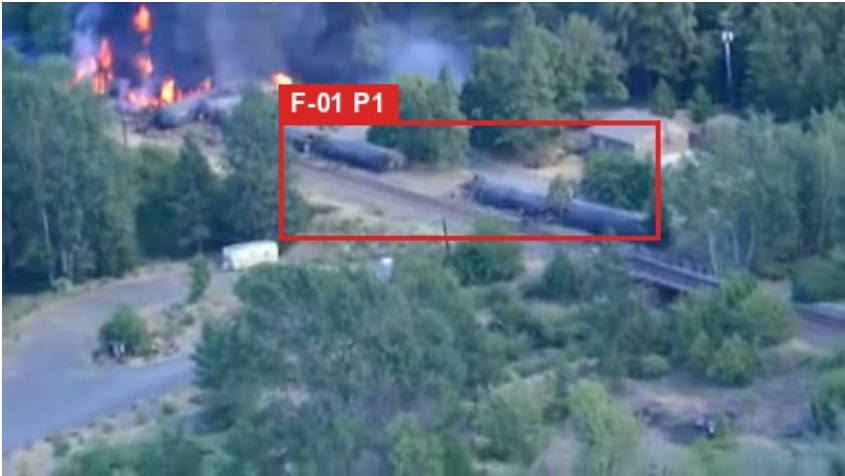
F-01 Intact tank cars close to the fire

| Extent | At least 6 cars within a few car lengths of the fire |

The next tank cars down the line are still on the rails and look intact, but they sit only a few car lengths from the fire and are exposed to its heat.

*Visual evidence:* Two groups of black tank cars upright on the track, the nearest roughly 2-4 car lengths from visible flames.

**For this finding:** Uncouple and pull the intact cars away from the fire once it is safe, or keep them cooled with water until they can be moved.

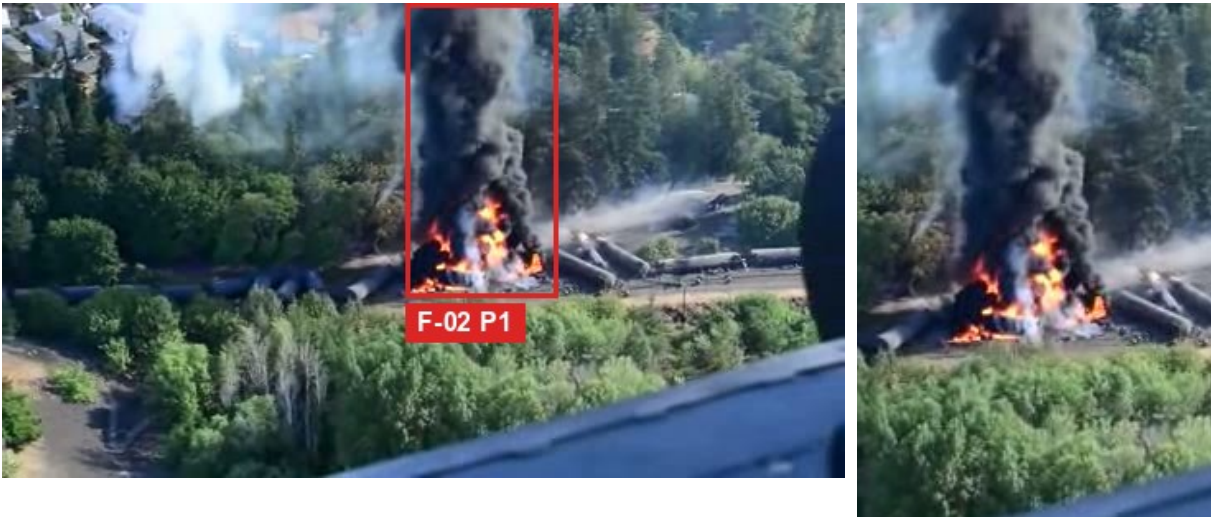
F-02 Crude oil fire with black smoke column

| Extent | Flames across about 2-3 car lengths |

Flames reach several metres high at the derailment and a dense black smoke column rises straight up out of the frame.

Visual evidence: Bright orange flames and a column of black smoke rising from the burning cars, with debris scattered at their base.

For this finding: Keep foam-equipped crews on the fire and cool the nearby tank cars with water until the fire is fully out.

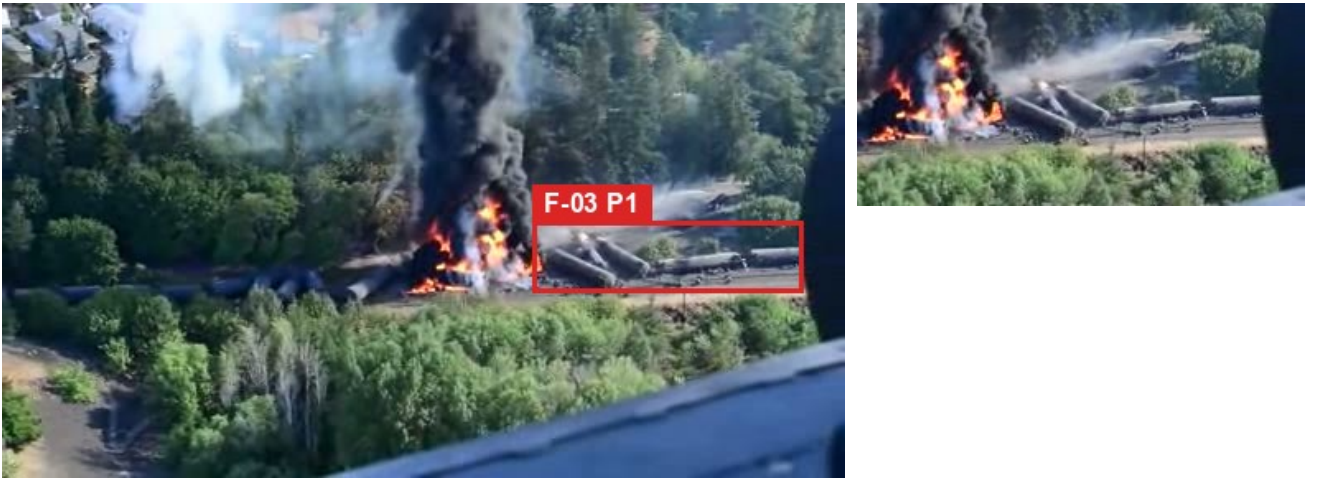
F-03 Derailed tank cars in zig-zag, several on their sides

| Extent | About 6 cars over roughly 100 m of track |

About six tank cars have jackknifed into a zig-zag off the track, several lying at steep angles or on their sides. Tank cars in this position can have punctured shells, sheared valves or damaged fittings.

Visual evidence: Cylindrical tank car bodies at sharp alternating angles, some lying almost across the track, directly next to the fire.

**For this finding:** After the fire is out, check every derailed car for leaks, transfer the remaining oil to undamaged tanks, then rerail or remove the cars and repair the track.

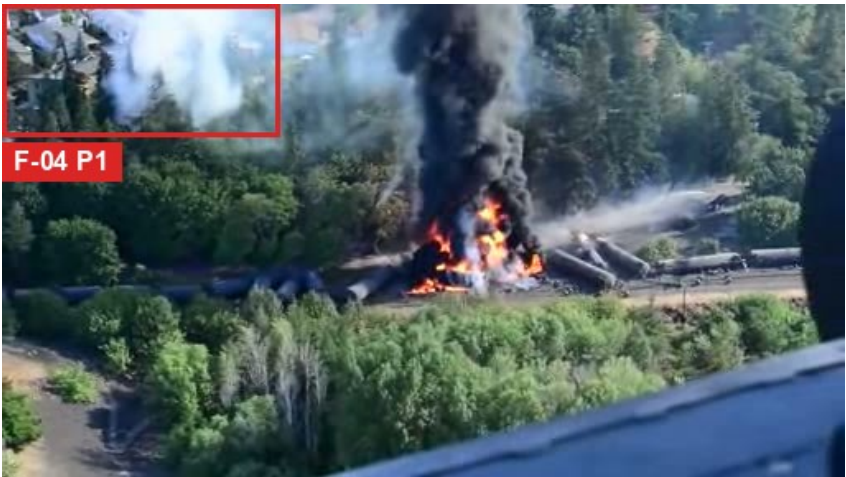
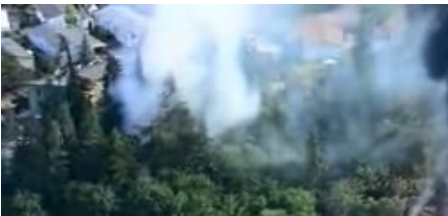
F-04 Smoke drifting over nearby homes

| Extent | Several houses under the smoke |

White and grey smoke is drifting across a row of houses at the top left, a short distance from the fire. People living there may be breathing it.

Visual evidence: Roofs and houses at the top-left corner partly hidden by a white smoke haze coming from the fire.

**For this finding:** Keep the evacuation or shelter-in-place order for these homes, and monitor air quality there until the fire is out.

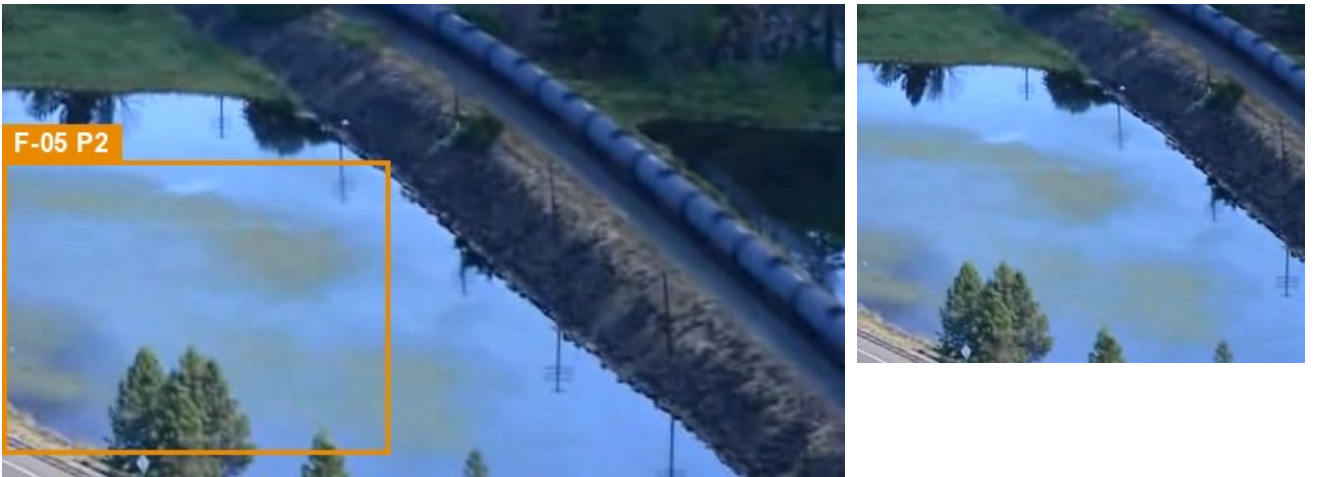
F-05 Yellow-green streaks on pond next to tank-car train

| Extent | Streaks across roughly the western half of the visible pond, tens of metres |

Long yellow-green streaks and patches float on the pond right next to the embankment where loaded crude tank cars are standing. They could be an oil sheen from the train, but they look equally like pollen or algae, which is common on still water in early June.

*Visual evidence:* Diffuse yellow-green bands on blue reflective water, no rainbow iridescence and no dark oil at the shoreline; resolution too low (512x288) to tell sheen from pollen.

**For this finding:** Have the spill response team check this pond with a sheen net or water sample before ruling out a release from the train.
