# Tank Farm - Storage Tank & Pipe Rack

Oil & Gas Facility · 2026-09-30

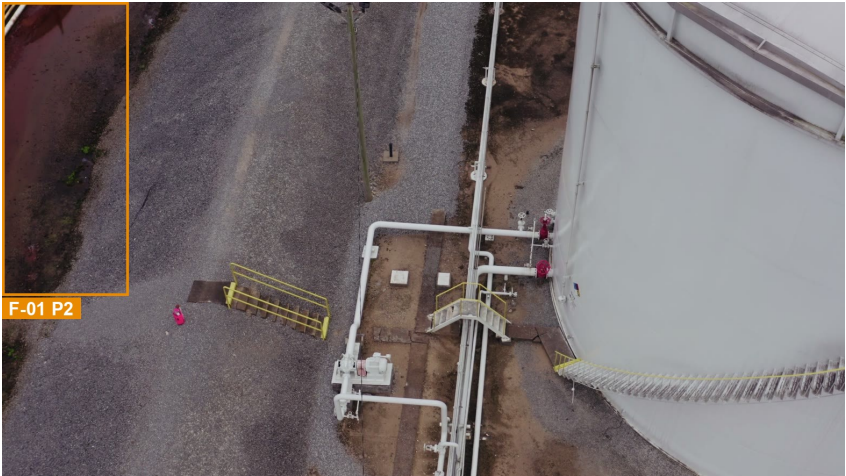
F-01 Reddish-brown wet discolouration in drainage channel

The drainage channel along the road has reddish-brown, wet-looking ground with weeds growing in it. It could be standing water with iron-rich sediment, or liquid draining from the tank area.

*Visual evidence:* Dark red-brown glossy surface along the channel, with green weeds along its edge.

**For this finding:** Sample the liquid or sediment in the channel; check where it drains from and that the tank area's drain valves are closed.

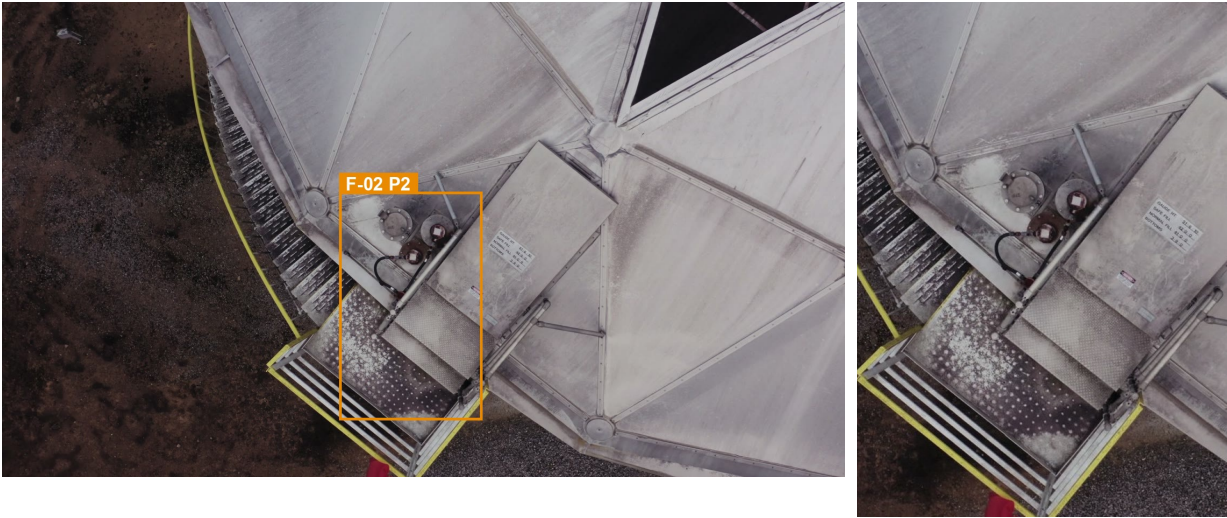
F-02 White crystalline deposits around roof hatches and stair landing

White powdery or crystalline deposits have built up around the roof hatch and vent fittings and on the stair landing below them. Deposits here often come from product vapour or liquid escaping through hatch or vent seals.  
*Visual evidence:* Bright white granular patches concentrated around the circular roof fittings and spread across the landing grating.

**For this finding:** Sample the deposit to identify it, then check the gaskets and seals on the roof hatches and vents; replace any that are worn and clean the deposits off.

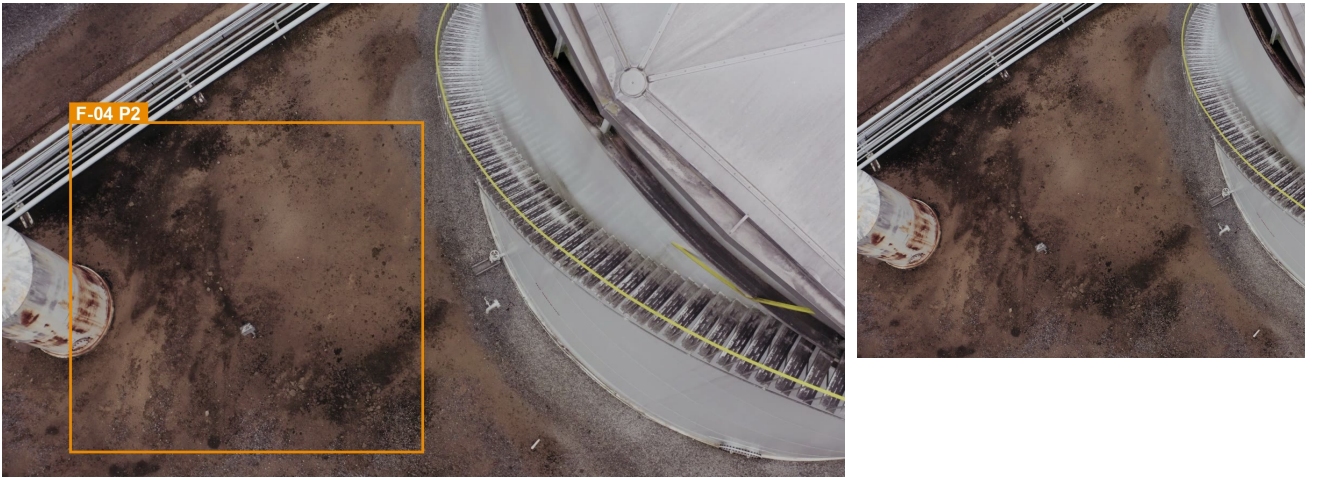
F-04 Dark soil staining along pipe rackP2 · Planned (within 30 days)

Dark stains follow the line of the pipe rack, which sits low over bare soil. Staining concentrated under piping often means drips from flanges, valves or drains over time.

Visual evidence: Dark patches strongest directly beneath and beside the pipes, fading further away.

**For this finding:** Take soil samples in the stained areas and test for hydrocarbons; if positive, find the source (buried line, flange or drain valve), repair it, and remove the contaminated soil.

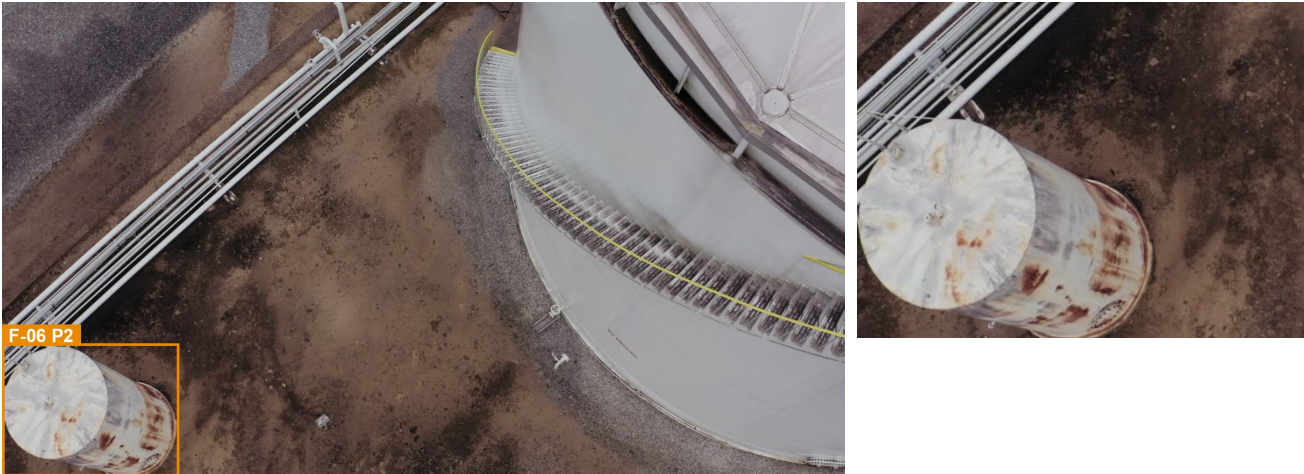
F-06 Corroded small vertical vessel

Closer view of the same vessel: heavy rust streaks on the shell and rust on the top.  
*Visual evidence:* Dense orange-brown streaks and patches on the shell.

**For this finding:** UT-gauge the vessel wall at the rusted areas; if thickness is fine, wire-brush or blast and recoat. If there is pitting, have an engineer assess it before it goes back in service.

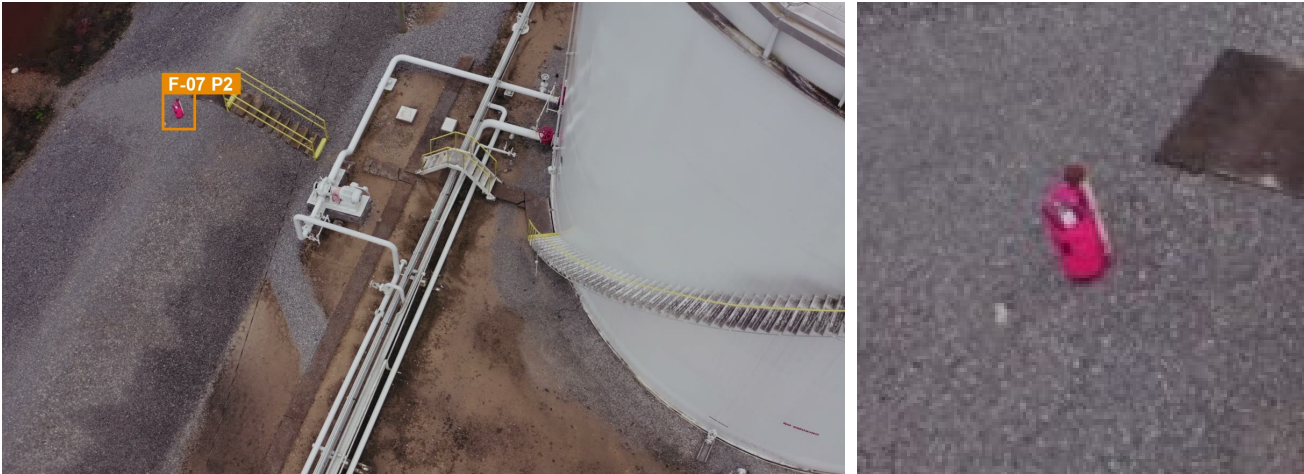
F-07 Loose red equipment lying on the ground

A small red item, possibly a portable fire extinguisher or gas detector, is lying loose on the gravel next to the crossover stairs rather than mounted or stored.

*Visual evidence:* Small bright red object on its side on the gravel.

**For this finding:** Identify the item; if it is a fire extinguisher, put it back on its bracket and check its inspection tag.

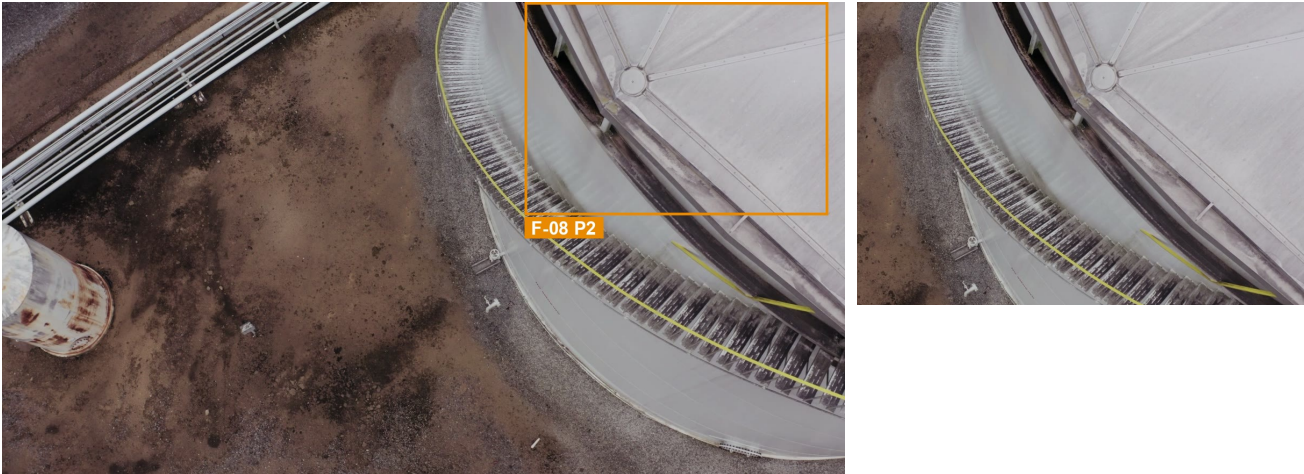
F-08 Dark band at roof-to-shell junctionP2 · Planned (within 30 days)

A dark band runs along the edge where the roof meets the tank shell. It could be staining from the seal area or just dirt that has collected there.

Visual evidence: Continuous dark grey band following the curve of the roof edge.

**For this finding:** Inspect the roof-to-shell seal from the wind girder or roof; check for vapour or product at the seal and repair if needed.
