# Abandoned Farmstead - Barn, Silos & Sheds

Buildings & Civic Property · 2026-09-30

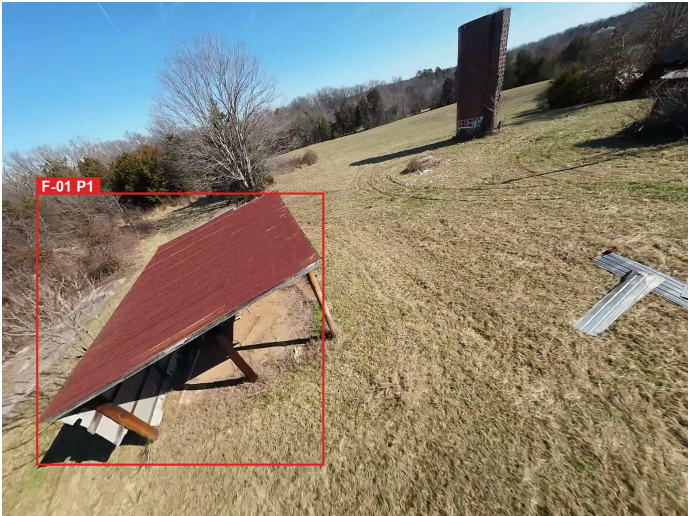
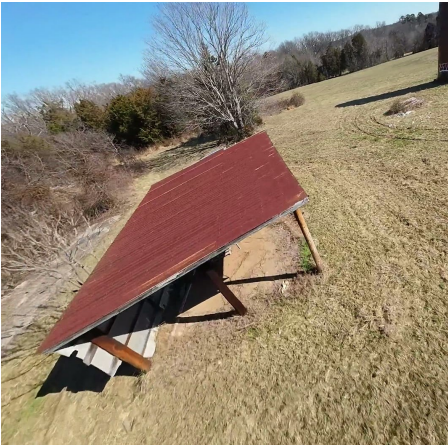
F-01 Collapsed shed roof lying on the ground

This shed's roof has dropped at one end and rests on the ground at an angle.

Visual evidence: Red roof panel sloping from its posts down to the ground; posts leaning.

For this finding: Demolish or prop the shed; keep people and vehicles from under it.

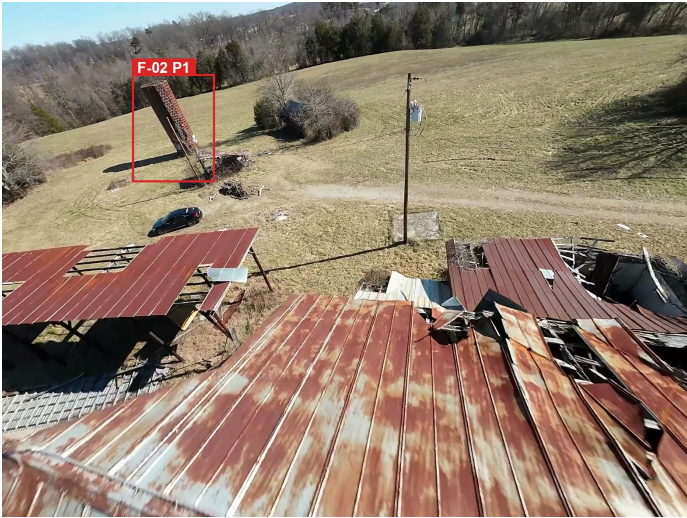
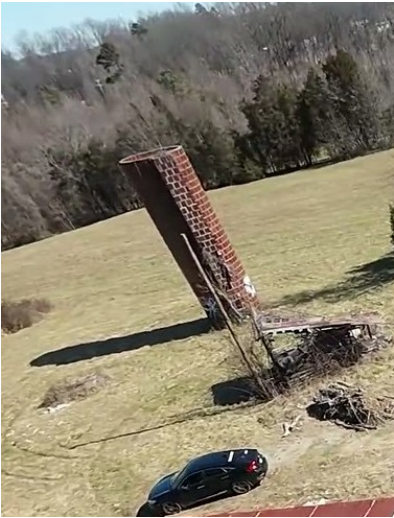
F-02    Roofless brick silo leaning

The roofless brick silo is clearly leaning off vertical.  
*Visual evidence:* Brick cylinder visibly tilted relative to the level ground and fence line.

**For this finding:** Fence off a fall zone of at least the silo's height, keep everyone away, and get a structural engineer to decide on emergency bracing or controlled demolition.

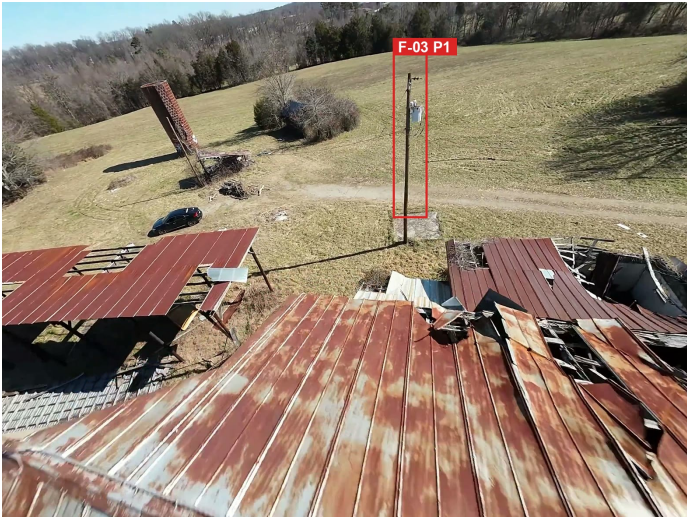
F-03 Power pole with transformer next to derelict shedsP1 · Immediate (within 24-72 h)

A power pole with a transformer stands close to the collapsed sheds. If the line is still live, it's a hazard for anyone clearing the site.

Visual evidence: Wooden pole with a pole-mounted transformer and lines, a few metres from the sheds.

For this finding: Ask the utility whether the service is live and have it disconnected before demolition or clearing.

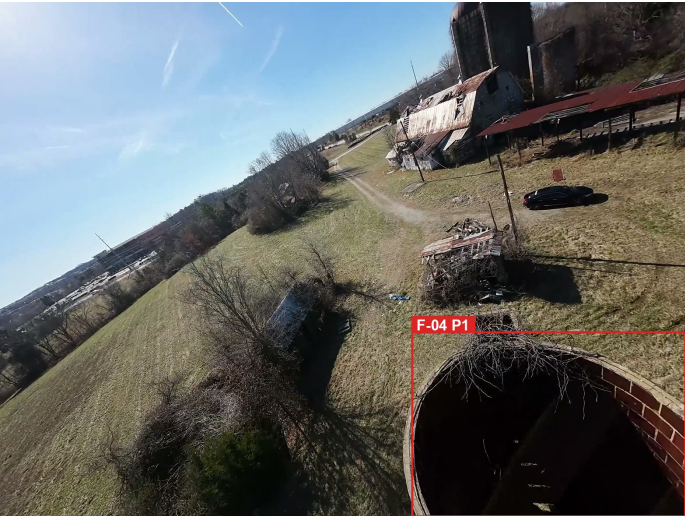
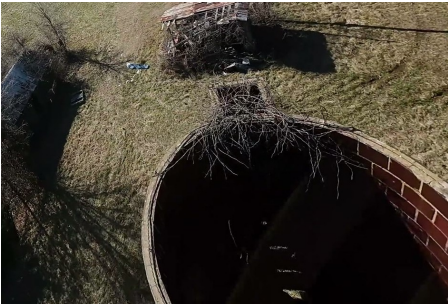
F-04 Open top of roofless silo

The brick silo has no roof; its open top collects rain and vines are growing over the rim, which loosens the brickwork.

Visual evidence: Open circular brick rim with vines across it, dark interior.

**For this finding:** Fence off a fall zone of at least the silo's height, keep everyone away, and get a structural engineer to decide on emergency bracing or controlled demolition.

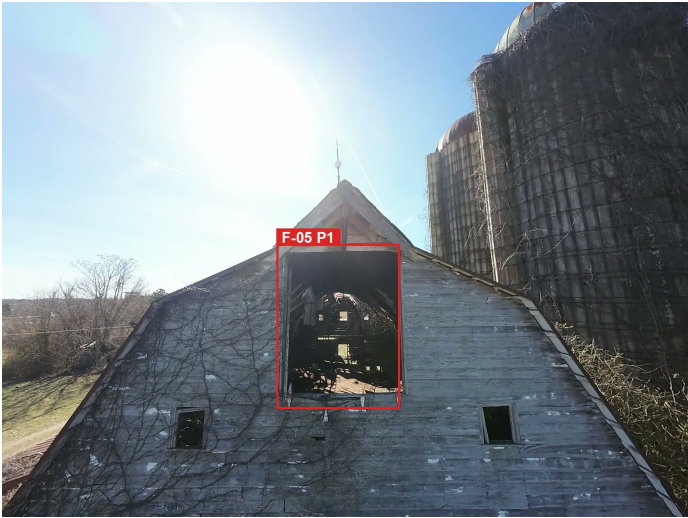
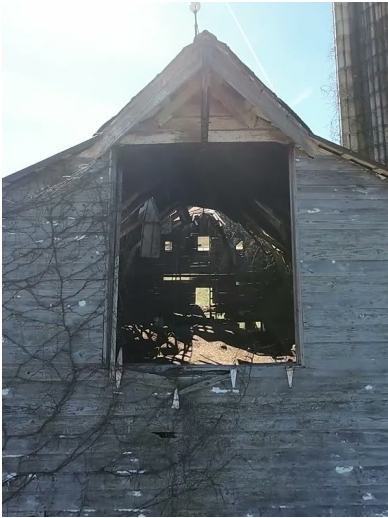
F-05 Hayloft door missing and roof collapse visible insideP1 · Immediate (within 24-72 h)

The hayloft door is gone, and through the opening you can see collapsed roof framing inside. Two small windows lower down are broken out.

Visual evidence: Large dark opening at the top of the gable with broken timbers visible inside; two empty window frames below.

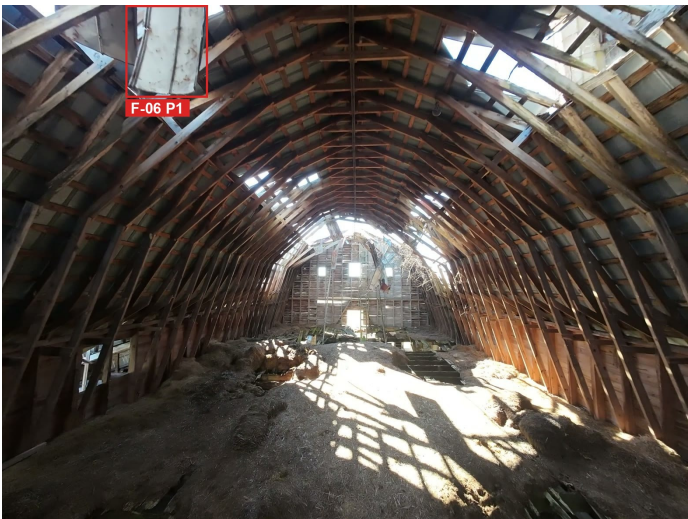
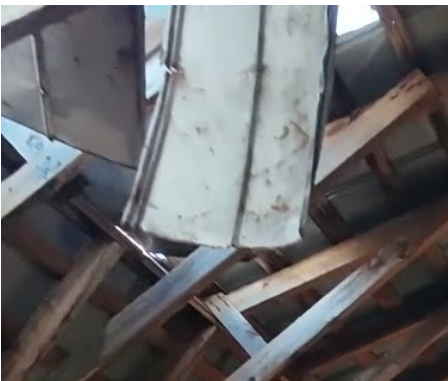
F-06 Loose metal sheet hanging from the rafters

A loose metal roof sheet is hanging down from the rafters and could fall on anyone below.  
*Visual evidence:* Grey sheet hanging at an angle from the top-left rafters.

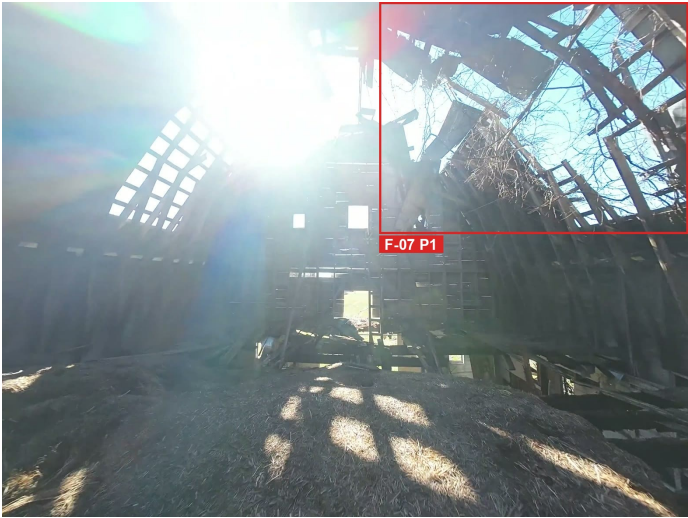
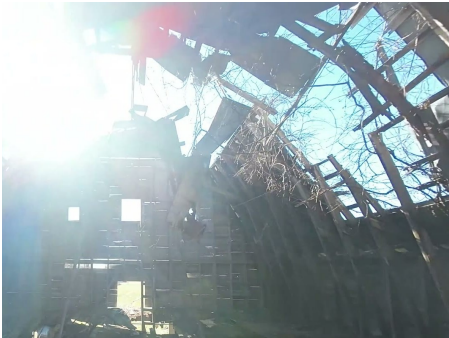
F-07   Roof collapsed at far end of barn

At the far end of the barn the roof has collapsed: rafters are broken and the roof is open to the sky.  
*Visual evidence:* Broken rafters and boards hanging down, open sky and branches visible through the roof.

**For this finding:** Treat the barn as unsafe; structural engineer to decide on demolition.

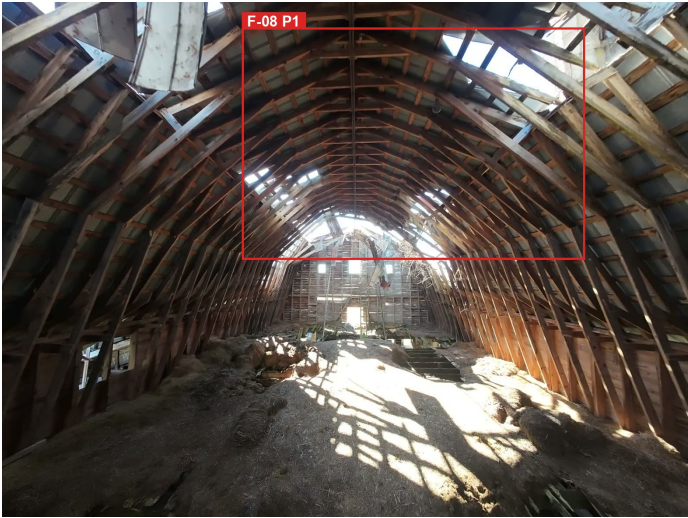
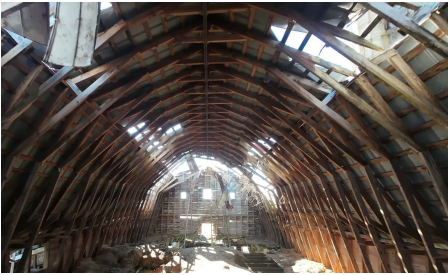
F-08 Daylight through missing roof boardsP1 · Immediate (within 24-72 h)

Inside the loft, daylight shows through large gaps where roof boards and sheets are missing. Rain is getting in and rotting the rafters.

For this finding: Structural assessment of rafters for rot; re-roof only if the frame is sound.

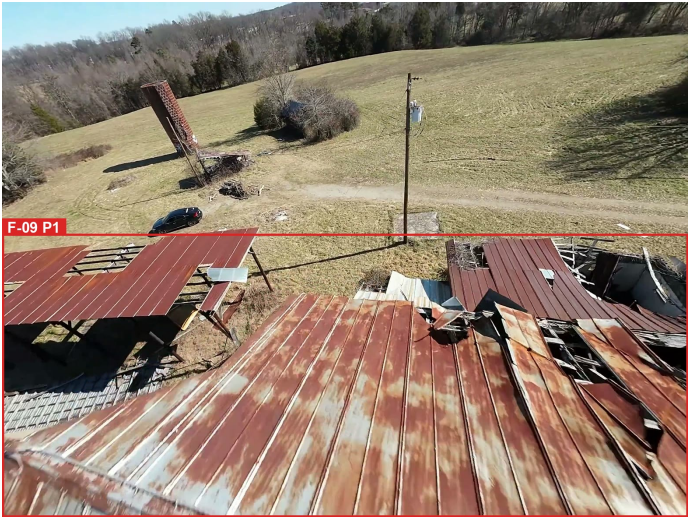
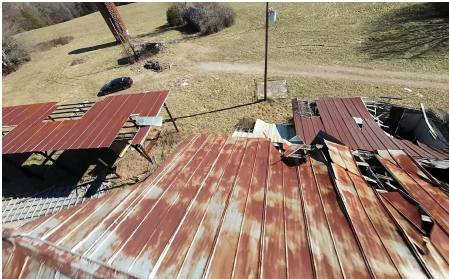
F-09Rusted and torn roofing on collapsed shedsP1 · Immediate (within 24-72 h)

The shed roofing is heavily rusted, and the sheets on the right are torn, folded and partly collapsed.  
*Visual evidence:* Orange rust over the corrugated sheets; crumpled sheets and broken framing on the right.

**For this finding:** Remove the collapsed roofing; the sheds are beyond simple repair.

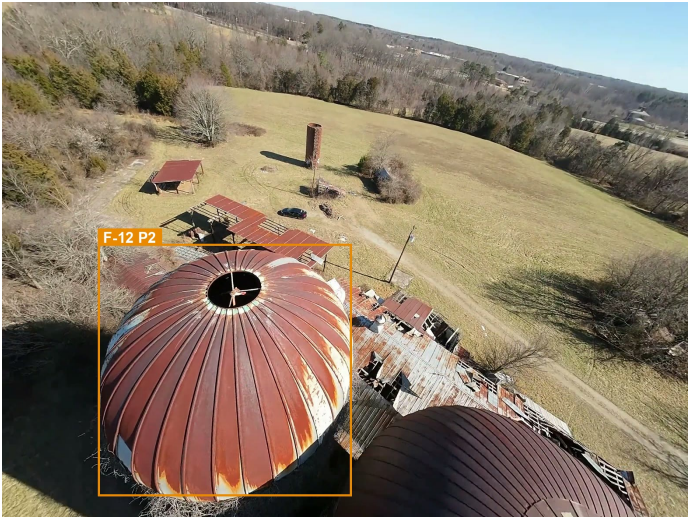
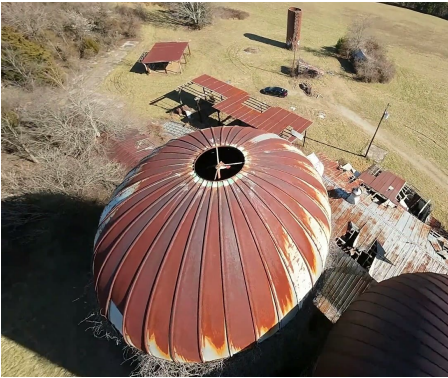
F-12Rusted silo dome with open top hatch

This dome is heavily rusted and its top hatch is open or missing, letting rain straight into the silo.  
*Visual evidence:* Rust-red dome with a black circular opening at the top.

**For this finding:** Close or cap the hatch; inspect and recoat or replace the dome.

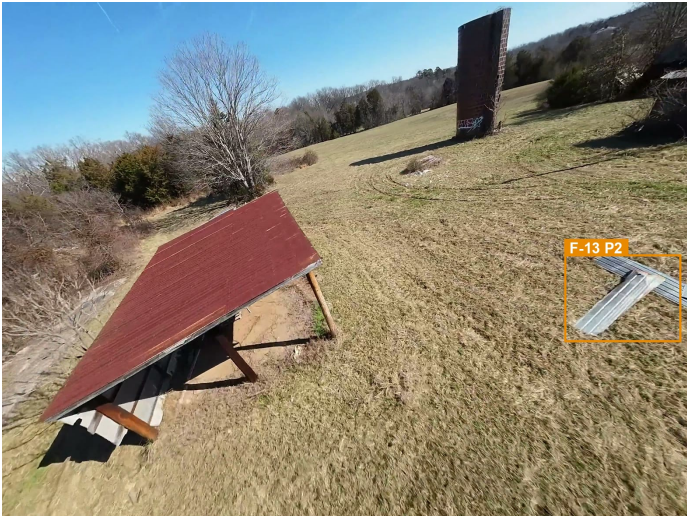
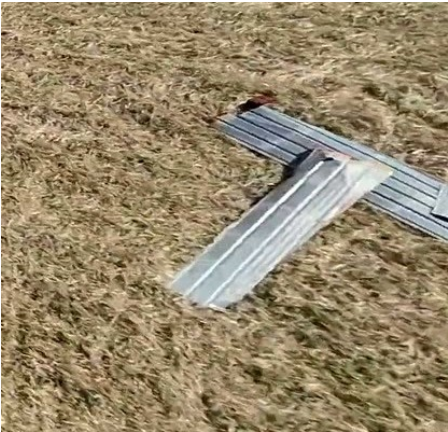
F-13 Loose metal sheets lying in the field

Loose metal roofing sheets are lying in the grass. Strong wind can throw them.  
*Visual evidence:* Grey sheet metal pieces on the ground away from any structure.

**For this finding:** Collect and stack or remove the loose sheets.

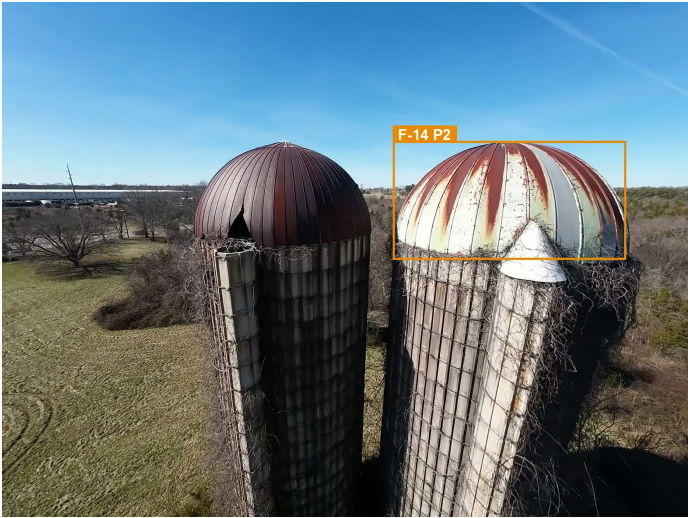
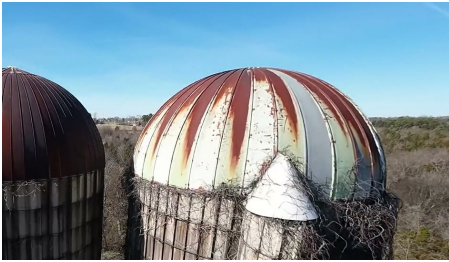
F-14 Heavy rust on silo dome

The right silo's dome has heavy rust streaks running down most of its panels and the coating has failed.  
*Visual evidence:* Orange rust runs between the ribs across the whole dome, bare metal showing.

**For this finding:** Check the dome for thinned or holed panels and loose fasteners; recoat or replace.
