# Solar Sample Portfolio (3 sites)

Solar PV Farm / Rooftop Array · 2026-09-30

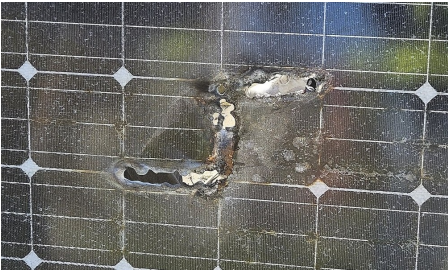
F-01 Burn-through holes in module glass

| Component | PV module (removed from Site A roof) |
| Extent | Area of about 4 cells, ~30 x 25 cm |
| Severity | Critical, score 3.90 / 4 |

The module has burned through from behind: two holes have melted through the glass and cells, with charred and melted material around them. This is the result of an internal electrical fault (hotspot or arc) that caught fire.

*Visual evidence:* Two ragged holes with melted, silvered edges, brown scorching around them across 3-4 cells.

**For this finding:** Keep the module out of service and send it for failure analysis or warranty; test the rest of the string and the other modules on the roof for the same fault.

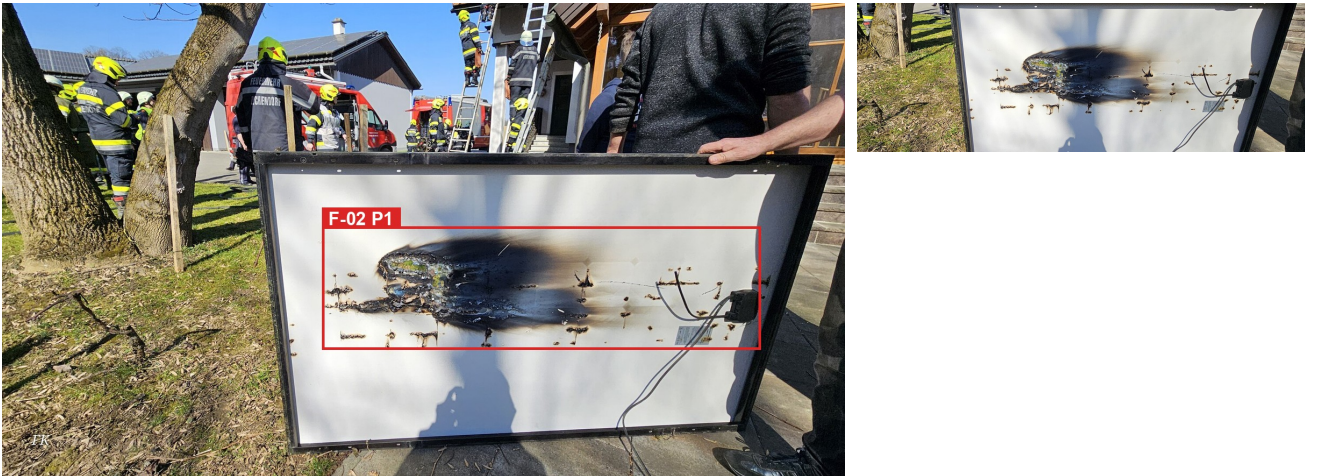
F-02 Scorched backsheet with burn marks along the cell connections

| Component | PV module backsheet (removed from Site A) |
| Extent | Burn area ~40 x 15 cm plus spots across most of the module width |
| Severity | Critical, score 3.88 / 4 |

The back of the module is badly scorched in a large patch, and there are many small burn spots in a line along the cell connections, some near the junction box. This points to an electrical fault inside the module, not an outside fire.  
*Visual evidence:* Large black burned area with melted material in the middle, plus a row of small brown-black burn spots across the backsheet.

**For this finding:** Keep for failure analysis; check the same model and batch elsewhere on the roof with a thermal camera, and have an electrician inspect the inverter's arc-fault and ground-fault settings.

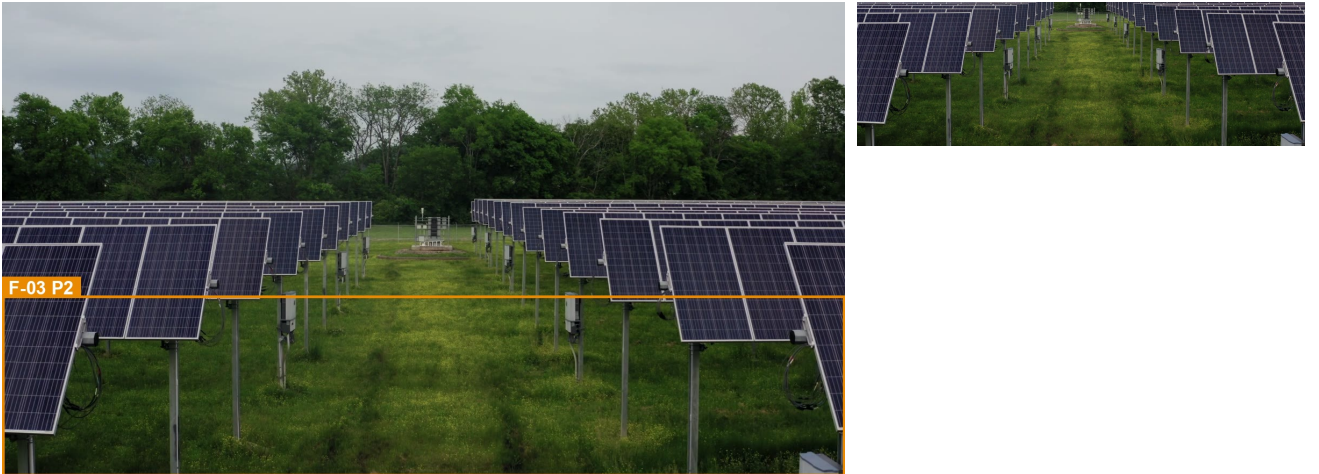
F-03 Tall vegetation under module rows

| Component | ground under the rows, Site B |
| Severity | Major, score 2.62 / 4 |

Grass and weeds are growing tall under and between the rows. In summer this can reach the lower module edges, shading cells, and dry grass is a fire risk next to cabling.

**For this finding:** Mow or graze under the rows on a regular schedule, keeping vegetation well below the lowest module edge.

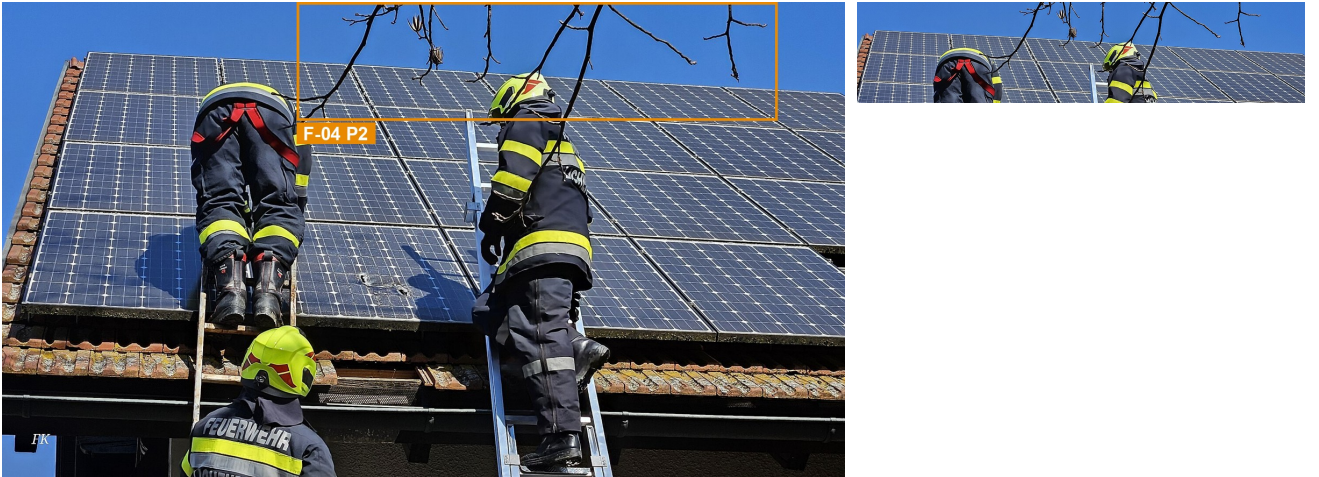
F-04 Tree branches overhanging the array

| Component | tree next to Site A roof |
| Severity | Moderate, score 2.17 / 4 |

Branches from a nearby tree hang over the top of the array. In leaf they will shade the upper modules for part of the day.

For this finding: Trim the tree back so it can't shade or drop debris on the array.

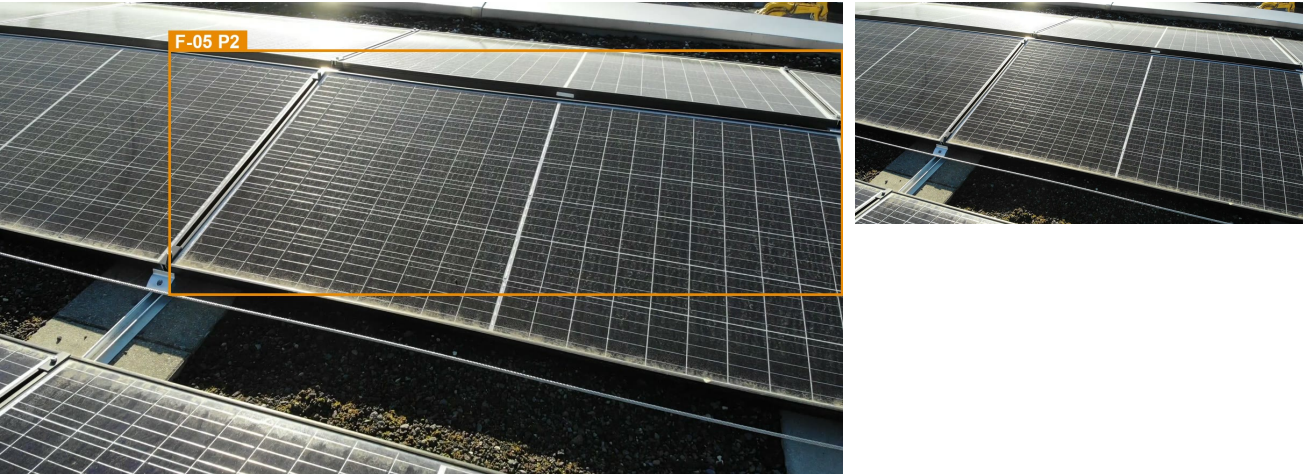
F-05 Dirt build-up along module lower edges

| Component | rooftop PV modules, Site C |
| Severity | Moderate, score 1.98 / 4 |

Dirt has built up in a band along the lower frame edge of the modules, where rain runs off and leaves grime behind. Edge soiling shades the bottom row of cells and cuts output more than even dust does.

Visual evidence: Grey-brown band of dirt along the bottom edge of the glass, plus speckled dust over the rest of the surface.

For this finding: Clean the modules, paying attention to the lower edge; check the tilt allows water to run off freely.

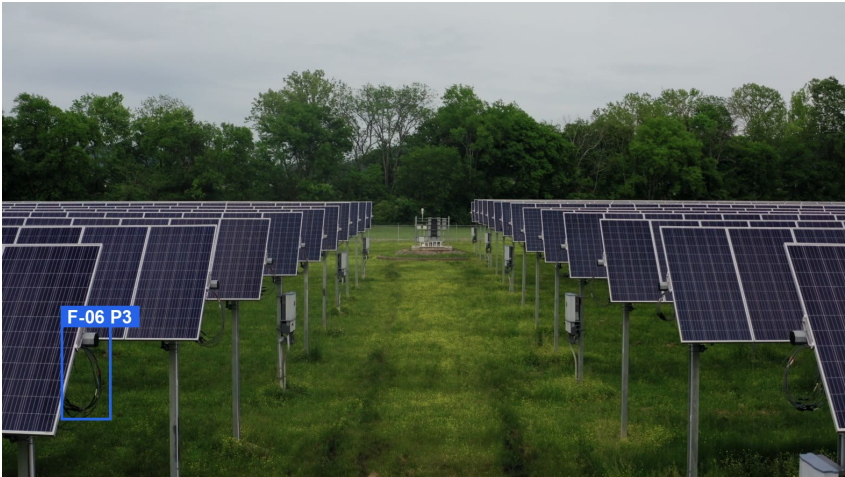
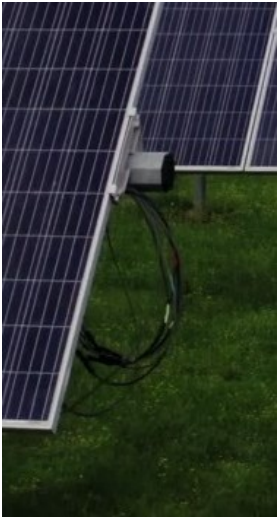
F-06 DC cables hanging loose under modules

| Component | string cabling under module rows, Site B |
| Severity | Moderate, score 1.67 / 4 |

Cables hang in loose loops below the modules at both sides of the aisle instead of being clipped to the racking. Loose cables can be chafed by wind, chewed by animals, or caught by mowers.

Visual evidence: Dark cable loops hanging freely below the module edges on the left and right.

**For this finding:** Isolate the strings, inspect the cables for damage, and clip them to the racking with UV-rated clips.

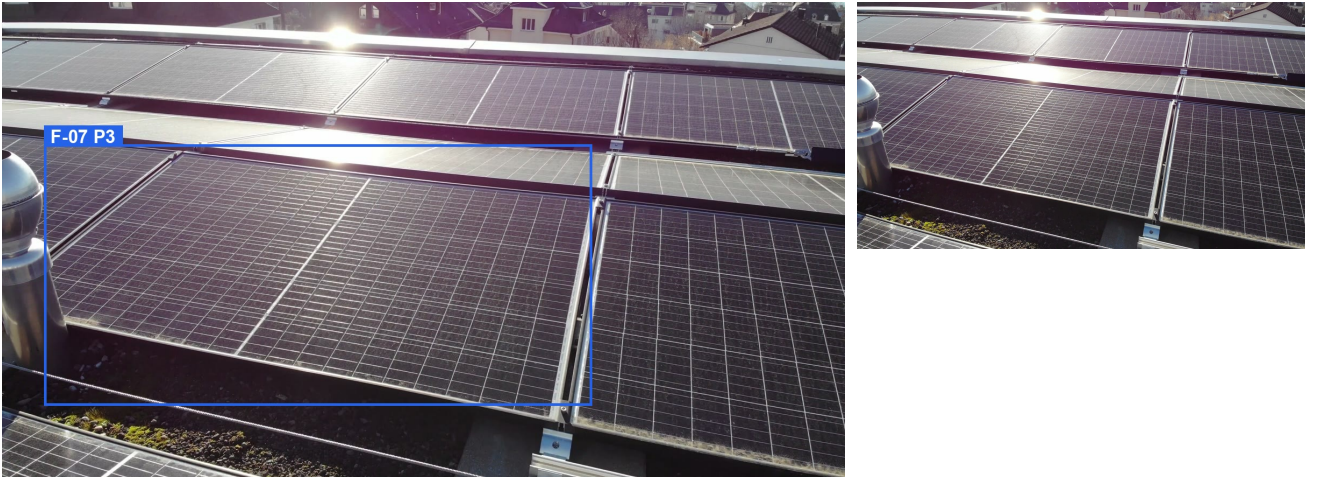
F-07 Dust and grime on module glass

| Component | rooftop PV modules, Site C |
| Severity | Moderate, score 1.70 / 4 |

The glass on several modules has a visible layer of dust and grime spread over the surface.  
*Visual evidence:* Matte, speckled film over the cells, clearest where the light catches it.

**For this finding:** Clean with deionised water and a soft brush; set a cleaning interval based on how quickly it builds up.
