<b>FINAL ASSEMBLY INSTRUCTION</b>	<b>PT5664</b>
	<b>POWER SUPPLY 4008 109 71110 MB</b>	Digital & Analog Composite WMF
Prepared by : BKB/Gbg

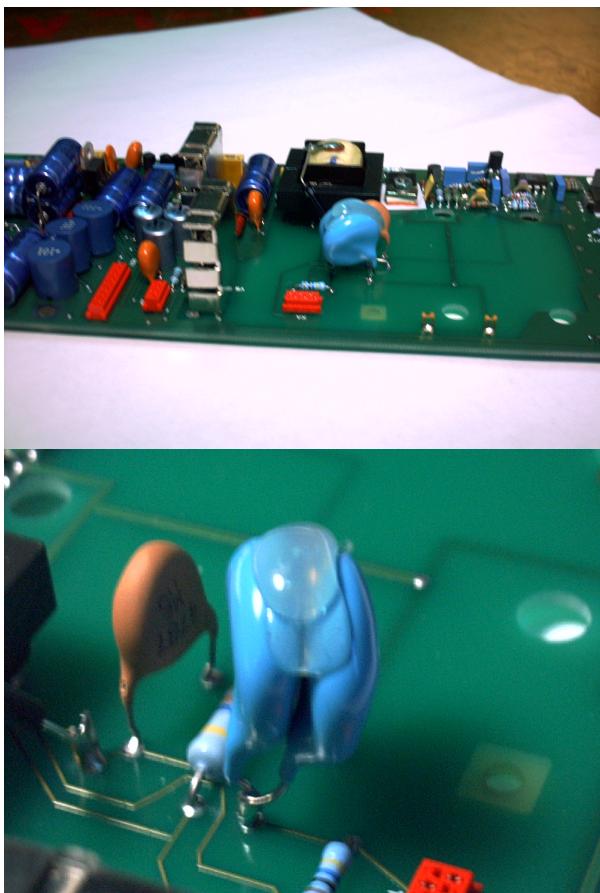
Some breaks of the power supply in the PT5664/50 have shown to be caused by a high tension capacitor, not living up the usual quality.

Therefore we have introduced a change of capacitor type which cures the main problem: flash-over in the capacitor. A flash over may cause the power supply to malfunction. At the same time two other changes which makes the operation more reliable.

Capacitor C-063 (10nF) to be changed to 2 pcs. 4,7nF, make: MuRata: DE1610-452E472M-KXSMKX12C50  
Both capacitors to be mounted as shown below:
