# Batch Inspection Report: karthik

### **\*\*Executive Summary: Maritime Vessel Inspection Findings\*\***

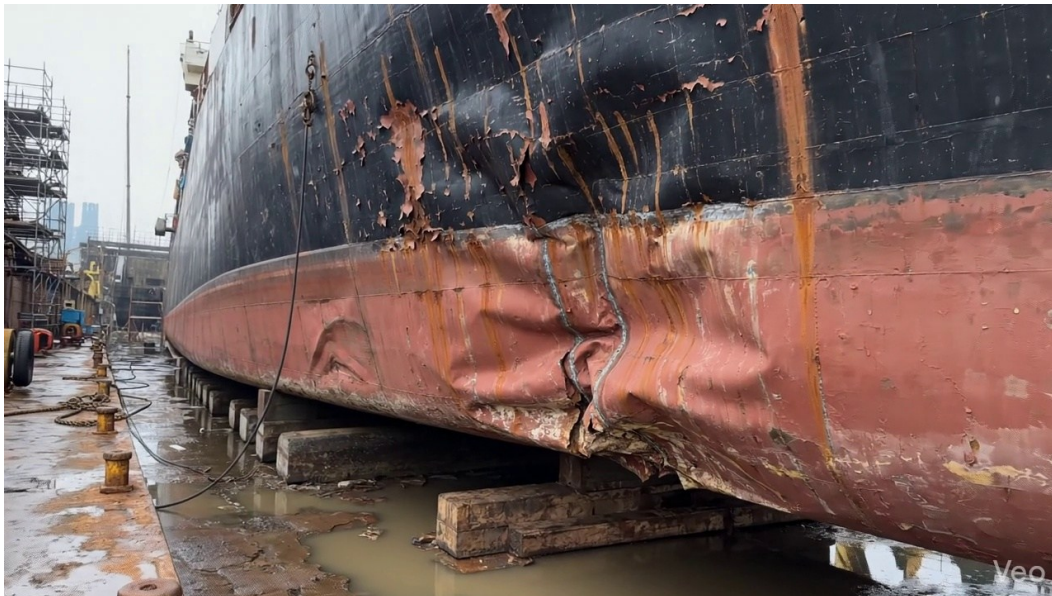
### 3.1 PD\_1

This report details the significant maritime defect identified as **DEFORMATION**, observed within a substantial portion of the **HULL\_AREA** (with a detected overlap ratio of 0.33). This defect has been classified with a **high severity**, necessitating immediate professional attention.

Structurally, deformation directly implies a significant reduction in both the local and global strength of the vessel. The out-of-plane bending of plating and stiffeners means these elements can no longer effectively transfer compressive and tensile loads as originally designed. This critically diminishes their contribution to the overall hull girder's ability to withstand longitudinal and transverse stresses, thereby reducing the vessel's primary strength. As per standard classification practice, significant buckling or warping necessitates structural renewal, typically involving cutting out and replacing the distorted metal with new, appropriately faired sections. While very minor, localized 'set-in' plating might occasionally be tolerated if it does not affect strength, the observed extent and high severity of this deformation affecting a substantial part of the HULL\_AREA demands immediate and thorough repair to restore the vessel's structural robustness to its design standard.

This document outlines the professional procedure for conducting structural repairs to vessel hull plating, specifically addressing localized deformation or buckling. The process emphasizes structural integrity, quality control, and adherence to classification society standards.

\* \*\*What Happens:\*\* Using thermal cutting equipment, all visibly distorted plate sections, along with any buckled or significantly bent girders or stiffeners, are meticulously cut away. The cutting boundary extends into the "sound metal," leaving a margin of at least three-quarters of the original plate thickness beyond the visible damage. This margin guarantees that the new weld will be executed on structurally sound material. Any underlying bent framing that is not being replaced is either straightened to its original alignment or removed if straightening is not feasible or effective.

\* \*\*What Happens:\*\* A new steel plate, matching or exceeding the original specified thickness and material grade, is fabricated. This new plate is precisely shaped and dimensioned to fit the aperture created by the removal of the damaged section. It is then carefully positioned against the remaining hull plating, ensuring correct alignment and minimal gaps. The new plate is secured in place with tack welds to maintain its position and alignment during the primary welding process. Subsequently, full-perimeter welding is initiated, ensuring good fusion with the existing hull structure. Appropriate preheat procedures are applied, particularly for thicker plates or higher-strength steels, to mitigate

\* \*\*What Happens:\*\* Continuous weld passes are applied to complete the full penetration welds around the perimeter of the new plate. E7018 low-hydrogen electrodes are typically utilized due to their excellent mechanical properties, high deposition rates, and resistance to hydrogen-induced cracking, making them suitable for critical structural applications. Throughout the welding process, careful attention is paid to controlling heat input to minimize thermal distortion. Techniques such as strong-backs, clamps, sequence welding, or skip welding may be employed to maintain plate alignment and prevent buckling. Once welding is complete, all weld seams are meticulously ground fair with the surrounding hull surface. This reduces stress concentrations, improves hydrodynamics, and ensures a smooth, aesthetically pleasing finish. In instances of extensive original buckling or if the repair significantly alters the local stress distribution, additional strengthening, such as doublers (pads welded over the joint) or new stiffeners, may be designed and applied to enhance the section modulus and reduce localized stress.

\* \*\*What Happens:\*\* The completed repair undergoes rigorous inspection. This includes comprehensive visual inspection for any surface defects, undercut, or incomplete fusion. Crucially, Non-Destructive Testing (NDT) methods, such as Magnetic Particle Testing (MPT), Liquid Penetrant Testing (LPT), or Ultrasonic Testing (UT), are employed to detect subsurface defects like cracks, porosity, or lack of fusion, ensuring the weld integrity meets classification society standards. Upon successful NDT, the new steel surface is thoroughly cleaned and prepared for coating. A primer coat is applied, followed by appropriate finish coats, meticulously restoring the corrosion protection system of the hull. Finally, the repaired deck or hull surface is faired back to its original contour, ensuring smooth lines, preventing drag, and maintaining the vessel's design profile.
