# Vessel Inspection Report

**Executive Summary: Maritime Vessel Condition Assessment**

### 3.1 PD\_1

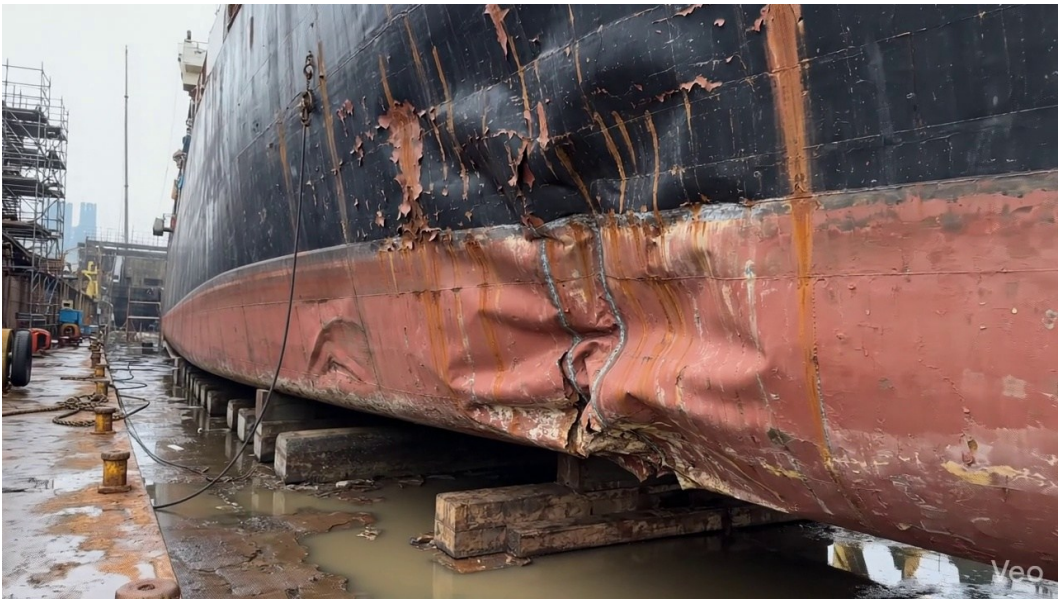
**\*\*Defect Name:\*\* DEFORMATION**

**\*\*Severity:\*\* High**

Deformation, specifically observed as buckling or warping, refers to an out-of-plane bending or distortion of the vessel's hull plating or structural stiffeners. Unlike simple indentations or minor set-ins, deformation involves a significant change in the original planar form of the material, causing it to bulge outwards or inwards from its intended shape. This condition typically arises from significant external forces such as grounding impacts, heavy sea loads (e.g., slamming), or internal stresses like those induced by uneven welding procedures or thermal stress during construction or repair. While minor, localized set-in plating might occasionally be tolerated if insignificant, true deformation implies a structural compromise.

This defect is deemed of **\*\*high severity\*\*** due to its direct and significant impact on the vessel's structural integrity, particularly the primary hull girder strength. Even seemingly moderate instances of buckling or warping severely impair the inherent strength, rigidity, and load-carrying capacity of the affected components. As this deformation is located within the critical HULL\_AREA, it directly undermines the fundamental structural backbone of the vessel, which is designed to withstand complex static and dynamic loads encountered at sea. Its presence indicates a failure to maintain design margins for strength and stiffness.

\* **Impairment of Hull Girder Strength:** The most critical implication is the severe impairment of the vessel's primary hull girder strength. The hull girder, which functions as a large beam, loses its ability to effectively withstand longitudinal bending moments (hogging and sagging) and torsional forces. Out-of-plane deformation significantly reduces the sectional modulus and moment of inertia of the affected area, directly diminishing the hull's overall resistance to these critical stresses.

\* **Loss of Stiffness and Load-Bearing Capacity:** Buckled plating and stiffeners lose their original design stiffness and load-bearing capacity. This effectively means the material is no longer contributing to the overall structural strength as intended, and the loads are transferred unevenly to adjacent, potentially undamaged, structural members, which were not designed to carry such additional or redistributed stresses.

\* **Stress Concentrations and Fatigue Life Reduction:** The distorted geometry creates highly localized stress concentrations around the buckles and their boundaries. These areas become hot spots for crack initiation and propagation under cyclic loading, leading to a significant reduction in the fatigue life of the affected components and, potentially, the entire hull structure.

\* **Mandatory Renewal:** Given these severe implications, classification practice mandates the correction of significant buckling by cutting out and replacing the distorted metal with new material of appropriate specification. This ensures the restoration of the original structural integrity, design strength, and safety margins.
