# Vessel Inspection Report

\*\*Executive Summary: Maritime Vessel Condition Assessment\*\*

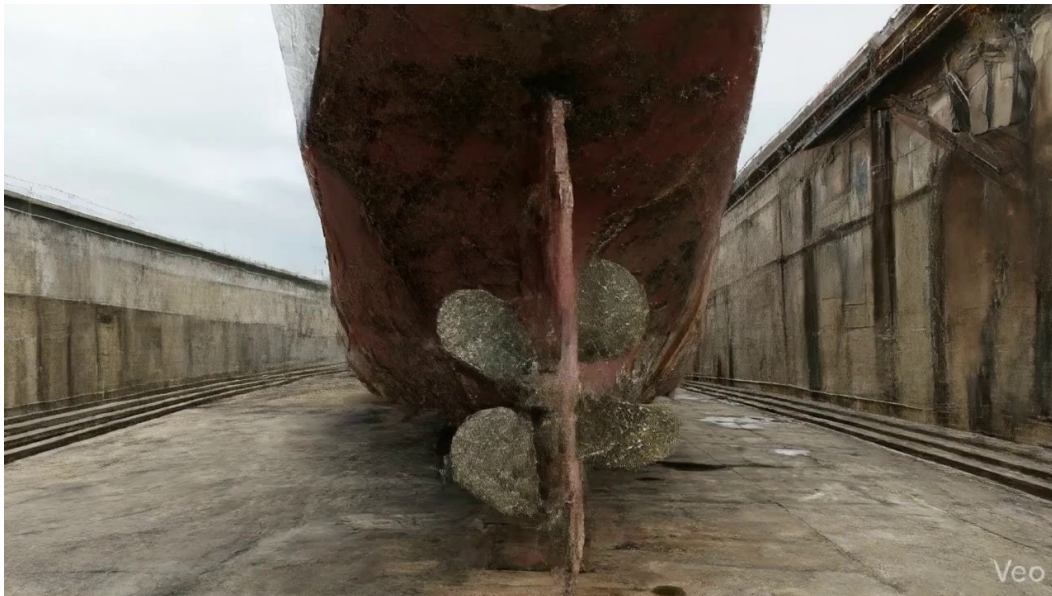
### 3.1 PD\_1

**\*\*Defect Explanation: Deformation (Buckling/Warping) - Medium Severity\*\***

Deformation, specifically noted as buckling and warping, has been identified in the vessel's structure, categorized with a medium severity rating. This defect primarily affects the KEEL\_AREA (with an approximate 11.5% overlap) and the PROPELLER\_AREA (with an approximate 15.7% overlap).

These distortions typically result from excessive localized loads such as grounding impacts, heavy dynamic sea loads, or significant internal stresses like those induced by uneven welding procedures or welding heat stress during construction or repair.

- \* **KEEL\_AREA:** Deformation here compromises the primary longitudinal strength member, increasing vulnerability to grounding damage and affecting the distribution of loads across the vessel's bottom.

- \* **PROPELLER\_AREA:** Distortion near the propeller can affect stern tube alignment, increase propeller-induced vibrations, or lead to accelerated wear and damage to the propulsion system components, including the propeller and shaft bearings.

Given the medium severity and location of the deformation in critical structural areas (Keel and Propeller), it is strongly recommended that a thorough engineering assessment be conducted by a qualified surveyor and/or naval architect. Remedial action, typically involving the cutting out and replacement of the distorted plating and stiffeners, must be undertaken in accordance with classification society requirements to restore the vessel's structural integrity and ensure continued safe and compliant operation. Small, localized set-in plating might sometimes be tolerated if proven insignificant, but the noted significant buckles necessitate renewal.

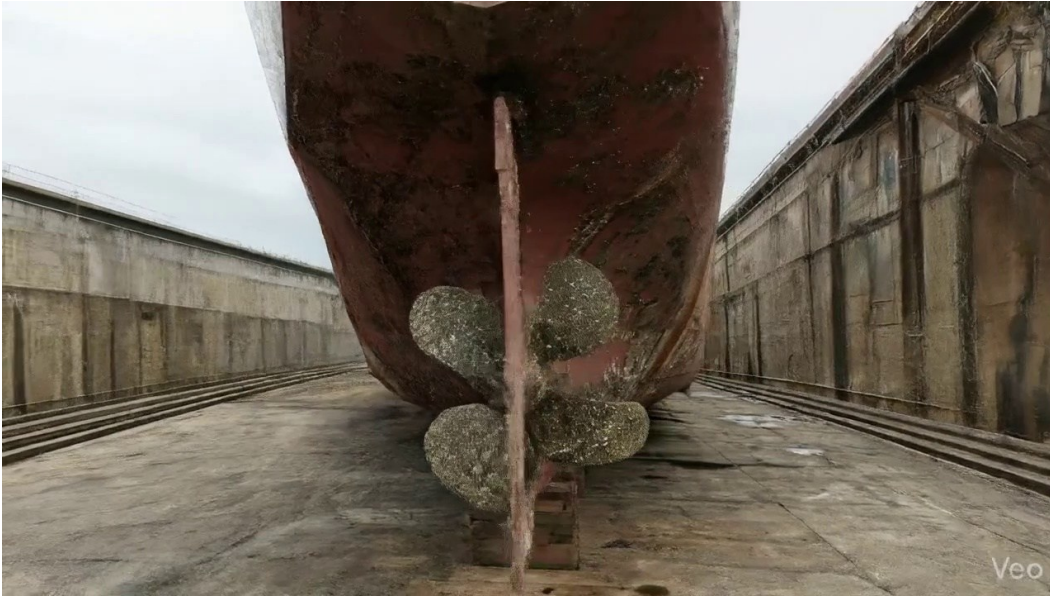
**Defect Name:** DEFORMATION

Deformation, specifically manifesting as buckling or warping, refers to an undesirable out-of-plane bending or distortion of a vessel's hull plating or its supporting stiffeners. This condition indicates that the metal has lost its original intended flat or contoured shape and has been subjected to stresses beyond its elastic limit. Common causes identified for such deformation include significant external forces like grounding impacts, exposure to heavy sea loads, or internal stresses generated during construction or repair, such as uneven welding heat stress.

This document outlines the professional repair process undertaken to address a deformed region on a vessel, ensuring the restoration of structural integrity, watertightness, and aesthetic fairness.

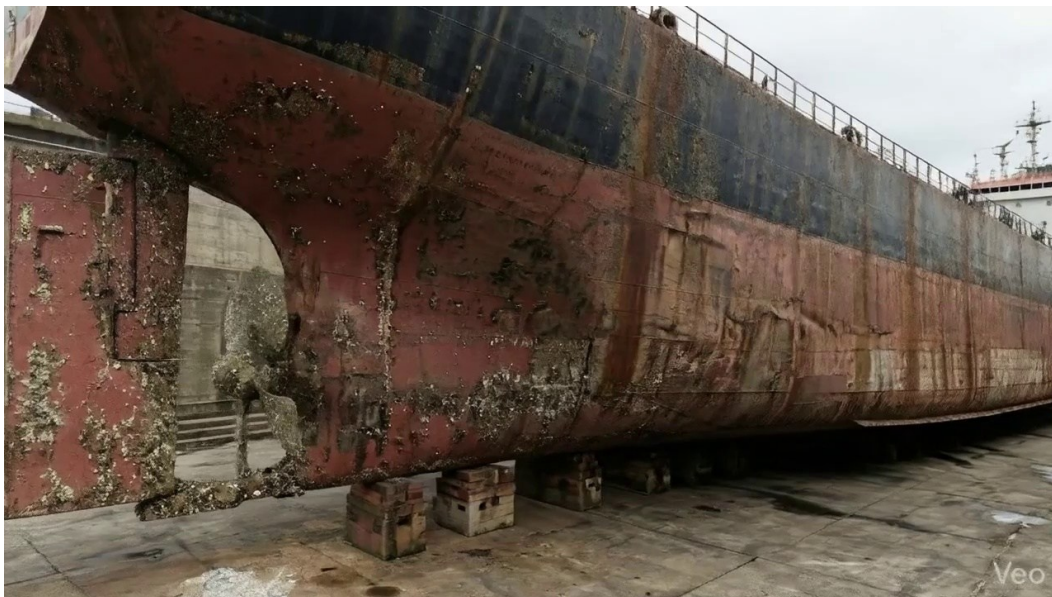
- \* **Classification Mandate for Renewal:** The standard classification practice of correcting buckling by cutting out and replacing the distorted metal, rather than attempting to straighten it, underscores the irreversible structural damage and loss of material properties that deformation signifies.

This report outlines the detailed process for localized maritime structural repairs, focusing on rectifying buckled or deformed hull plating, and addresses the necessity of each step, the activities performed, the utility of specified equipment, and overarching safety and structural considerations.

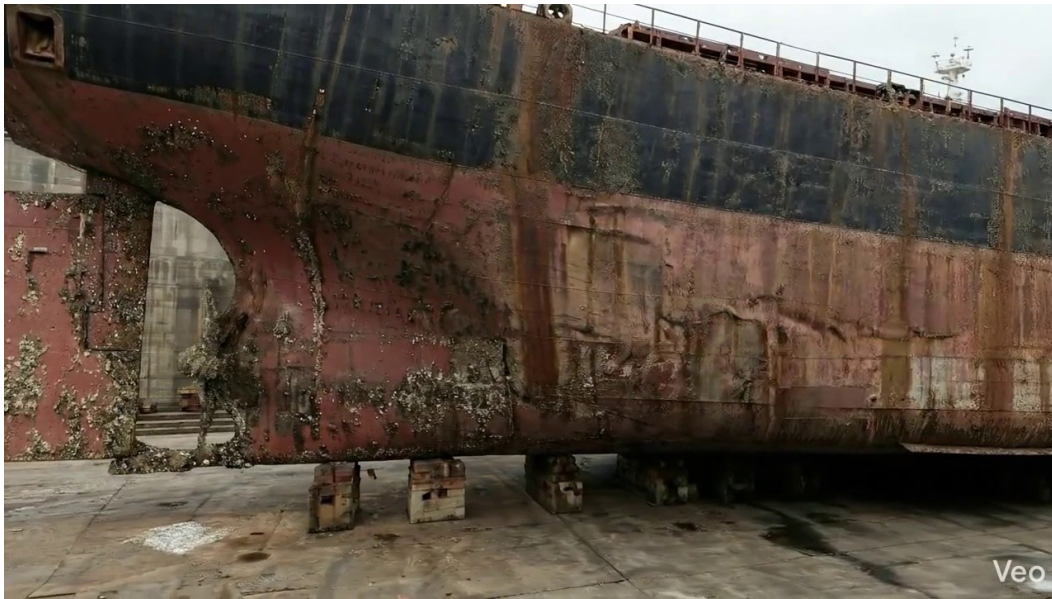
Based on classification practice and the high severity, significant deformation typically necessitates correction by cutting out and replacing the distorted metal to restore the original structural integrity and design geometry. Local repairs or fairing are generally not sufficient to fully restore original strength and prevent recurrence.

### ## Vessel Inspection Report: Explanation of Hull Plate and Framing Repair Process

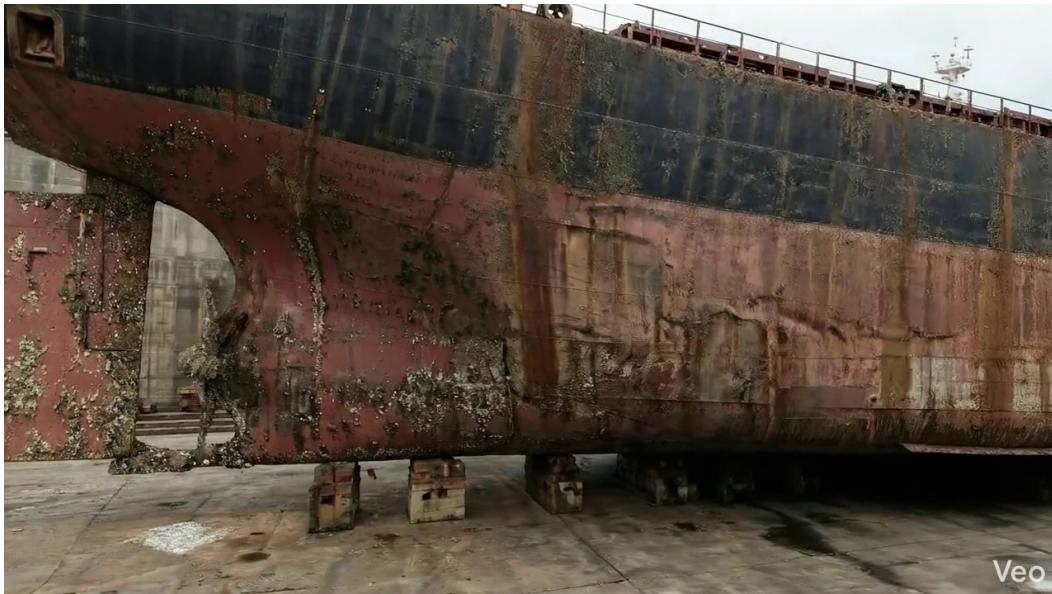
Structurally, deformation signifies a direct reduction in both the local and global stiffness and strength of the affected plating and stiffeners. The out-of-plane bending fundamentally reduces the plate's effective cross-sectional area and its ability to carry compressive and shear loads efficiently, potentially leading to premature buckling failure of the entire plate panel or adjacent structural members. For stiffeners, buckling reduces their effectiveness in supporting the plating and transferring loads to main frames and bulkheads. This directly compromises the vessel's longitudinal strength, which is vital for resisting hull girder bending moments. Classification societies mandate the correction of significant buckling, typically by cutting out and replacing the distorted metal, because it represents a fundamental weakening of the primary structure that cannot be reliably ignored or tolerated for safe operation.

**\*\*Vessel Inspection Report - Deformed Hull Plating Repair Process Explanation\*\***

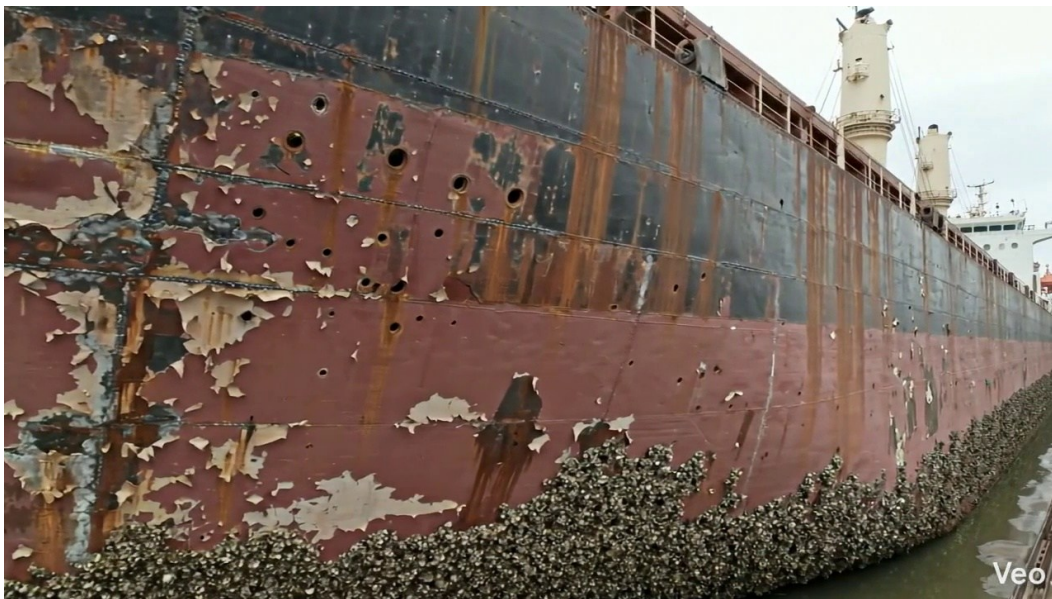
Given the medium severity and the critical nature of the HULL\_AREA, the classification practice for significant buckles typically involves cutting out and replacing the distorted metal with new, correctly formed plating and/or stiffeners to restore the original structural integrity and comply with classification rules. Therefore, appropriate repair action is recommended to rectify this deformation.

##### ## Vessel Inspection Report: Maritime Steel Plate Repair Methodology
