Building Survey

118 Walcote Drive
West Bridgford
Nottingham
NG2 7GY

Date of Inspection: 29/03/2019

Job reference: 125590

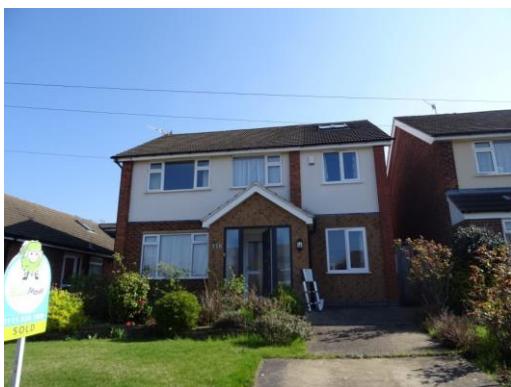
The ridge tile to the property is mortar bedded. No significant unevenness or deterioration is noted to the mortar bedded ridge tile. The remainder of the front pitch to the property is covered with a concrete interlocking tile. Minor dishing is noted to the front pitch of the property.

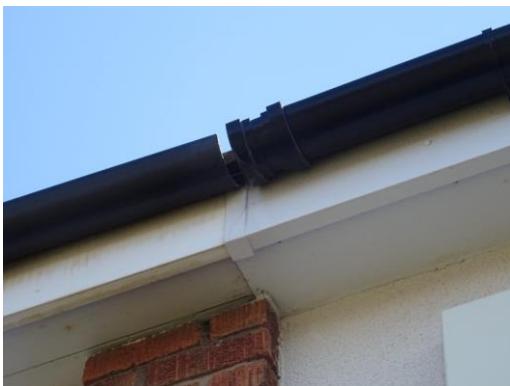
The PVCu gutters connect into a PVCu downpipe to the left hand side elevation of the property. The remainder of the eaves are finished with PVCu fascia boards and soffits. These will benefit from a deep clean.

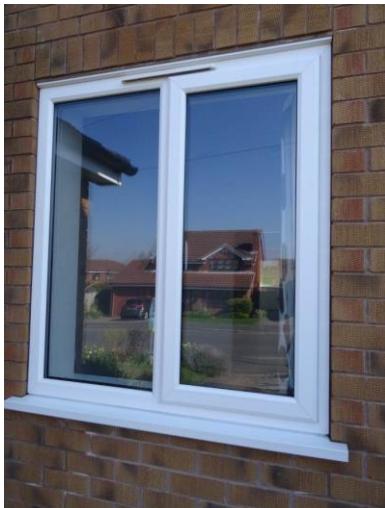
The window at ground floor level to the left hand side is PVCu double glazed. Copies of FENSA certification should be obtained for the windows should these have been replaced post 2002. Minor deterioration of the mortar is noted around the perimeter of the window and we would recommend proactively upgrading with a mastic seal in order to mitigate any potential penetrating water ingress issues.

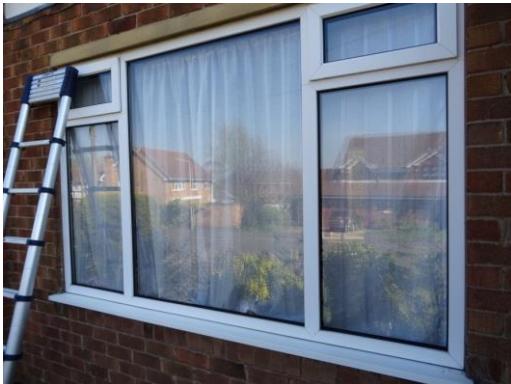
There is evidence of a concrete lintel above the structural opening. There is no significant evidence of rotational movement however minor deterioration of the mortar pointing is noted and consideration may be given to repointing with a good quality lime based mortar.

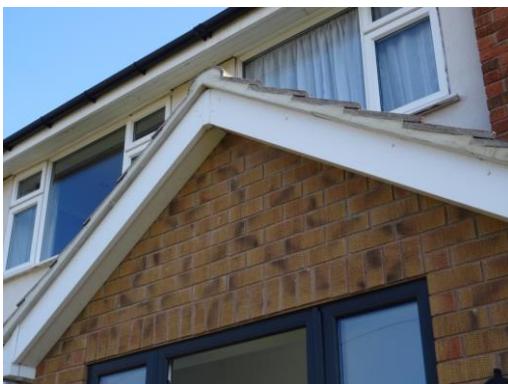
The remainder of the verge and eaves are finished with PVCu fascia boards and soffits. These will benefit from a deep clean.

PVCu gutters are provided at eaves level to the porch connecting into PVCu downpipes. The PVCu rainwater goods generally appear serviceable. The remainder of the walls to the porch are exposed facing brickwork and appear of cavity wall construction. No significant unevenness or deterioration is noted to the brickwork.

We are unable to fully confirm the presence of a physical DPC at low level however assume one is present in a property of this.

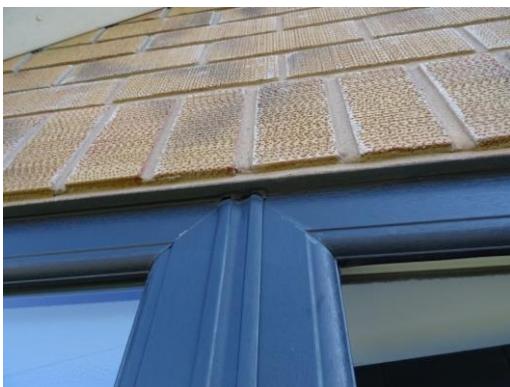
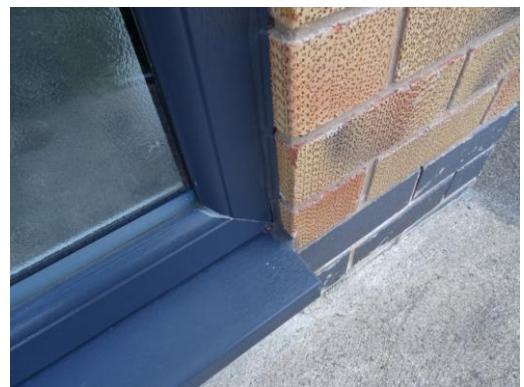
There is evidence of toughened markings to the full height glazing to the left and right hand side and there is evidence of a supporting lintel above the structural opening. Consideration may be given to obtaining further advice from a local specialist to re-secure the PVCu trim.

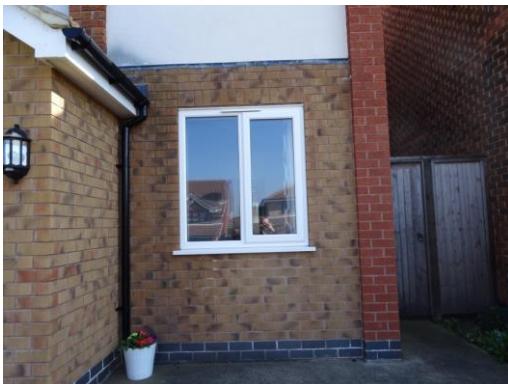
Minor step cracking is noted below the ground floor window to the left hand side. We would not consider this significant however consideration may be given to the pointing with a good quality lime based mortar. Spot mortar pointing is noted in areas suggesting the walls have been retrospectively installed with cavity wall insulation. Copies of all installation certification should be obtained.

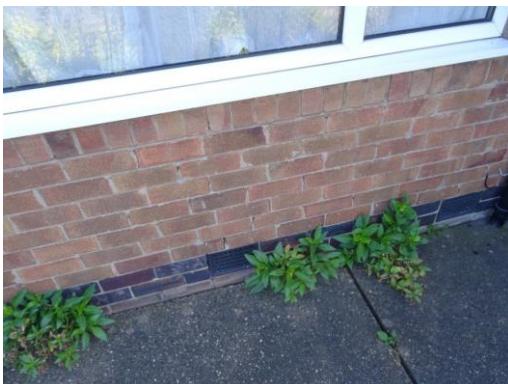
Minor deterioration of the mortar pointing is noted in areas. Consideration may be given to repointing with a good quality lime based mortar.

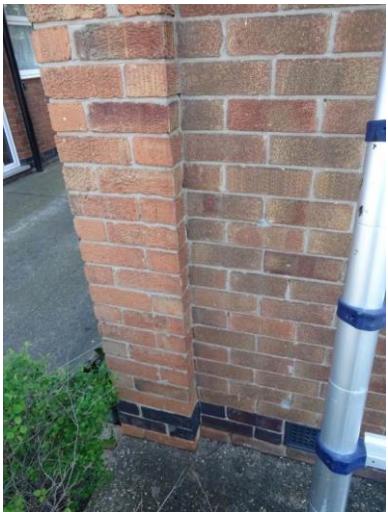
Ventilation bricks are noted at low level providing ventilation to the ground floor construction. We are unable to fully confirm the presence of a physical DPC at low level however there is a double course of exposed engineering brickwork we assume providing the only damp proof course to the area.

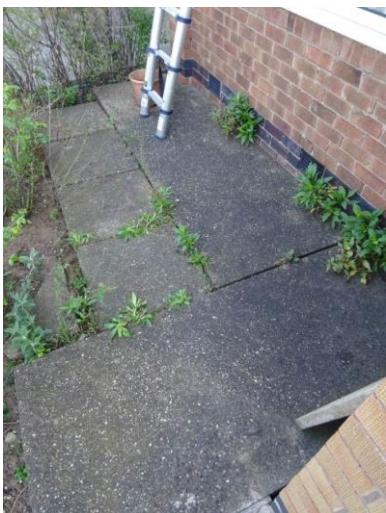
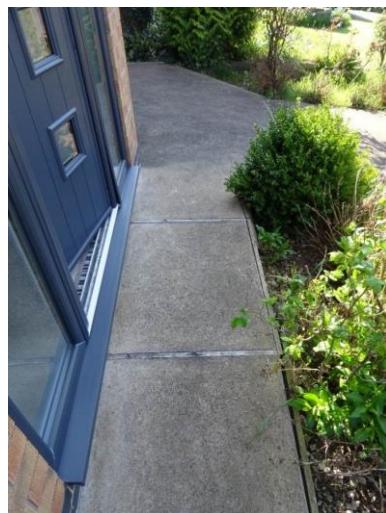
Consideration may be given to clearance of the weed growth to the front driveway. Minor vegetation build up is noted and consideration may be given to clearance and power spraying in order to improve aesthetic appearance.

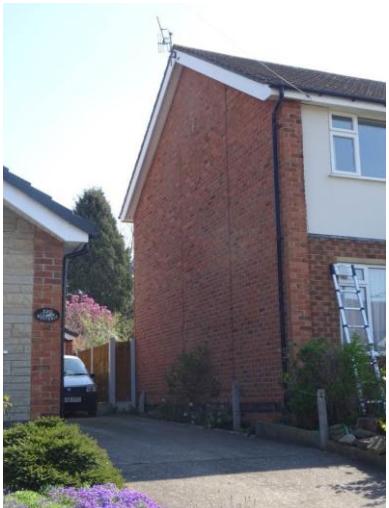
The verge to the left hand side is mortar pointed. Minor hairline cracking and deterioration is noted in areas. We would not consider this significant and we would allow for repointing in the short to medium term.

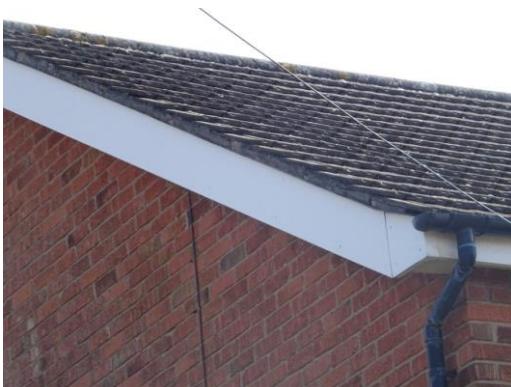
The remainder of the verge to the left hand side was finished with a PVCu fascia board and timber soffit. Minor deterioration is noted to the decorative finish of the timber soffits, specifically towards the rear eaves. We would allow for minor timber repairs as necessary prior to redecoration.

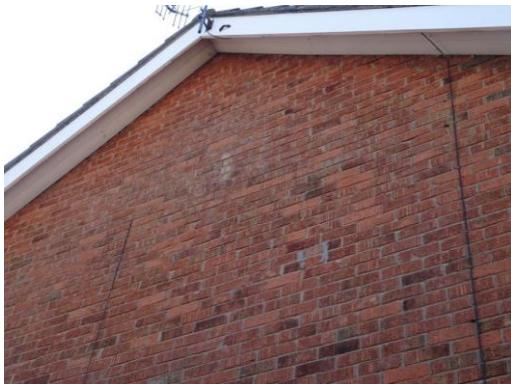
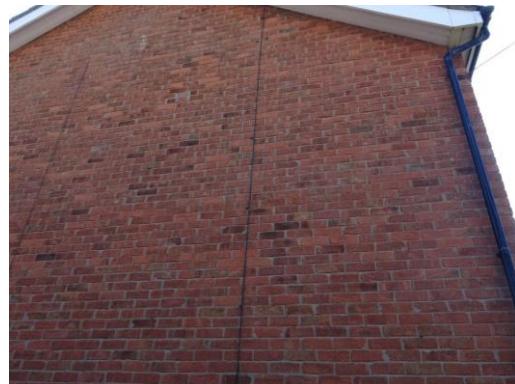
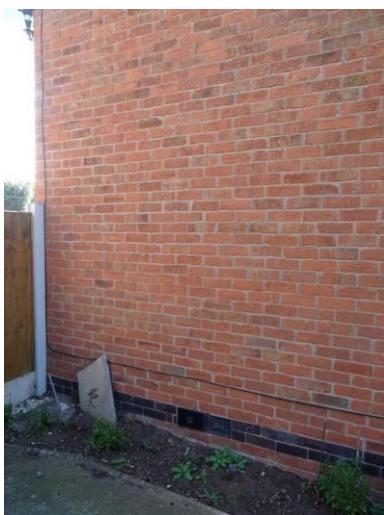
Ventilation bricks are provided at low level providing ventilation to the ground floor construction.

We were unable to fully confirm the presence of a physical DPC at low level however there is a double course of exposed engineering brickwork we assume providing the only damp proof course.

Minor spalling and deterioration is noted to the low level brickwork below the engineering brick DPC. Consideration may be given to sporadic cutting out and replacement of the worst affected bricks.

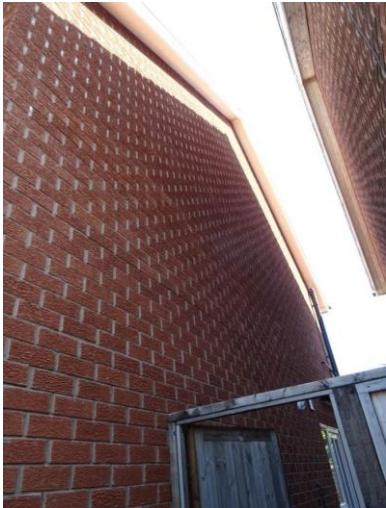
The verge to the right hand side is mortar pointed. No significant cracking or deterioration is noted to the mortar pointed verge however inspection was limited as a result of the restricted nature of the site. The remainder of the verge is finished with PVCu fascia boards and soffits. These generally appear serviceable however would benefit from a deep clean.

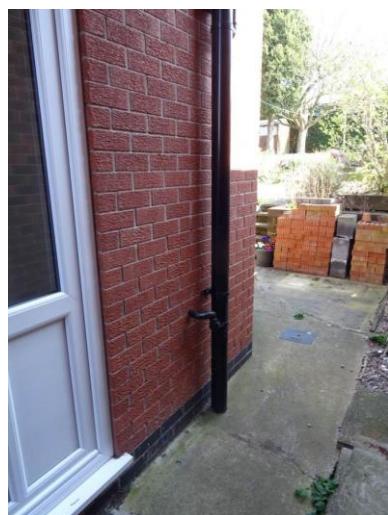
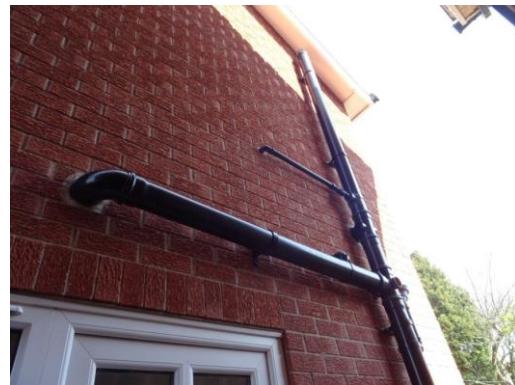
The remainder of the right hand side elevation wall of the property is exposed facing brickwork and appears of cavity wall construction. No significant cracking or deterioration is noted to the brickwork or mortar pointing.

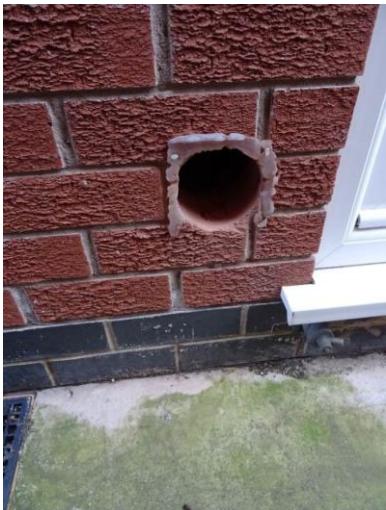
We are unable to fully confirm the presence of a physical DPC at low level however there is a double course of exposed engineering brickwork. We assume there is a physical DPC on an extension of this type and age.

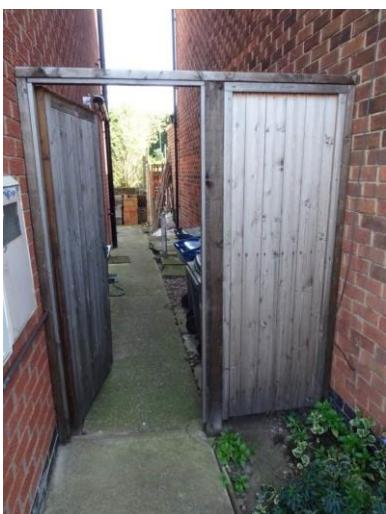
Minor unevenness is noted to the concrete path to the right hand side elevation of the property. We would not consider this significant. Consideration may be given to power spraying.

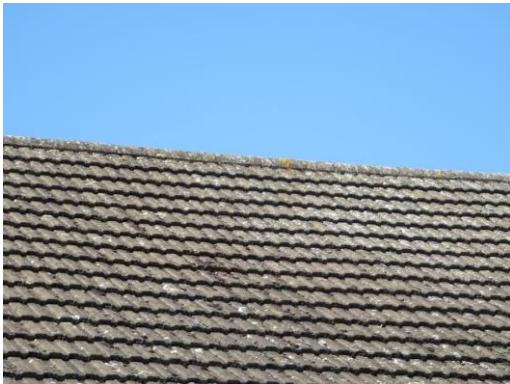
The ridge tile to the property is mortar bedded. The mortar bedded ridge tile to the extension generally appears serviceable however minor deterioration is noted to the remainder of the mortar bedded ridge tile to the main property. We would allow for proactive re-bedding in the short term.

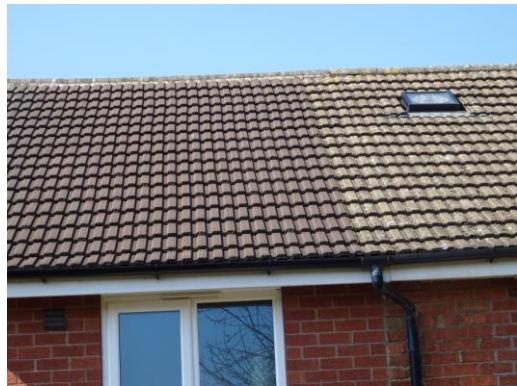
PVCu gutters are provided at eaves level. No leakage or blockage is noted to the PVCu gutters to the rear elevation of the property however the PVCu downpipes do appear to have been patch repaired at eaves level. We would recommend that the PVCu downpipes are proactively repaired or replaced as necessary.

We would recommend clearance of the open gulley at ground level and installation of a drain tidy as necessary.

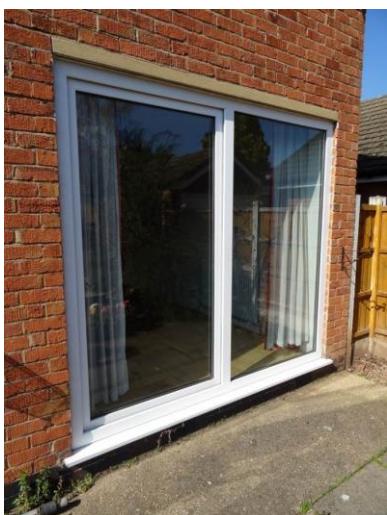
The rear patio doors are PVCu double glazed. We are unable to fully confirm the presence of toughened markings to the glass and consideration may be given to obtaining further advice from a local glazing specialist.

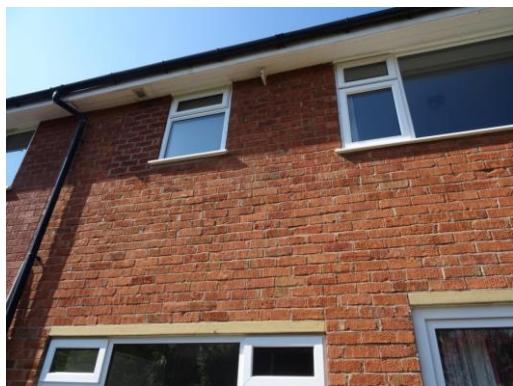
There is evidence of a concrete boot lintel above the structural opening with no evidence of cracking or rotational movement. The remainder of the rear elevation wall is exposed facing brickwork and appears of cavity wall construction. No significant cracking is noted suggesting any structural movement. Minor hairline vertical cracking is noted between the main rear elevation wall and the rear elevation wall of the extension.

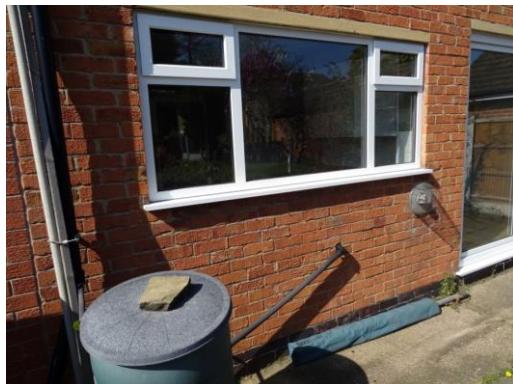
Spot mortar pointing is noted in areas suggesting the walls have been retrospectively installed with cavity wall insulation. Copies of all installation certification should be obtained.

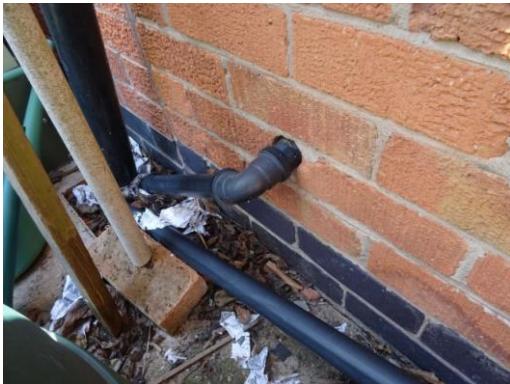
Consideration may be given to installation of a perimeter mastic seal around the PVCu pipework.

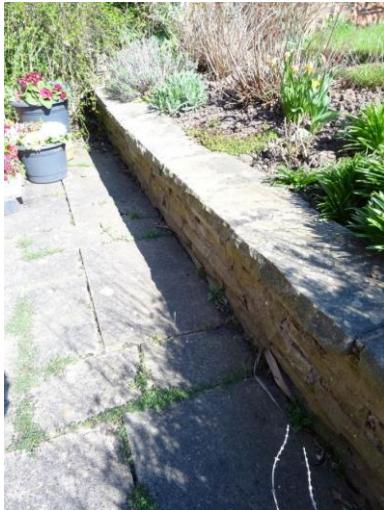
A number of the copings to the retaining wall of the garden are loose and we would allow for re-bedding in the short term. The retaining wall is leaning slightly however this is unlikely to worsen significantly.

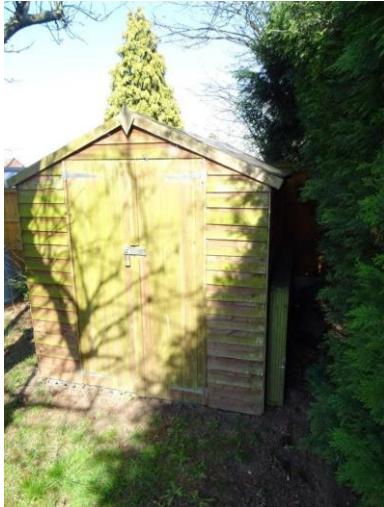
The timber shed towards the rear of the rear elevation site areas would benefit from a deep clean and redecoration in the short term.

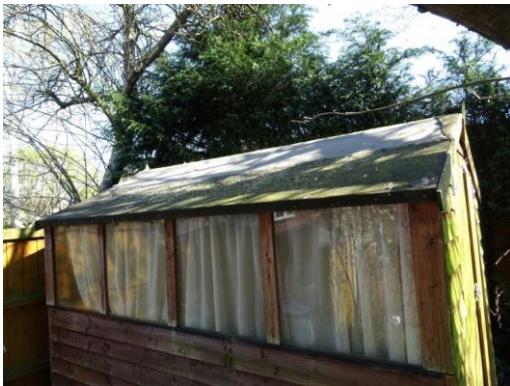
The felt roof covering is deteriorating and we would recommend this is proactively overlaid.

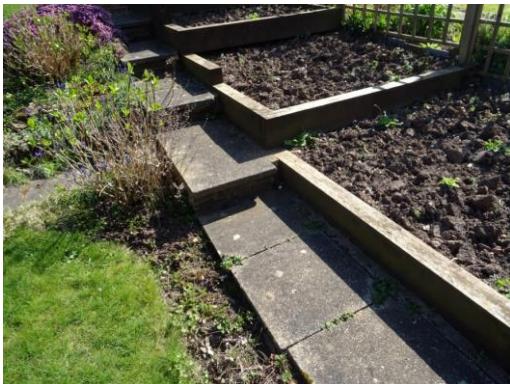
The remainder of the rear elevation site areas are laid to grass and appear well maintained. Minor looseness and unevenness was noted to the path along the rear garden. We would allow for proactive lifting and re-bedding in order to provide a level surface.

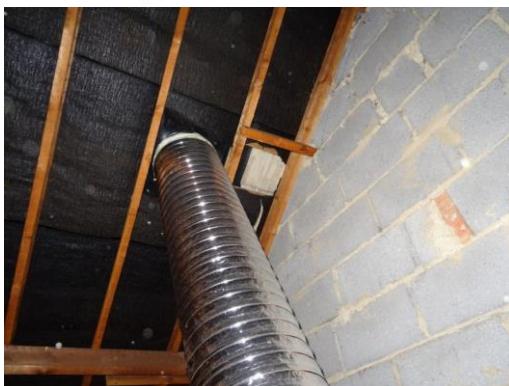
There is a membrane between the rafters and external roof covering providing additional watertightness with deterioration noted adjacent to the rear roof light. We would recommend this area is monitored with an allowance for proactive repair as necessary in order to mitigate any potential penetrating water ingress issues.

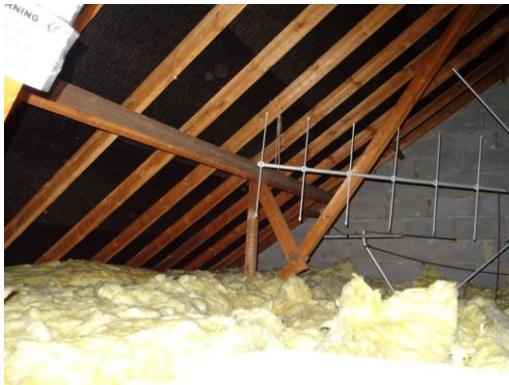
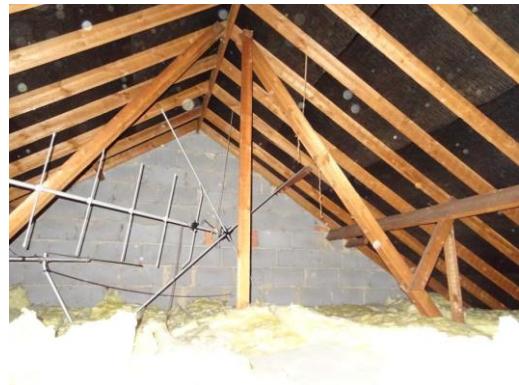
The roof space is insulated at joist level with approximately 250mm of loft roll insulation.

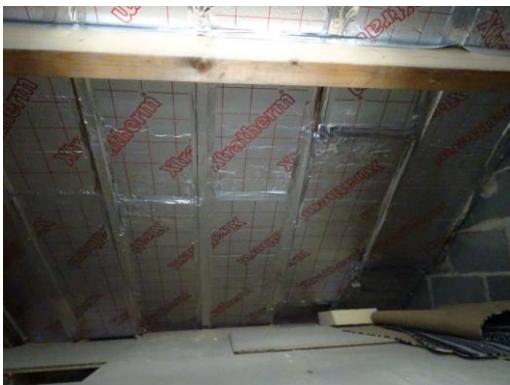
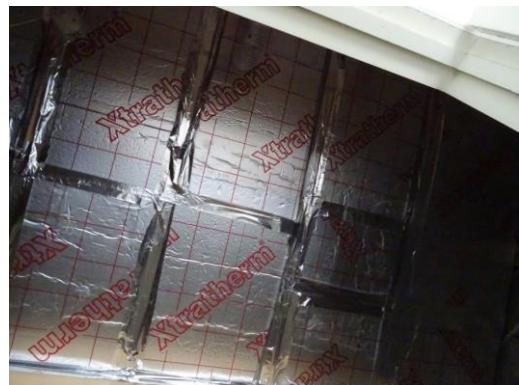
A small roof space is provided above the en-suite shower room. The rear purlin is exposed with no obvious deflection noted. The roof space is insulated at rafter level as anticipated in an installation of this type and age.

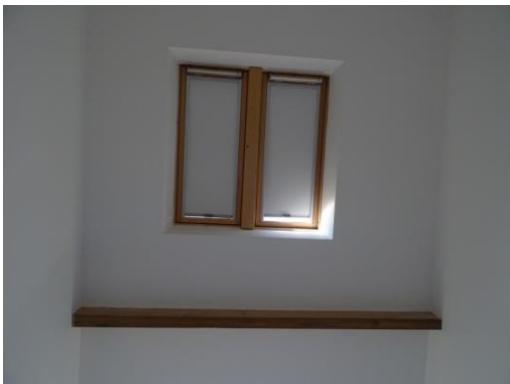
We were unable to comment on whether the Velux rooflights to the front pitch open and close correctly at the time of survey due to their height and location.

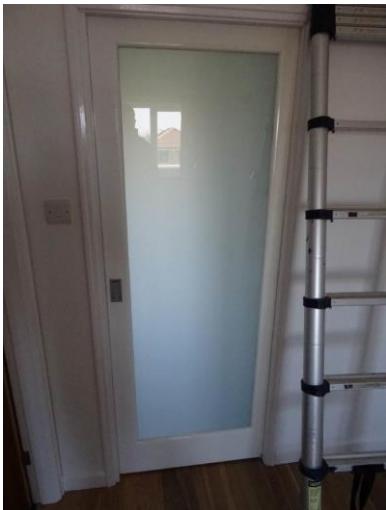
The door between the en-suite and the master bedroom is glazed to its entire height however we are unable to fully confirm the presence of toughened markings to the glass. Consideration may be given to replacement should young children be using the property. The sliding door did open and close correctly at the time of survey.

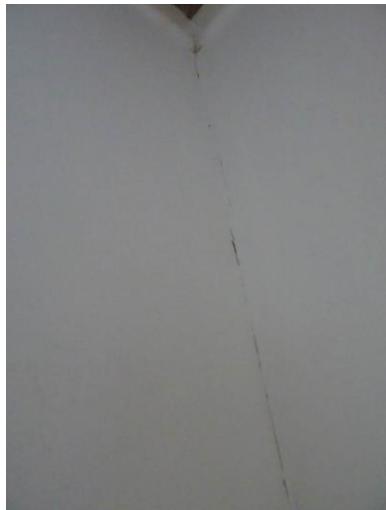
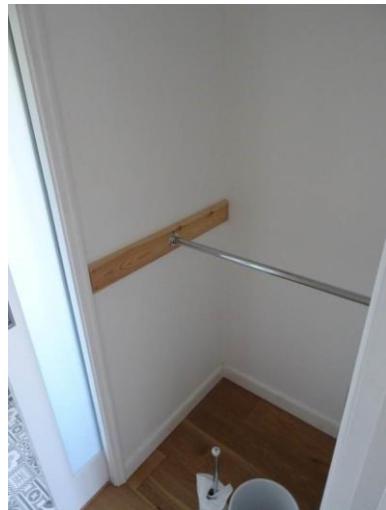
No significant unevenness or deterioration is noted to the wall and ceiling finishes within the closet space. Small gaps are noted in areas with vertical cracking noted. Consideration may be given to redecoration in the short term.

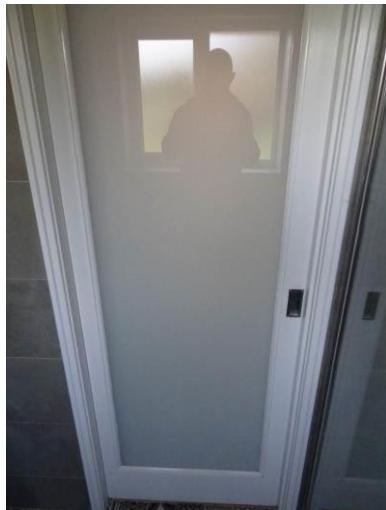
An additional sliding door is provided between the en-suite and the closet space. This was glazed to its entire height and we are unable to fully confirm the presence of toughened markings to the glass. Consideration may be given to replacement should young children be using the property.

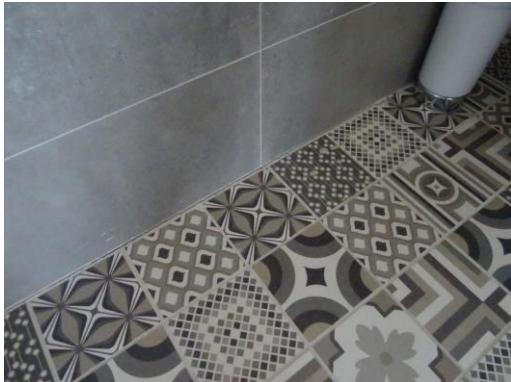
The walls and floors are finished with ceramic tile. No significant unevenness or deterioration is noted to the wall and ceiling finishes. Minor hairline cracking is noted between the wall and ceiling finishes. Consideration may be given to an installation of a perimeter silicone seal in order to mitigate any potential water ingress.

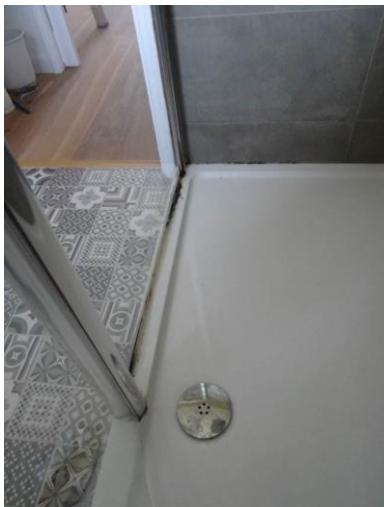
Sanitary appliances feature WC, wash hand basin and shower enclosure with mains fed shower. The sanitary appliances generally appear serviceable however significant black mould spores were noted around the base of the shower tray. We would recommend this is proactively raked out and renewed by a local professional in the immediate term.

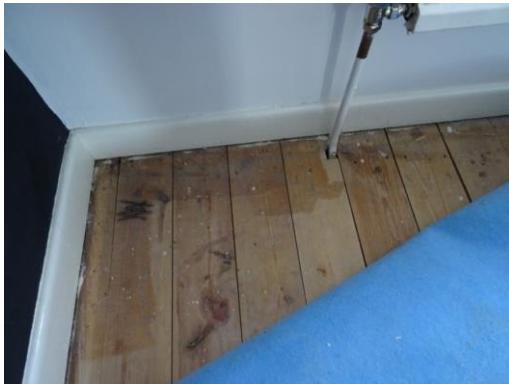
The floor is covered with carpet. The carpet is poorly fitted adjacent to the front wall and consideration may be given to replacement. The carpet was partially lifted to reveal exposed timber floorboards. No significant deterioration is noted.

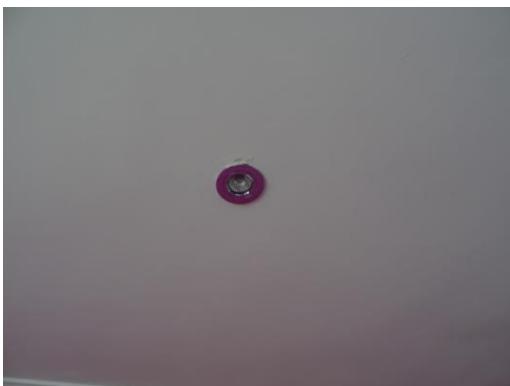
Recessed downlighters are provided and these do appear to have been questionably filled in areas.

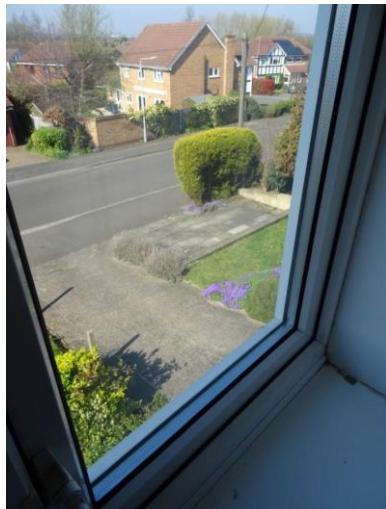
A number of the front windows are locked and we would recommend further advice obtained from a local window specialist. Minor staining is noted to the double glazed

units in areas and we would recommend further advice obtained from a local glazing specialist.

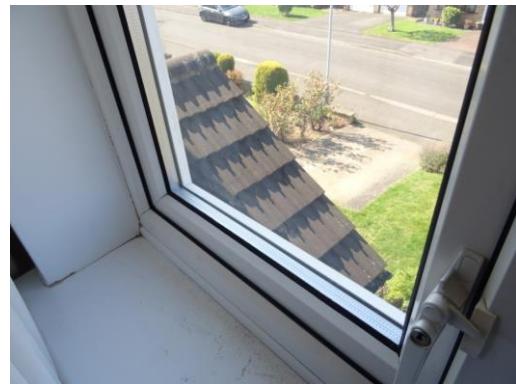
Minor black mould spores are noted around the window reveal. We would recommend cleaning with a diluted bleach solution in the short term and installation of a new seal around the window in order to mitigate any potential draught issues.

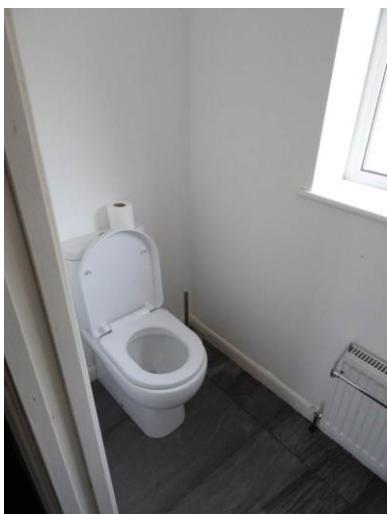
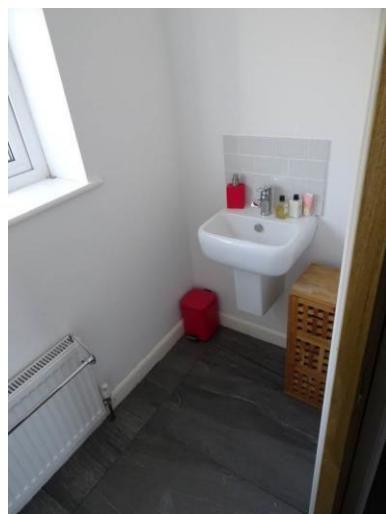
WC

The recessed downlighters to the ceiling require re-fixing.

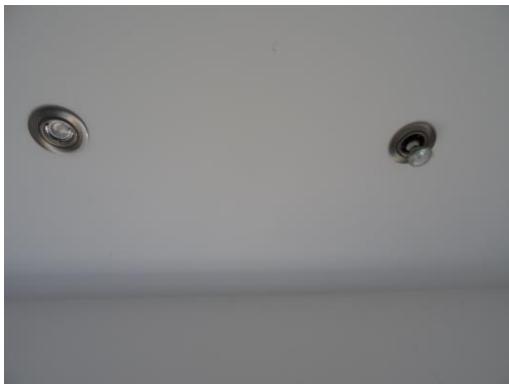
The walls and ceiling are plasterboard finished with paint. Minor hairline cracking is noted in areas and consideration may be given to redecoration in the short term.

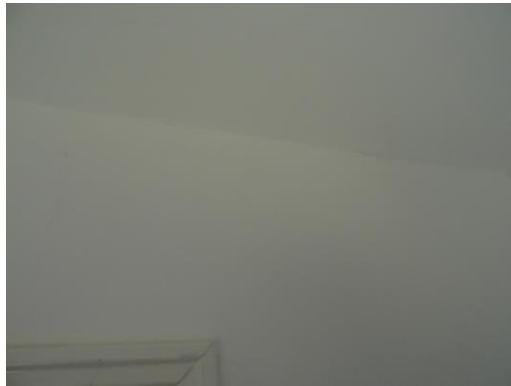
The walls are finished at low level with timber skirtings. Small gaps are noted in areas and consideration may be given to filling and redecoration in the short term.

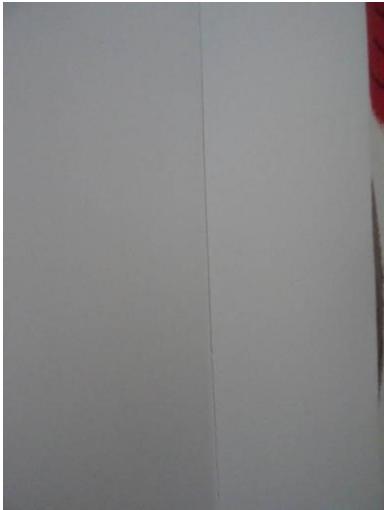
The walls are finished at low level with a ceramic tile upstand detail. Small gaps are noted around the perimeter and consideration may be given to filling and redecoration in the short term.

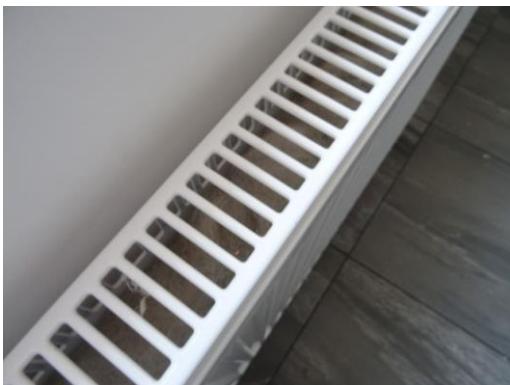
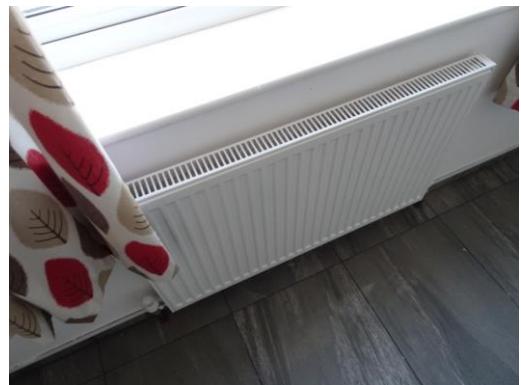
Heating is provided to the front wall with a large radiator with thermostatic radiator valve to the left hand side. The radiator was not operational at the time of survey and we are unable to comment on its effectiveness. Consideration may be given to cleaning the radiator in the short term as minor hair build up was noted to the radiator.

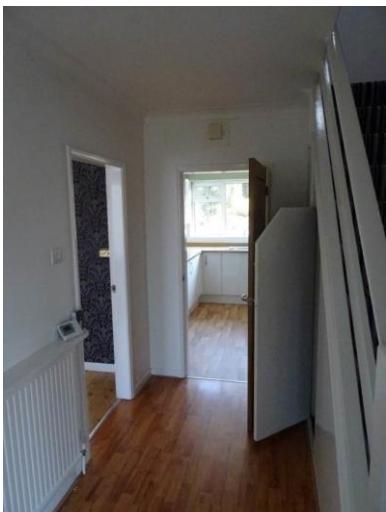
Hallway

Minor hairline cracking is noted to the lining paper ceiling finishes. We would not consider this significant.

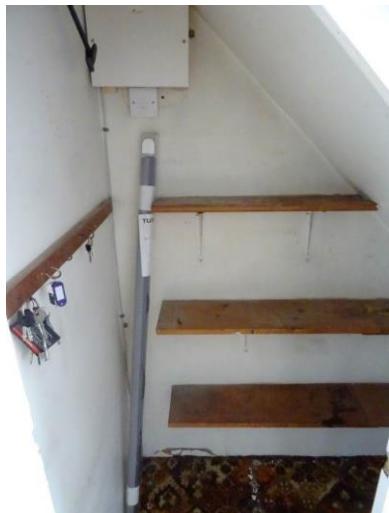
The plaster wall and ceiling finishes are damaged and deteriorating in areas. Consideration may be given to minor plaster repairs.

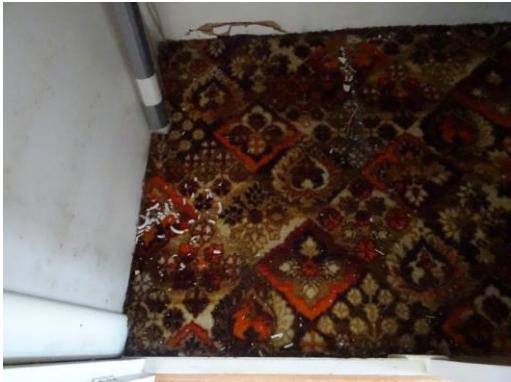
The floor is carpet and appears to be in a serviceable condition however would benefit from modernisation and a deep clean. We note loose glass across the area preventing it from being lifted.

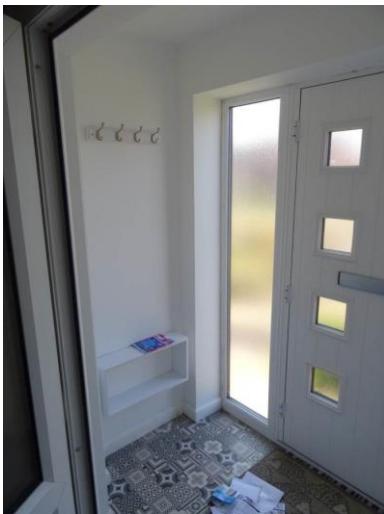
Porch

The walls and ceilings are plasterboard finished with paint. No significant unevenness is noted however minor hairline cracking is noted. Consideration may be given to redecoration in the short term.

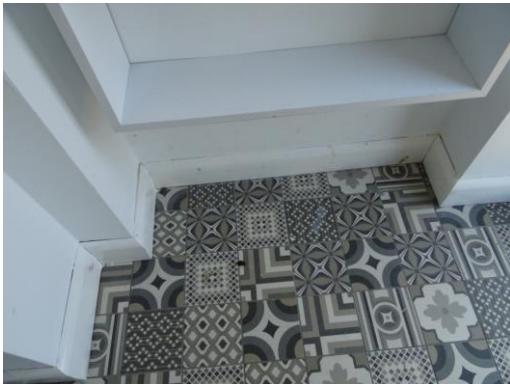
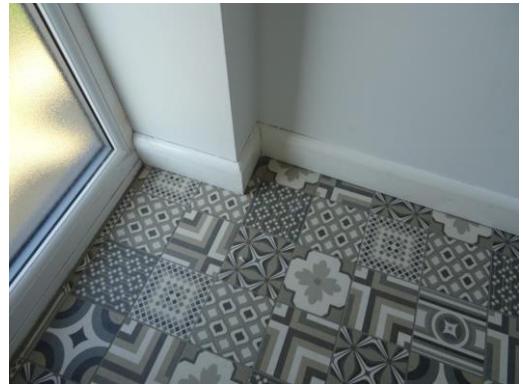
Consideration may be given to installation of a perimeter seal around the front entrance door.

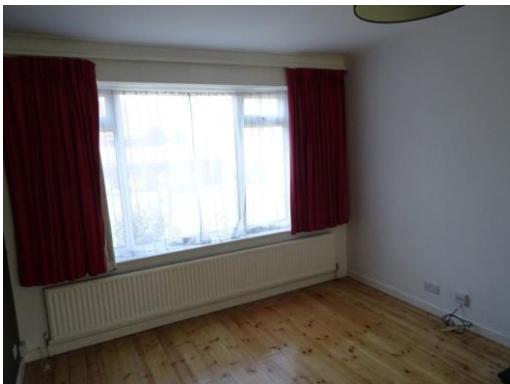
Living Room

Minor difficulty was noted opening and closing the rear patio doors. We would recommend further advice obtained from a local specialist to repair as necessary.

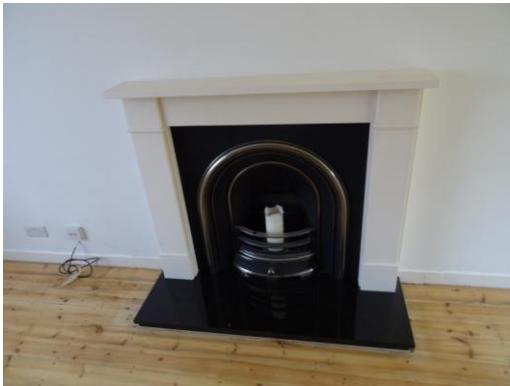
Thermostats for the heating system are provided to the living room. These are generally dated and we assume are redundant.

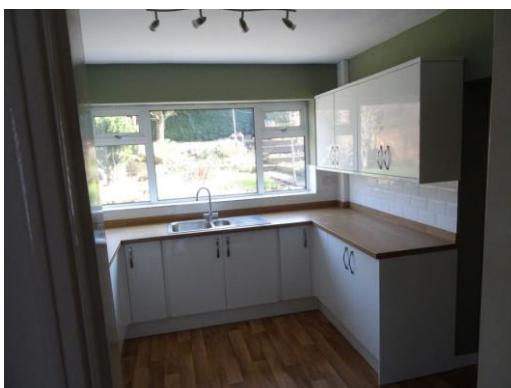
Kitchen

The walls and ceiling are plaster finished with paint. No significant unevenness or deterioration is noted however these do appear to have been poorly decorated in areas.
