# BV MARINE SURVEY SERVICES

## UNDERWATER INSPECTION REPORT (UWI) — 水下檢查報告

| Vessel: | YM WELLNESS | IMO No: | 9786654 |

Report No: BV-UWI-SG-2024-1015-YMWN | Page 1 of 1

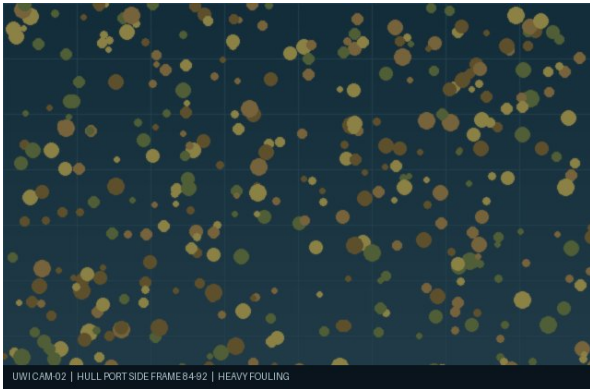
\*Photo: Port side hull, frame 84-92 — heavy barnacle clustering, ~7 months since last cleaning.

| Zone | Biofouling | Paint |
|---|---|---|
| Port (Fr.40-90) | Heavy* | ~28% |

| Overall Hull Biofouling Score (1-100): | 42 (HEAVY) |

Overall hull condition is assessed as heavily fouled, consistent with extended interval since last hull cleaning (approx. 7 months, last performed 08-MAR-2024 Kaohsiung). Predominant fouling type is barnacle (*Balanus* spp.) clusters concentrated on port side and flat bottom, with moderate slime coverage elsewhere. Antifouling paint breakdown is moderate (avg. 21.6%) and approaching the threshold where re-coating should be considered at next scheduled drydock. Propeller and rudder are in fair-to-good condition with no urgent concerns; light blade roughness noted but does not warrant immediate polishing.

| Hull Cleaning Recommended: | YES — PRIORITY |

**Recommendation:** Schedule in-water hull cleaning within next 30 days to mitigate further speed loss and fuel penalty. Propeller polishing can be deferred to next drydock (currently scheduled 2025-10-01) unless further performance degradation is observed in interim Noon Report data. Estimated speed recovery post-cleaning: 0.6-0.9 kt based on similar fouling profiles on sister vessels.

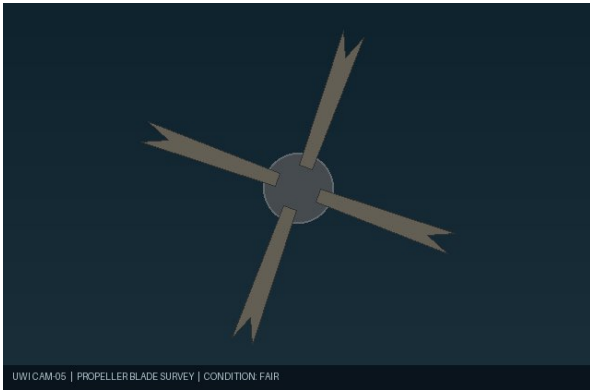
Photo: Propeller blade survey, 4 blades visible, surface condition rated FAIR.

| Component | Cond. | Notes |
|---|---|---|
| Blade Surface | Fair | Light roughness |
| Leading Edge | Fair | Minor erosion, OK |
