Our Ref: APPBCA-2025-24

Building Resilience Group

**ADVISORY TO TOWN COUNCILS ON REGULAR MAINTENANCE OF BUILDINGS AND RESPONSIBILITIES UNDER THE BUILDING CONTROL ACT 1989 ("BC Act") w.e.f. 1 October 2025 (PREVIOUSLY UNDER BUILDING MAINTENANCE AND STRATA MANAGEMENT ACT ("BMSMA"))**

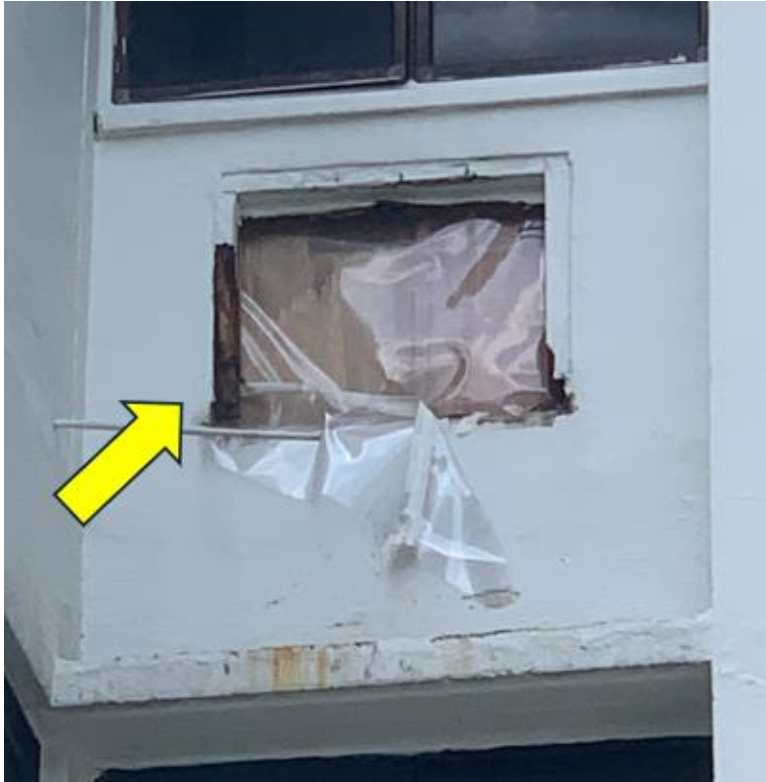
Air-Conditioning Unit Falling from Height Due to Deteriorated Timber Frames

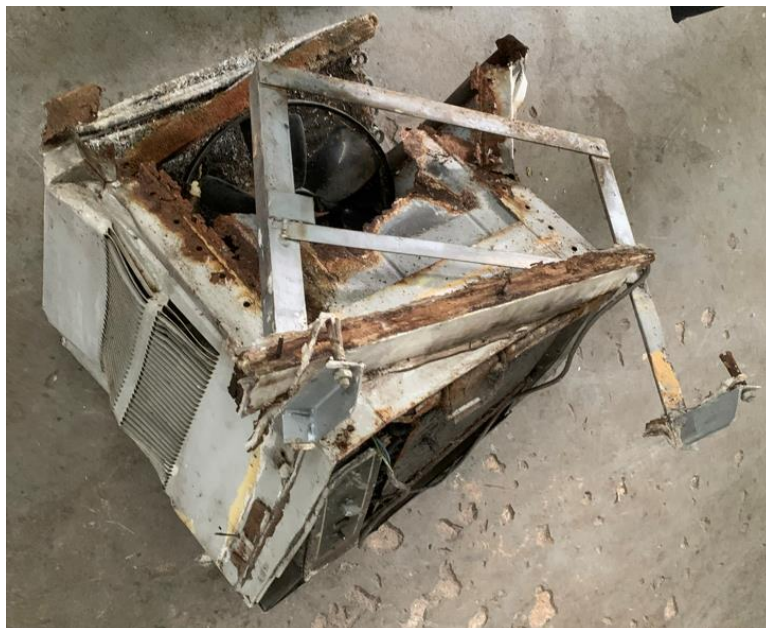
Fallen Air-Conditioning Unit

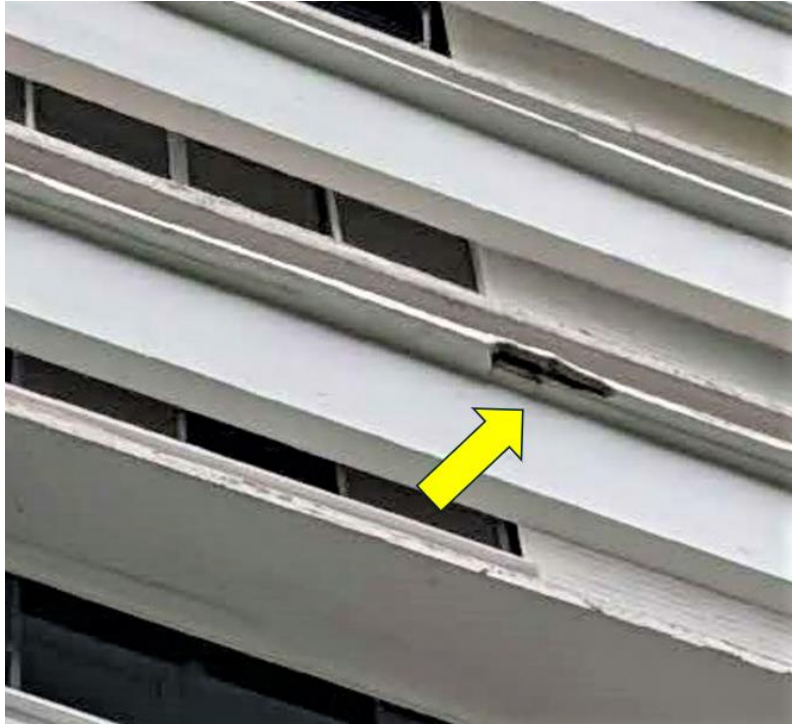
Spalling Concrete at Underside of Sunshade

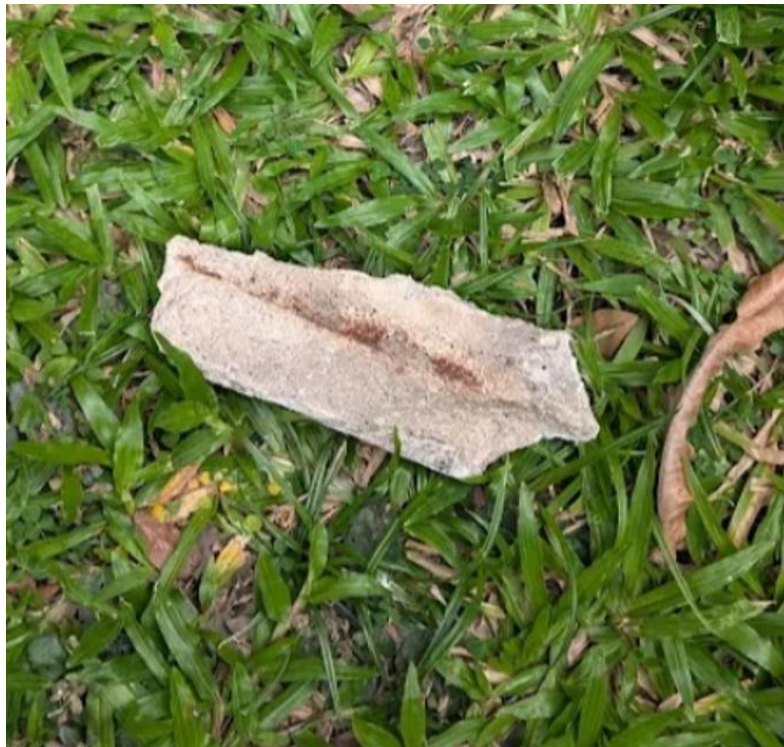
Fallen Piece of Spalling Concrete

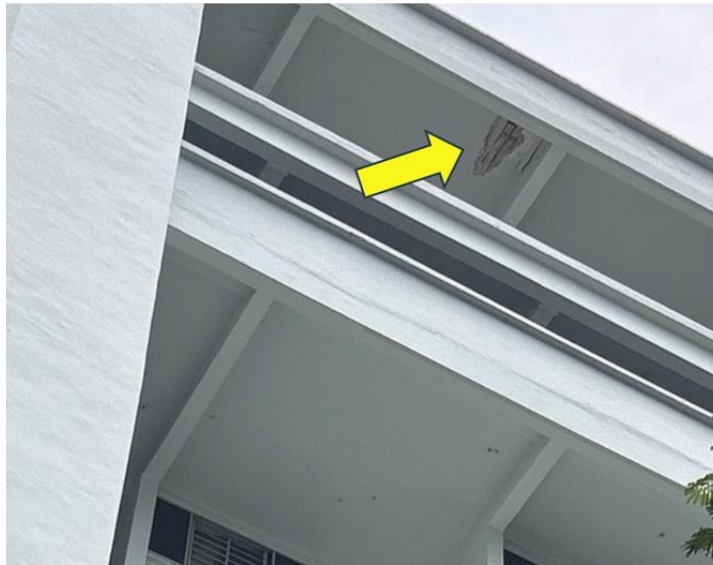
Spalling Concrete at Soffit

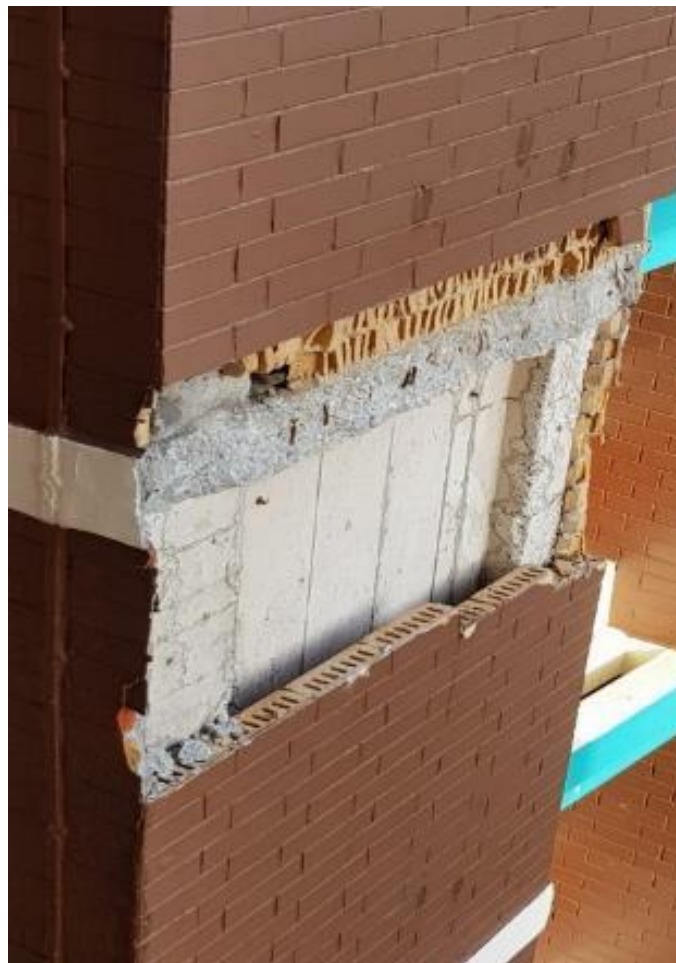
Fallen Brick Cladding

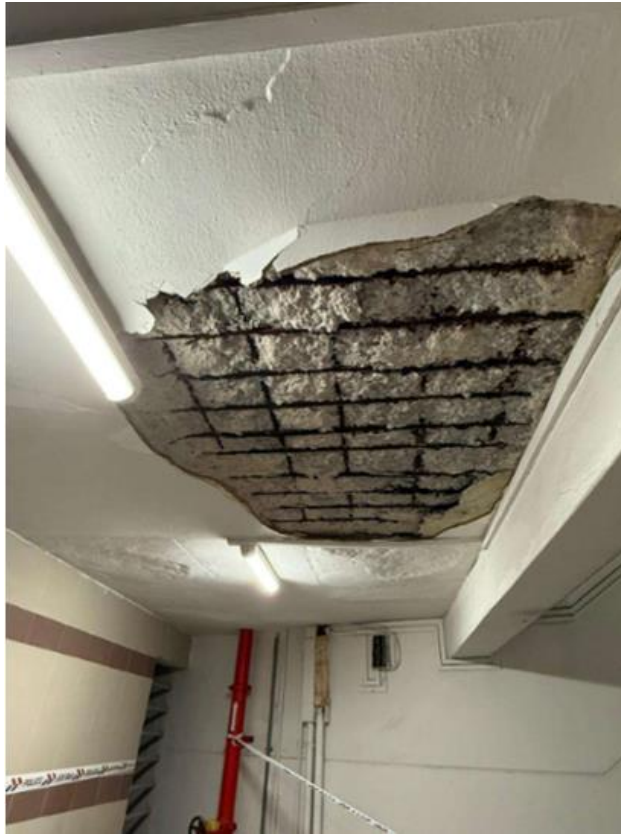
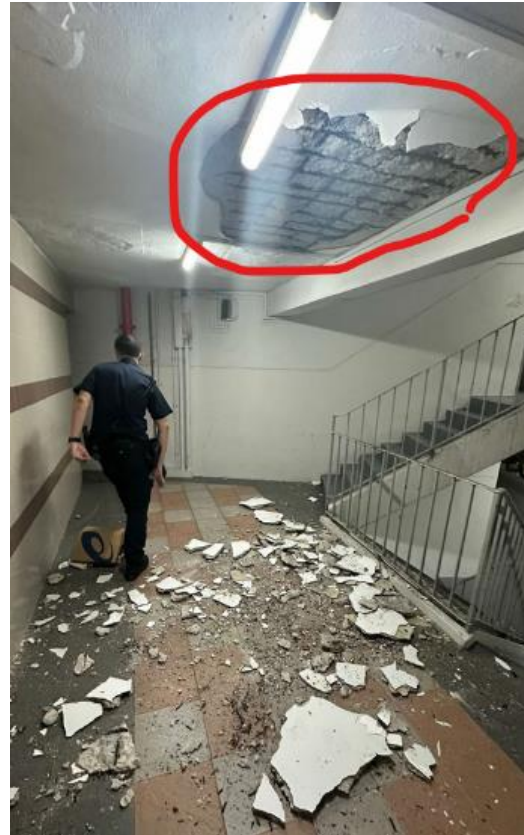
Extensive Fallen Spalling Concrete at Lift Landing

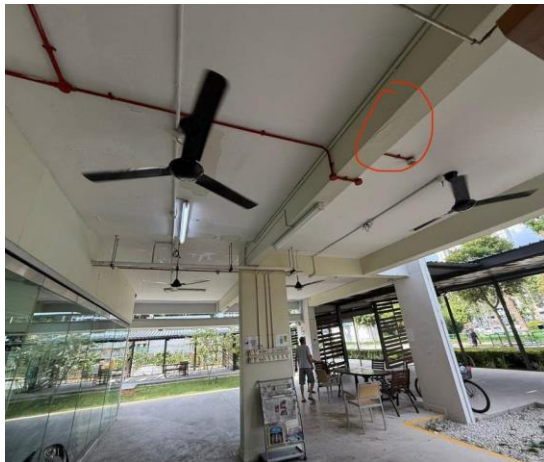
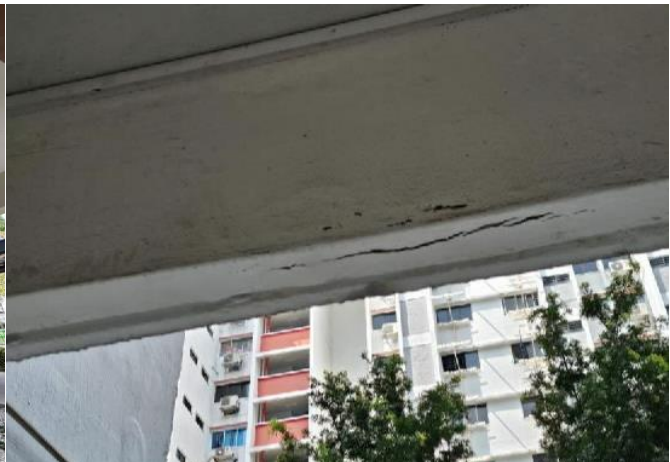
Cracks on Beam at Voiddeck Area

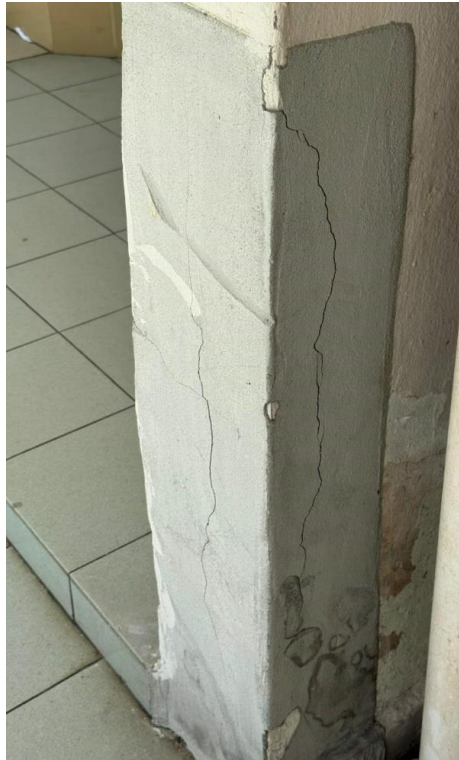
Re-surfaced Cracks on Column at Lift Lobby due to Inappropriate Repair

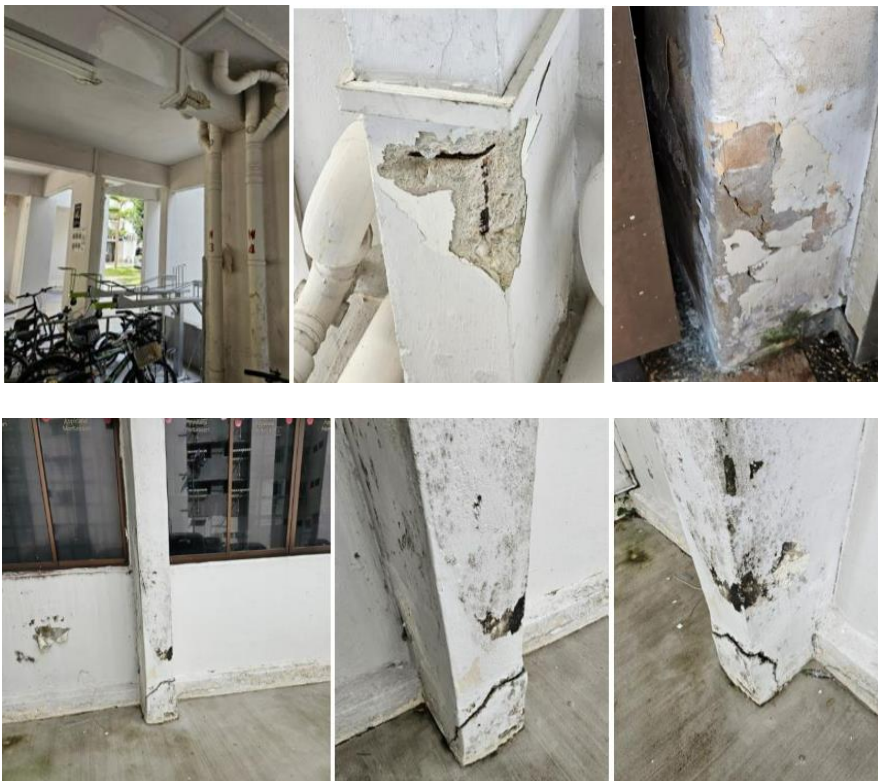
Cracks and Spalling at Columns
