Group #07

Bridge-00

18g, 1700N

October 17, 2014

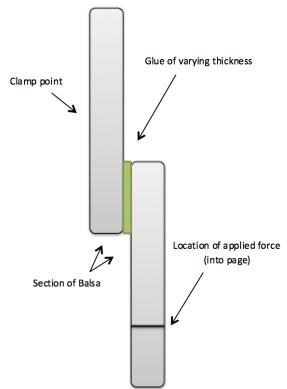
Figure 6: Joint test layout.

After the bridge had undergone the final test and did not perform as well as we had hoped, we decided to test further the joint strength at varying amounts of glue. 40 tests using 8 cm 5mm balsa wood pieces were glued together like seen in Figure 6.

There were 4 groups that we decided on testing; a very small amount (A), a thin layer (B), a sufficient amount so that glue spills out from the sides of the joint (C) and a very thick layer of glue, making a visible layer between the joints, - with overflow - similar to our bridge (D). We wanted to test the weight the joint could hold before the wood itself or the glue joint broke.

To test, the joints were clamped at to the surface of a table with half the joint hanging off, and the other half on. 1N weights were progressively hung off the unsupported member, to simulate a gradually increasing force. The weight was applied at a constant distance from the edge of the joint so the moment was consistent for our 40 tests. The data collected can be seen in Figure 7 and the graph in Figure 8, where group 1, 2, 3 and 4 correspond to A, B, C and D accordingly.
