Group #07

Bridge-00

October 17, 2014

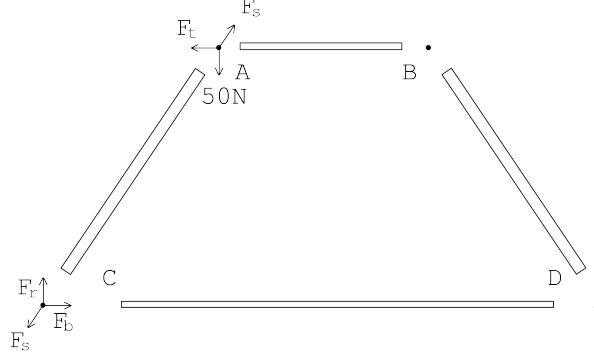
Figure 3: Trapezium truss.

ium truss was analyzed, and then extended to approximate the entire bridge. Internal forces, nodes and members are labelled as per Figure 3. As the truss is symmetrical, only two nodes needed to be analyzed. For a load of 100 N divided equally between

nodes A and B, force equilibrium for nodes A and C are described in equation blocks 1 and 2 respectively.
