Group #07

Bridge-00

18g, 1700N

October 17, 2014

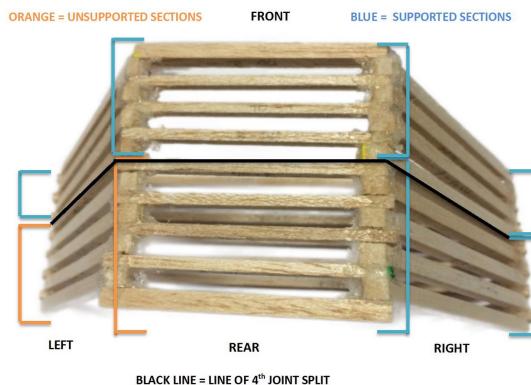
Figure 4: Labelled sections.

Upon a load being applied to the top of the bridge, it became evident that the rear left corner did not have the length to fully span the gap. The rear 4 trapeziums immediately started to slip down into the gap below the block. This was ultimately the cause of the actual load being significantly below the predicted load. The four supported trapeziums at the front of the structure still held, and they performed as they were expected to. However, no member of the bridge actually failed. Other minor factors played a part, such as the bridge being slightly higher at the top in the rear and the overall strength of the glued joints. In an attempt to analyse why no member broke, the full sequence of events is laid out.

To prevent the rear left section of the bridge from instantly separating and falling down under the load, the joints needed to supply an upward force, equivalent to the downward force on the section. This resulted in a shear force on the 5th joint on the upper left hand side, a shear force on the 4th joint on the lower left hand side, and moments about the corresponding joints on the left hand side. Joints are labelled in figure 4.

The joints on the left hand side however, were more susceptible than the right hand side. The joints on the left had separated by about 2 mm prior to failure. Due to the much higher shear strength this was unexpected, however, the balsa glue having a high elasticity was what enabled this. The span of the bridge meant that the right joints had only rotated between 0° and 2° approximately, while during testing they were able to maintain rotation of up to 45° prior to failure, which was when the max force was reached. There was also a small shear force on each joint on the right, but the glue was able to absorb this at this time, as it was significantly less than the shear on the left joints.

After the glue had reached a critical length on the left hand joints, it sheared, leaving little to no support on this side for the first 4 trapeziums, which was shown by them sinking significantly into the gap.

The only support the section had at this time on was from the two joints on the right hand side, which were now experiencing a large moment, combined with a shear force.
