## **Appendix C: Fish Screening Project Descriptions**

### **Screening Project List**

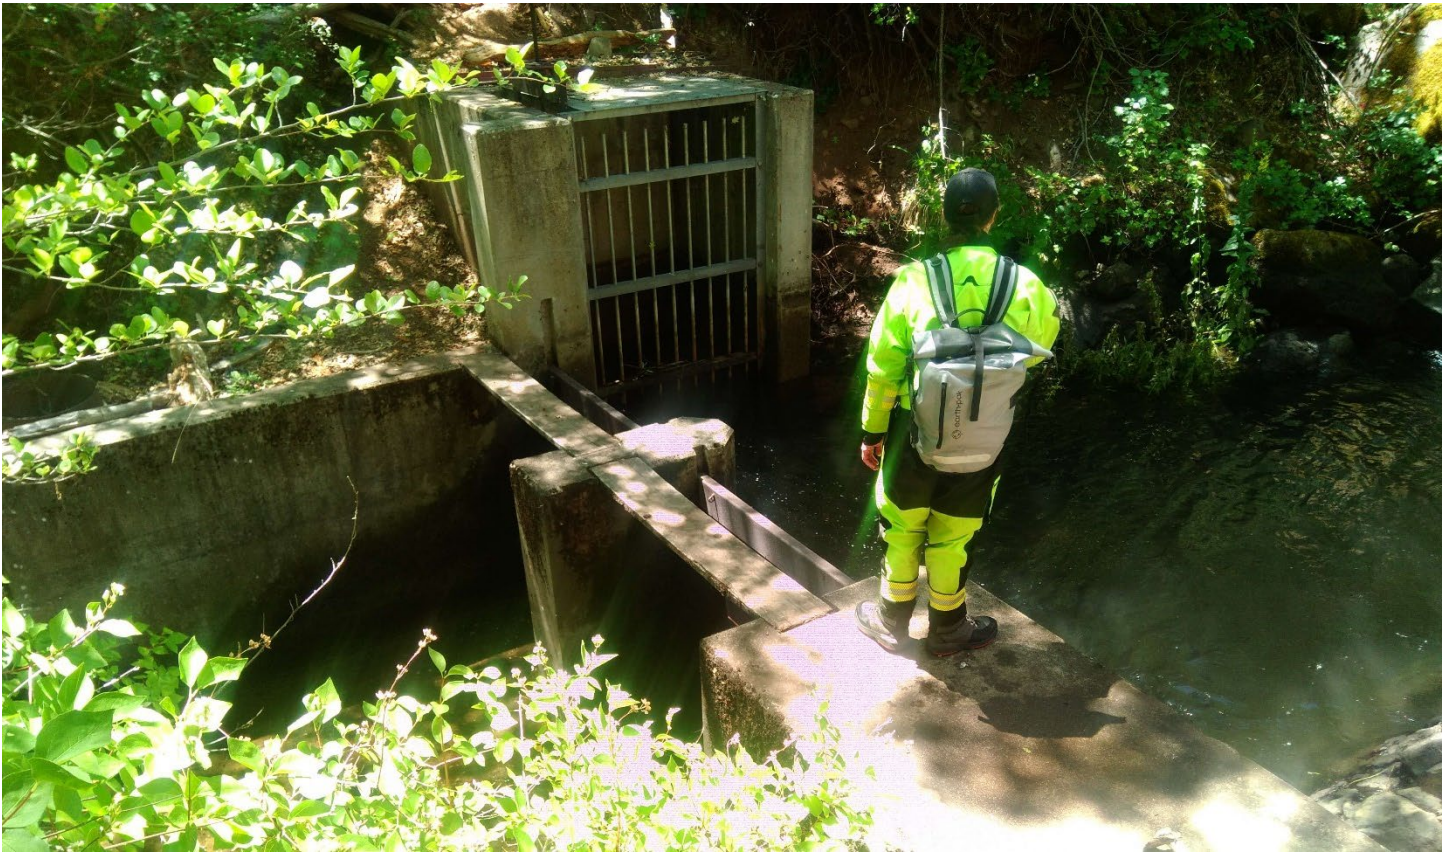
**Project# FA-1a**

Figure 3. Diversion at FA-1a. City of Yreka 'Dam B.' June 2021.

**Screen:** No

**Size score:** 5      **Benefit score:** 5      **Fish Impact:** 3      **Total score:** 3.8      **Priority Tier:** High

**Notes:** City of Yreka 'Dam B.' Secondary diversion for Yreka water supply. Used in conjunction with FA-1a. This diversion is planned to be blocked by a fish passage barrier installed through agreements defined in the Amended Klamath Hydro Settlement Agreement and screening will likely no longer be necessary.

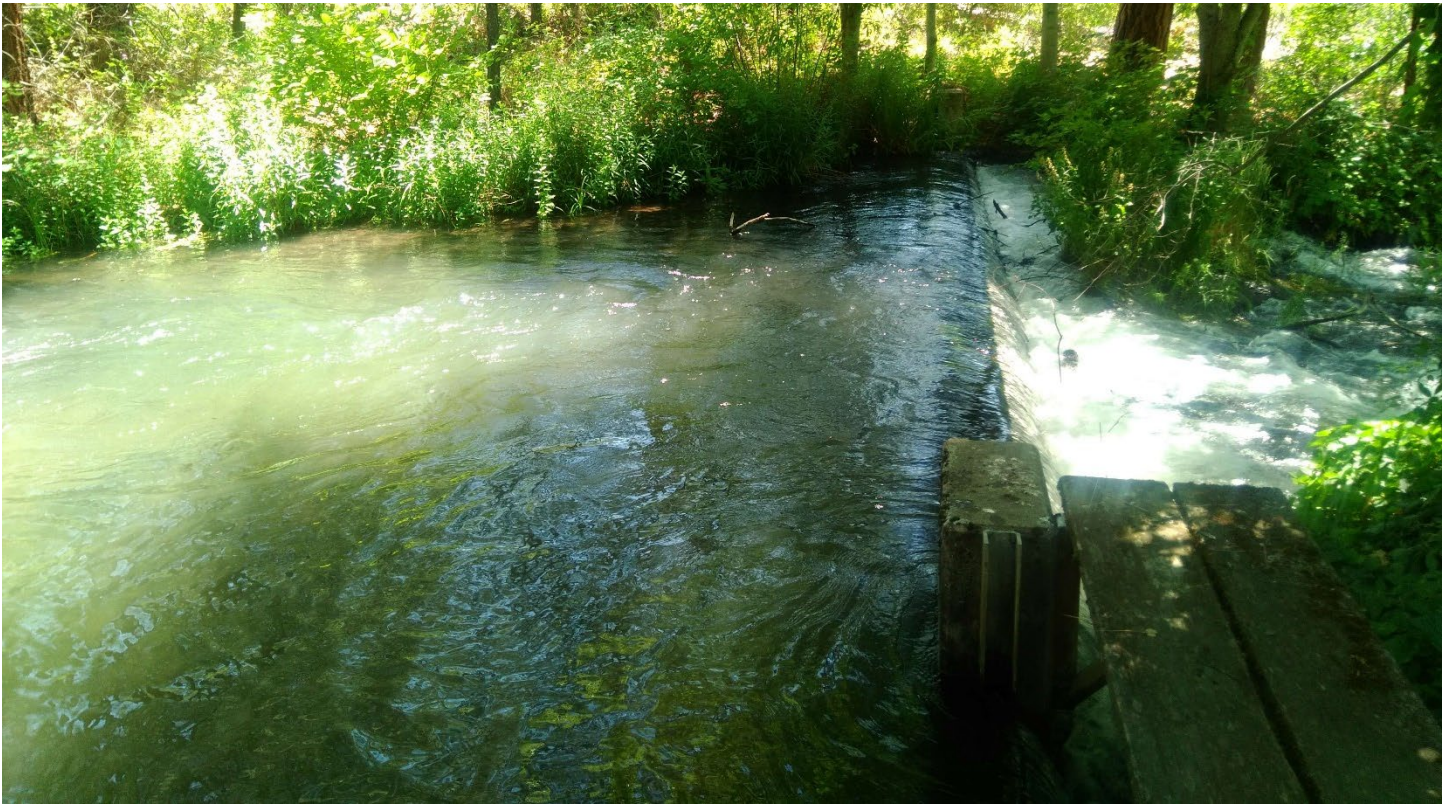
**Project# FA-1b**

Figure 4. Diversion at FA-1b. City of Yreka 'Dam A.' June 2021.

**Screen:** No

**Notes:** City of Yreka 'Dam A.' Primary diversion for Yreka water supply. Used in conjunction with FA-1b. This diversion is planned to be blocked by a fish passage barrier installed through agreements defined in the Amended Klamath Hydro Settlement Agreement and screening will likely no longer be necessary.

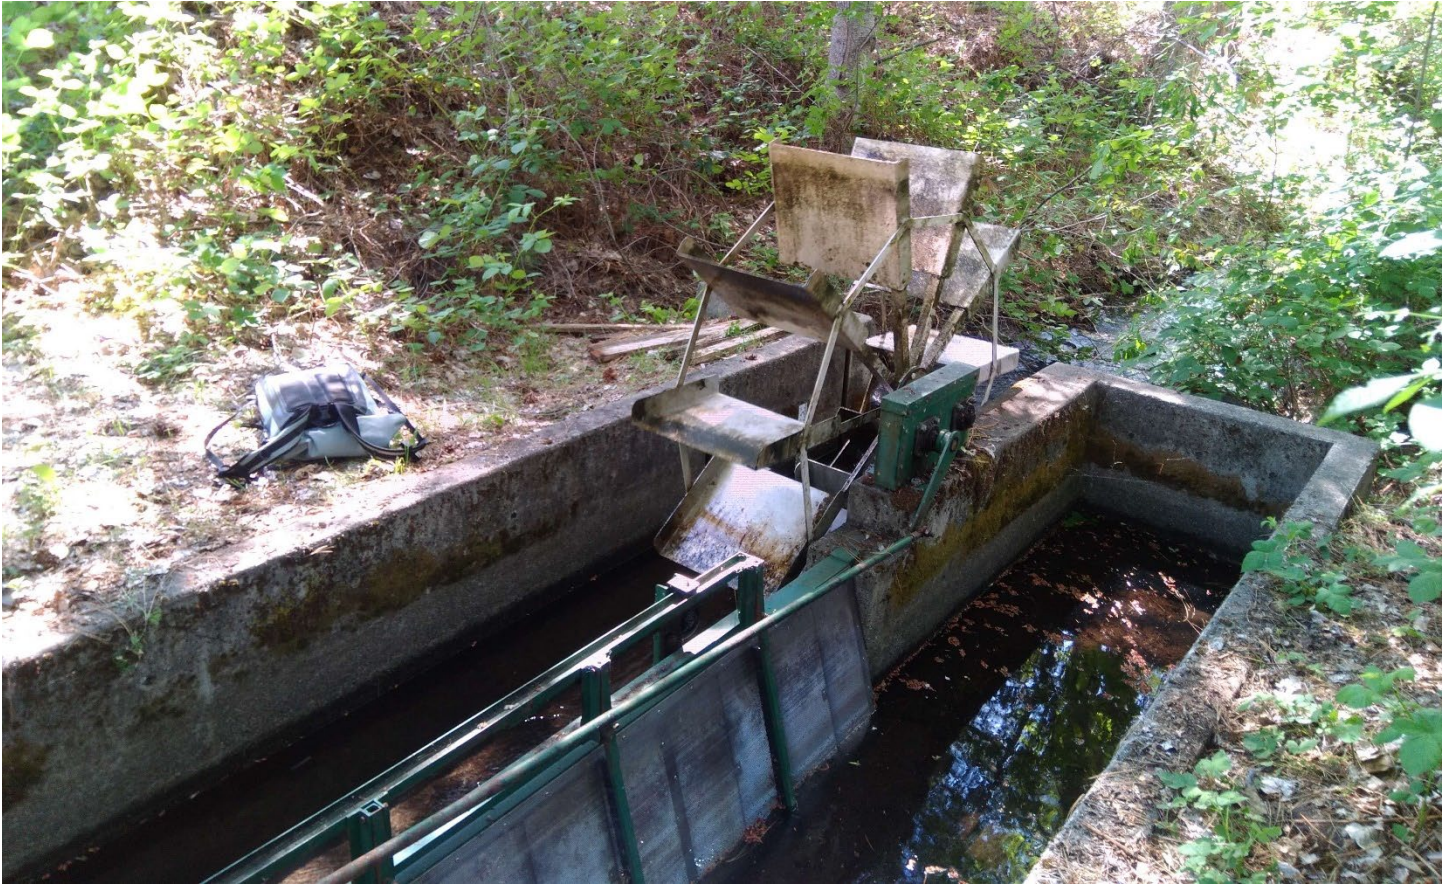
**Project# SH-1**

Figure 5. Fish screen at SH-1. June 2021.

**Size score:** 5      **Benefit score:** 5      **Fish Impact:** 1      **Total score:** 2.6      **Priority Tier:** Medium

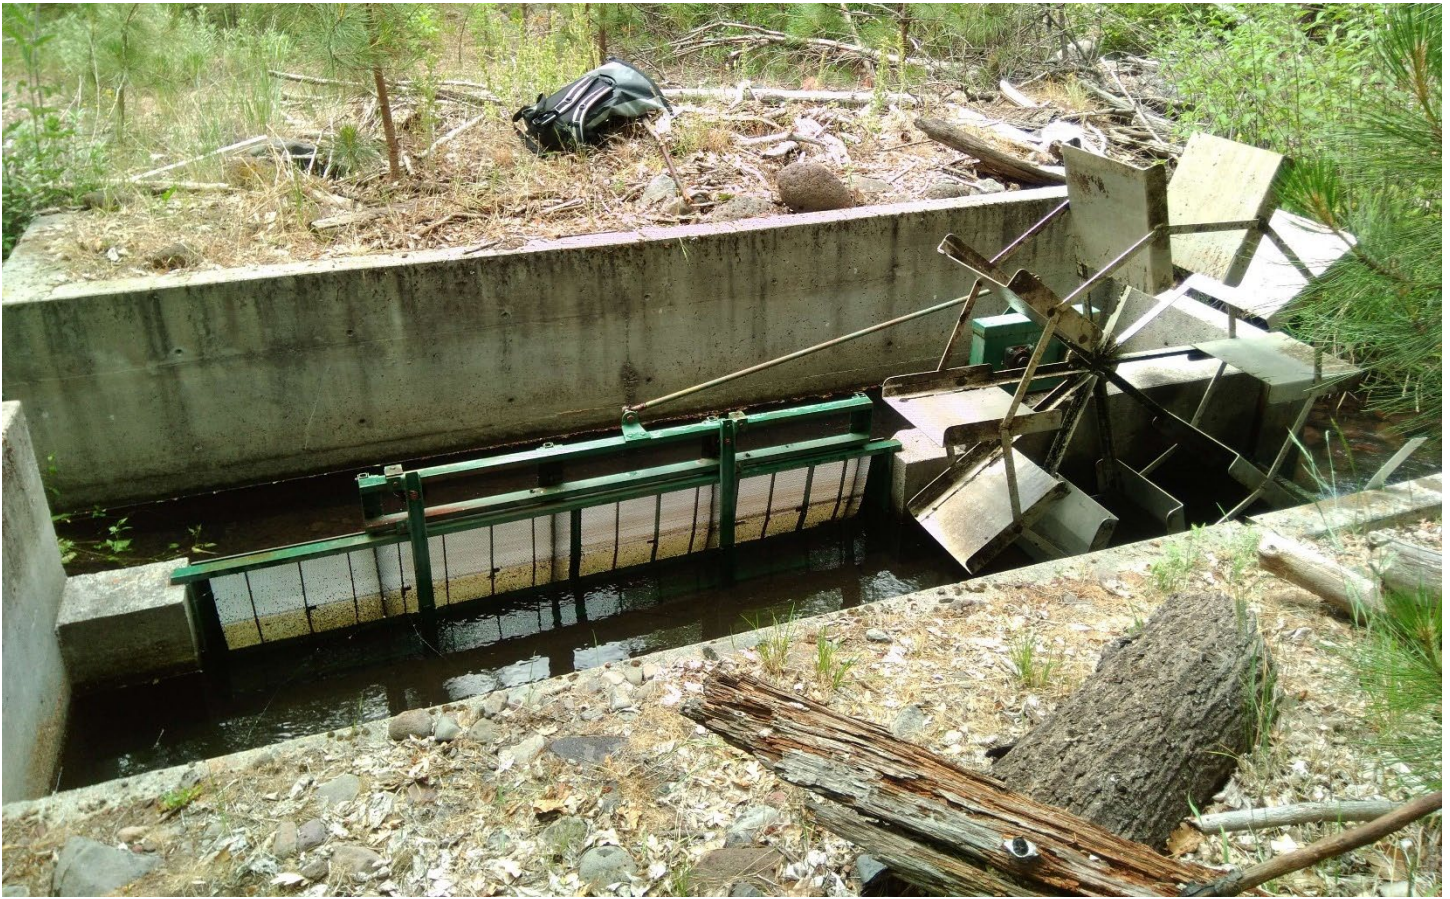
**Project# SH-2**

Figure 6. Fish screen at SH-2. June 2021.

**Size score:** 4      **Benefit score:** 5      **Fish Impact:** 1      **Total score:** 2.4      **Priority Tier:** Low

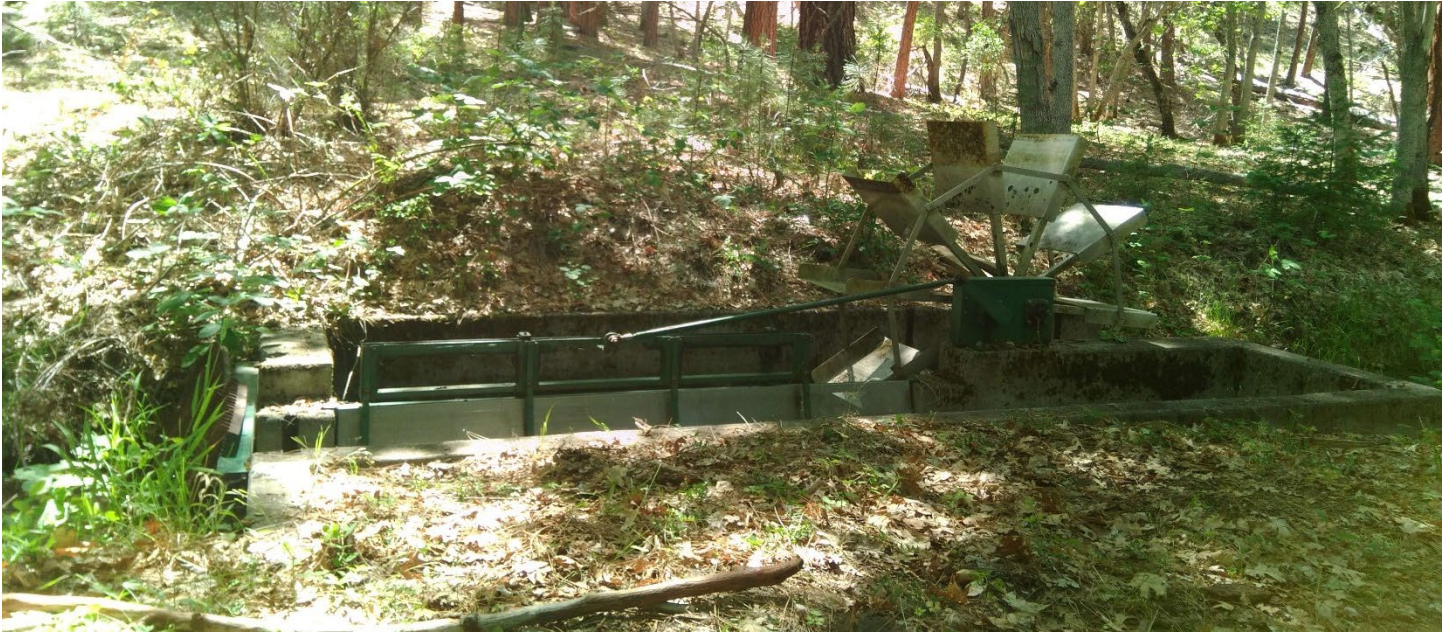
**Project# GS-1**

Figure 7. Fish Screen at GS-1. June 2021.

**Screen:** Yes

**Size score:** 4      **Benefit score:** 5      **Fish Impact:** 1      **Total score:** 2.4      **Priority Tier:** Low

**Notes:** Stockwater for 250 head, used annually, measured (maximum reported measurement is 3cfs).

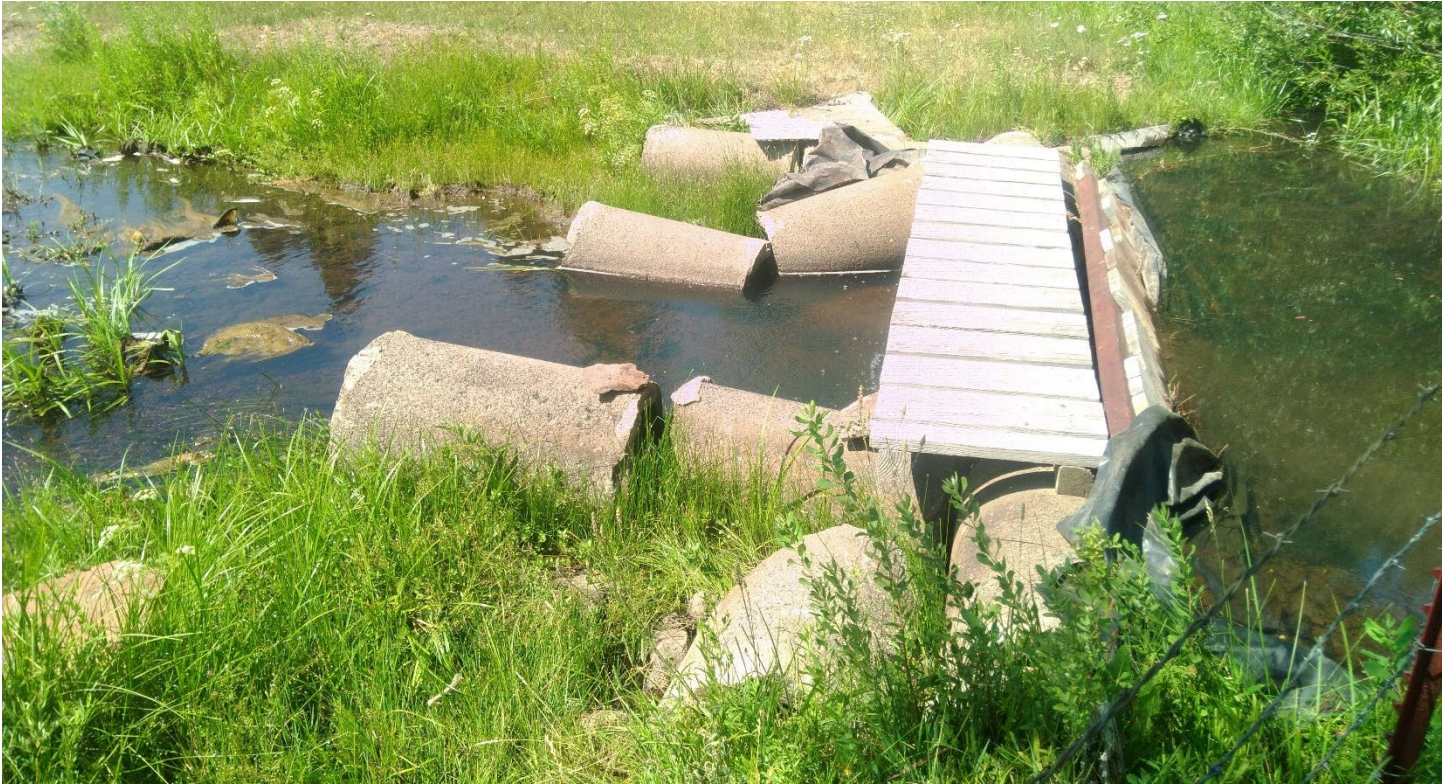
**Project# SP-3**

Figure 8. Diversion location for SP-3 and SP-4. July 2021.

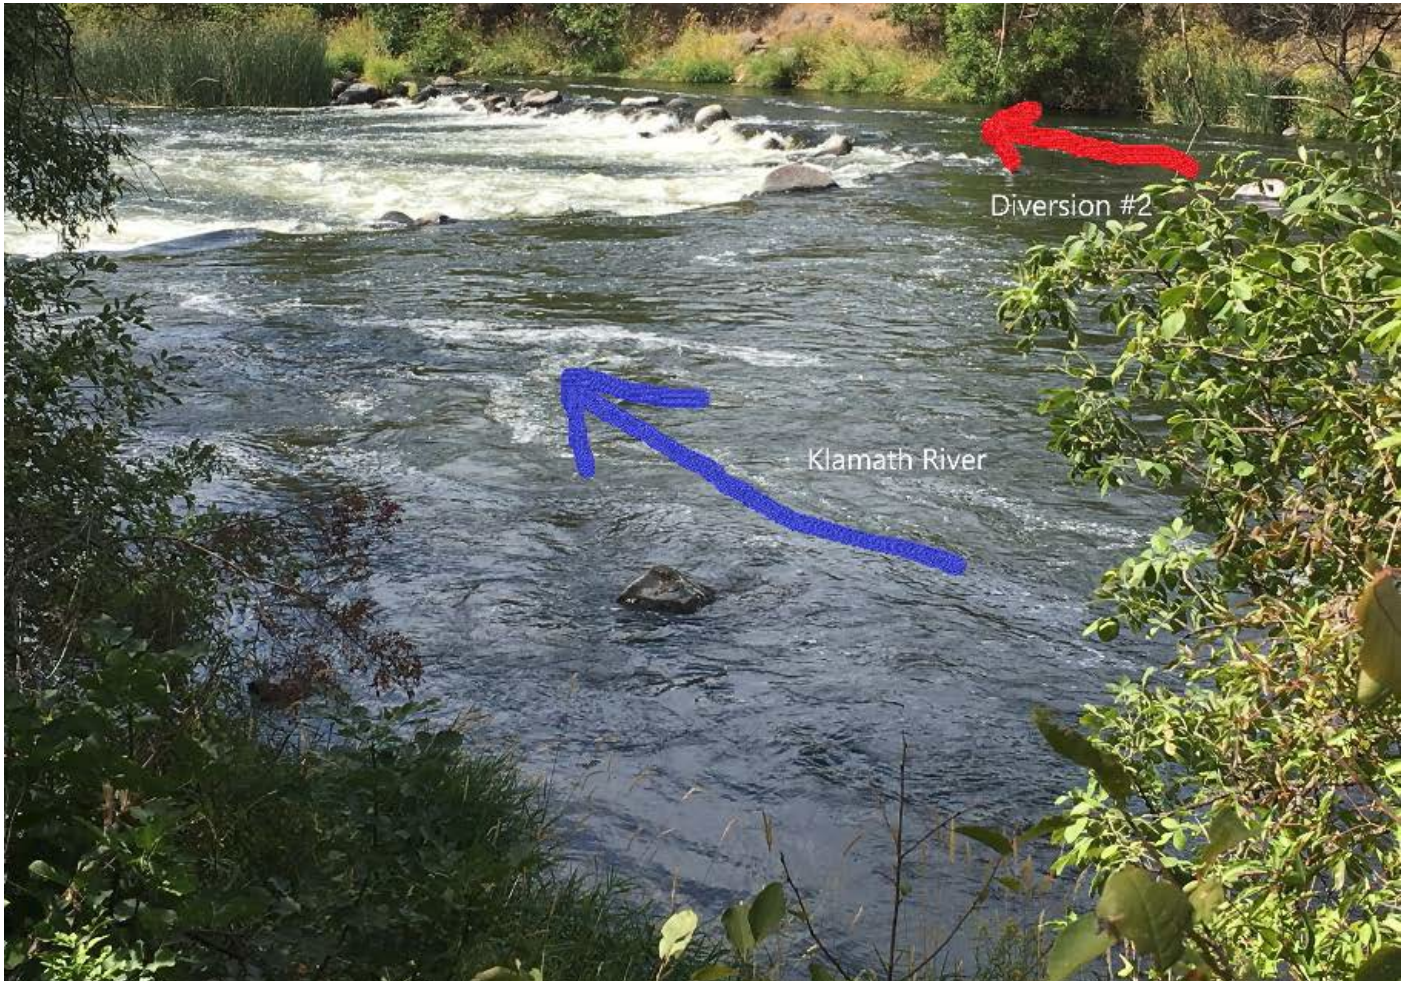
**Project# KL-5**

Figure 9. KL-5 diversion (red arrow) and mainstem Klamath River flow (blue arrow). September 2019. Photo credit: ODFW.

There is an unscreened diversion on river right of the Klamath River in Oregon that is designed to capture a portion of the Klamath River's flow using an angled boulder weir and ditch system (Figure 9, Figure 10). This ditch is 7 feet wide and parallels the river, intersects with Hayden Creek, and continues for 1700 feet before irrigating property belonging to PacifiCorp in CA. Hayden Creek drains directly into the ditch and we found water leaking out of a small breach in the ditch at a natural depression, likely from the natural channel of Hayden Creek. It appears that the majority of Hayden Creek water was going into the diversion and escaping at a blown out, tarped section of the ditch (Figure 12). It is possible that when the tarp is not in place (when irrigation water is not needed) all the water from the diversion is going back into the river at this point creating attraction flow in which adult fish then migrate up Hayden Creek to spawn. This theory warrants further investigation in the late winter/early spring.

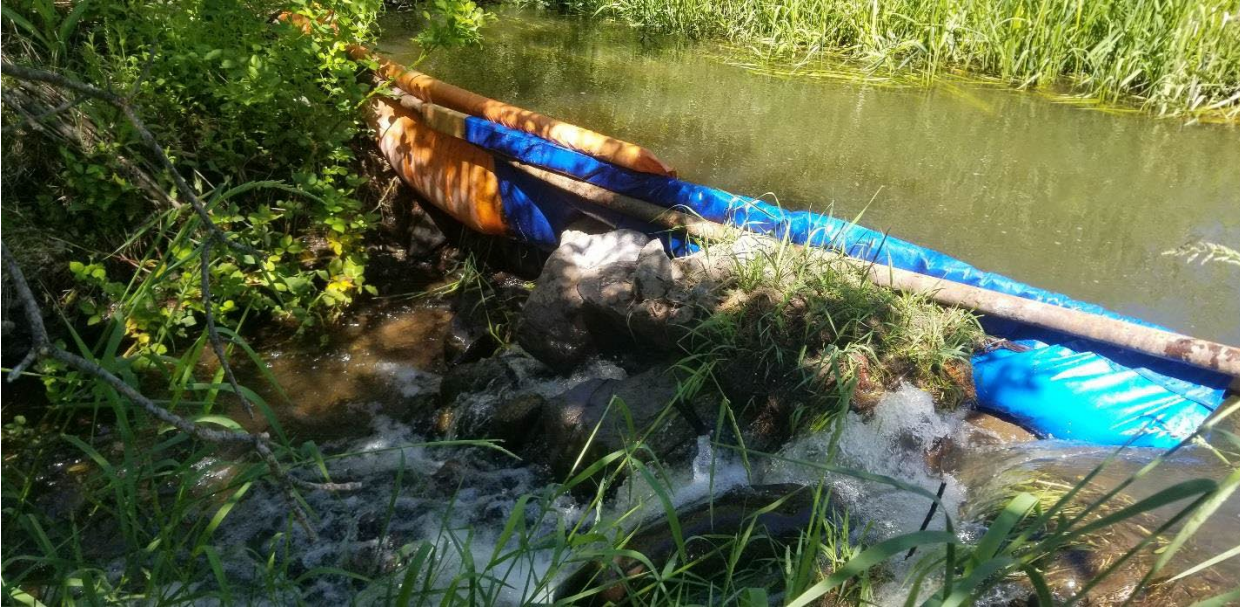
The ditch is in poor shape and has several areas of failure where water is leaking out toward the Klamath River (Figure 11, Figure 12). The ditch is surrounded by reed canary grass (RCG), but it is not growing in the main ditch channel probably due to the depth of the ditch (2-4 ft) and the velocities that prohibit channel RCG growth.

Figure 11. Map showing leaky ditch prior to reaching the point of use downstream

Figure 12. Picture of ditch damage and tarps used to fix the leak approximately 50 ft west of where the ditch crosses Hayden Creek. Salmonids and Dace were found in the channel created by this failure. Photo credit: ODFW.

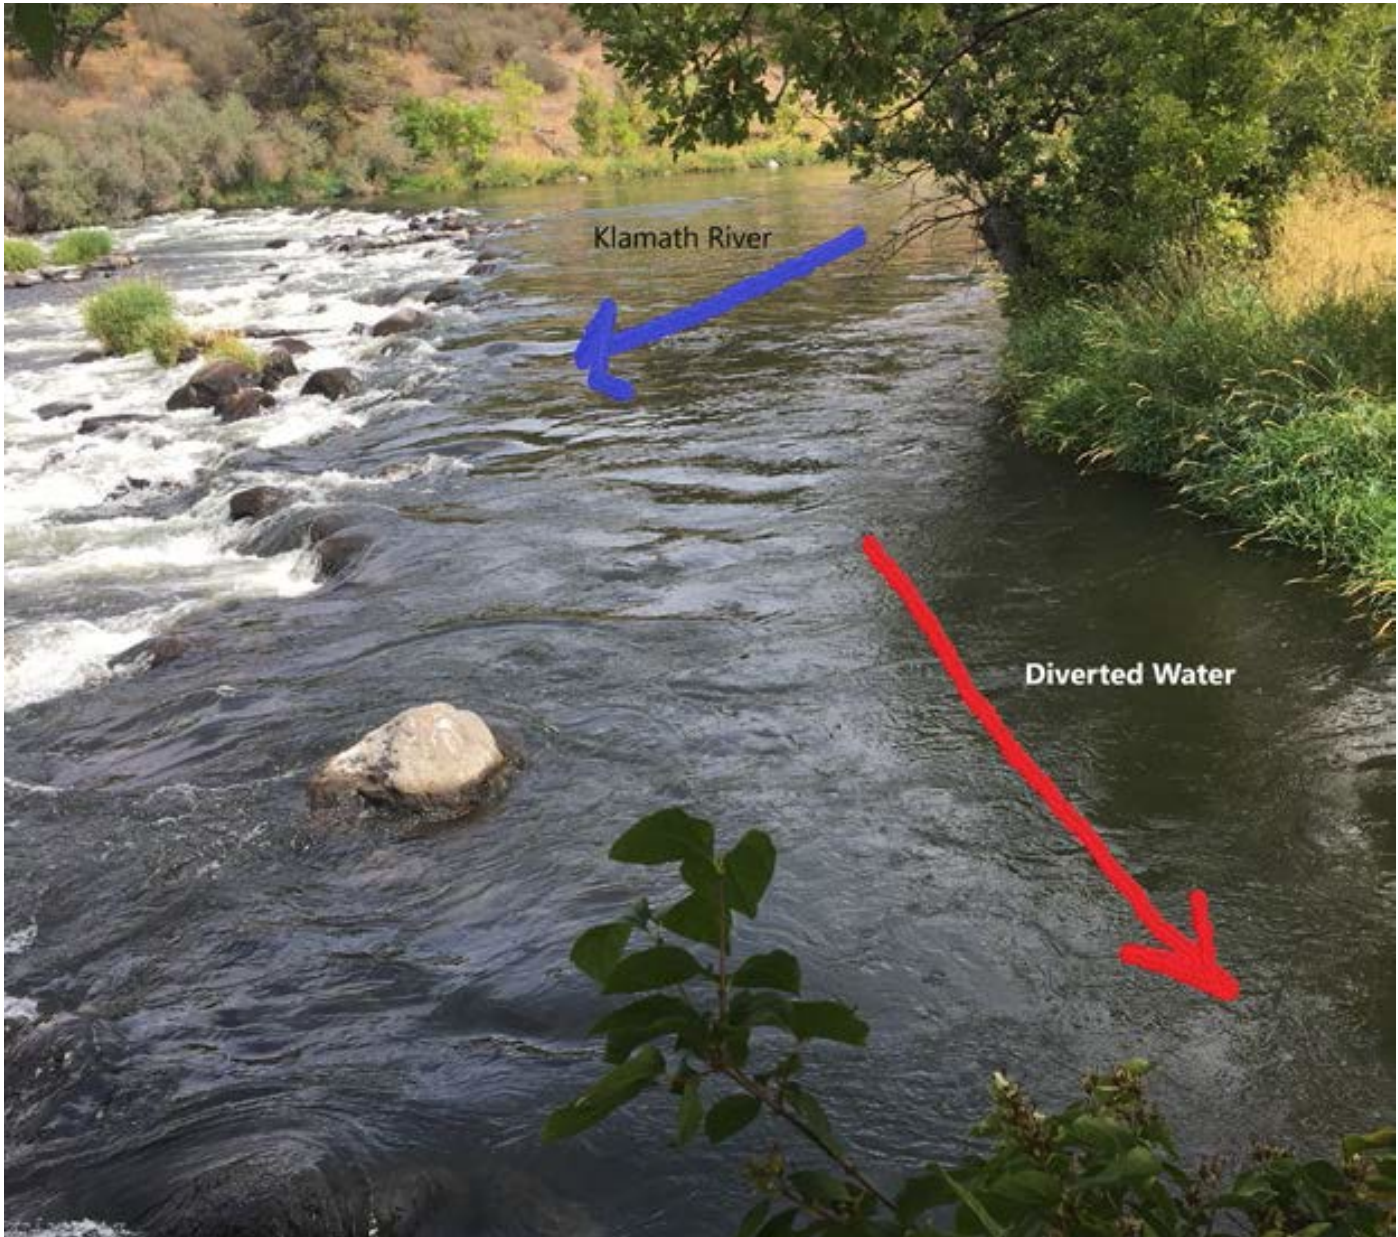
**Project# KL-6**

Figure 14. KL-6 diversion (red arrow) and mainstem Klamath River flow (blue arrow). September 2018. Photo credit: ODFW. September 2018.

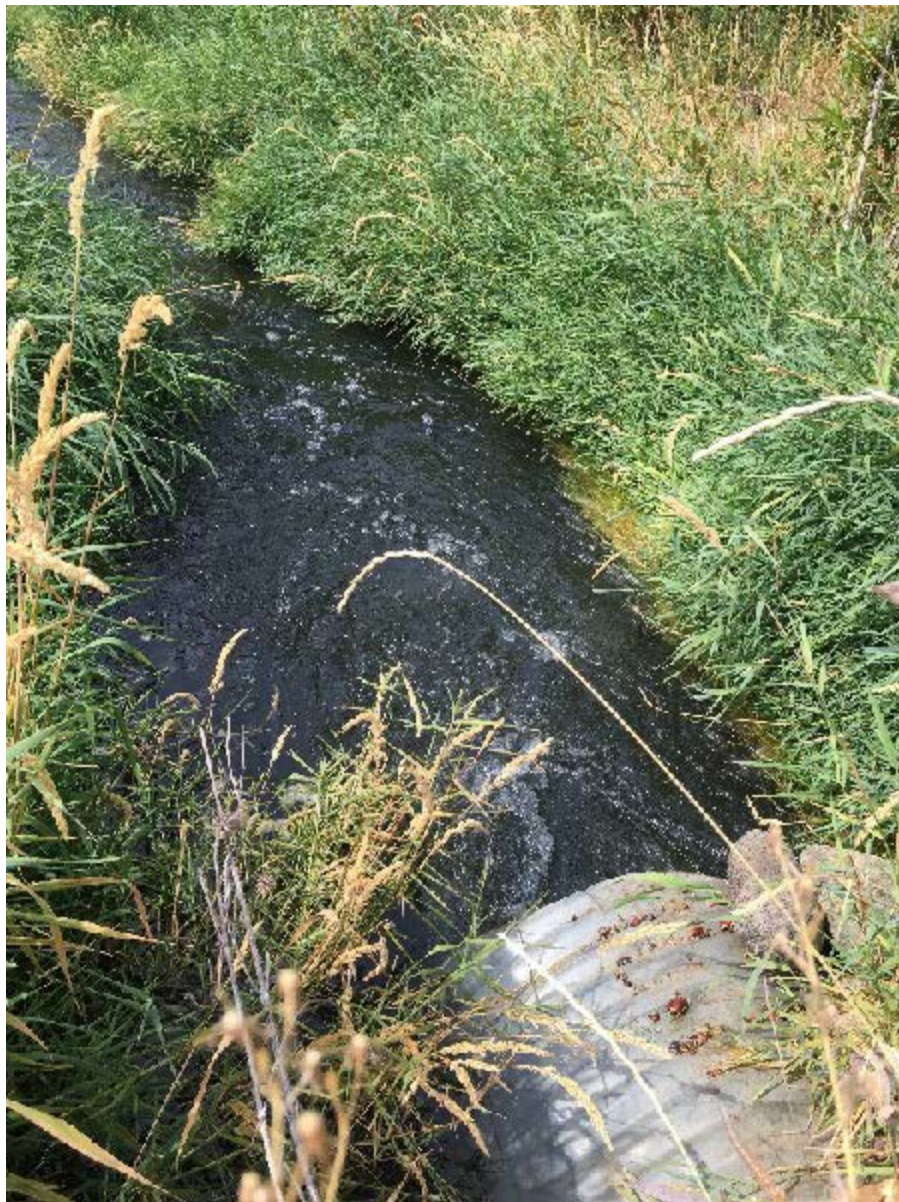
Figure 15. Culvert behind headgate on KL-6 in 2018. ODFW estimated flow of ~30 cfs. Photo credit: ODFW.

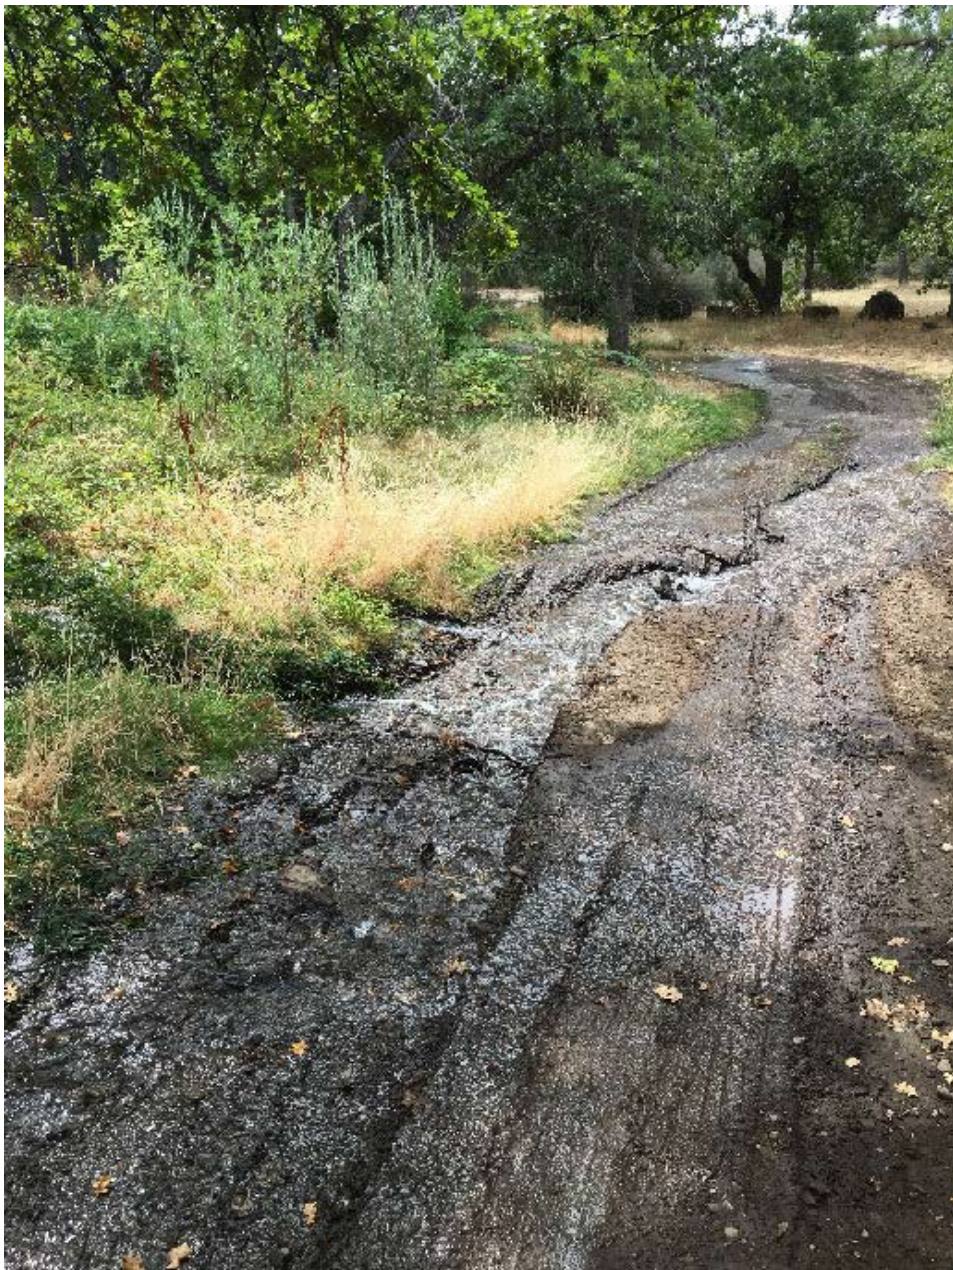
Figure 16. Water from KL-6 diversion flowing over dirt road in 2018. Photo credit: ODFW.

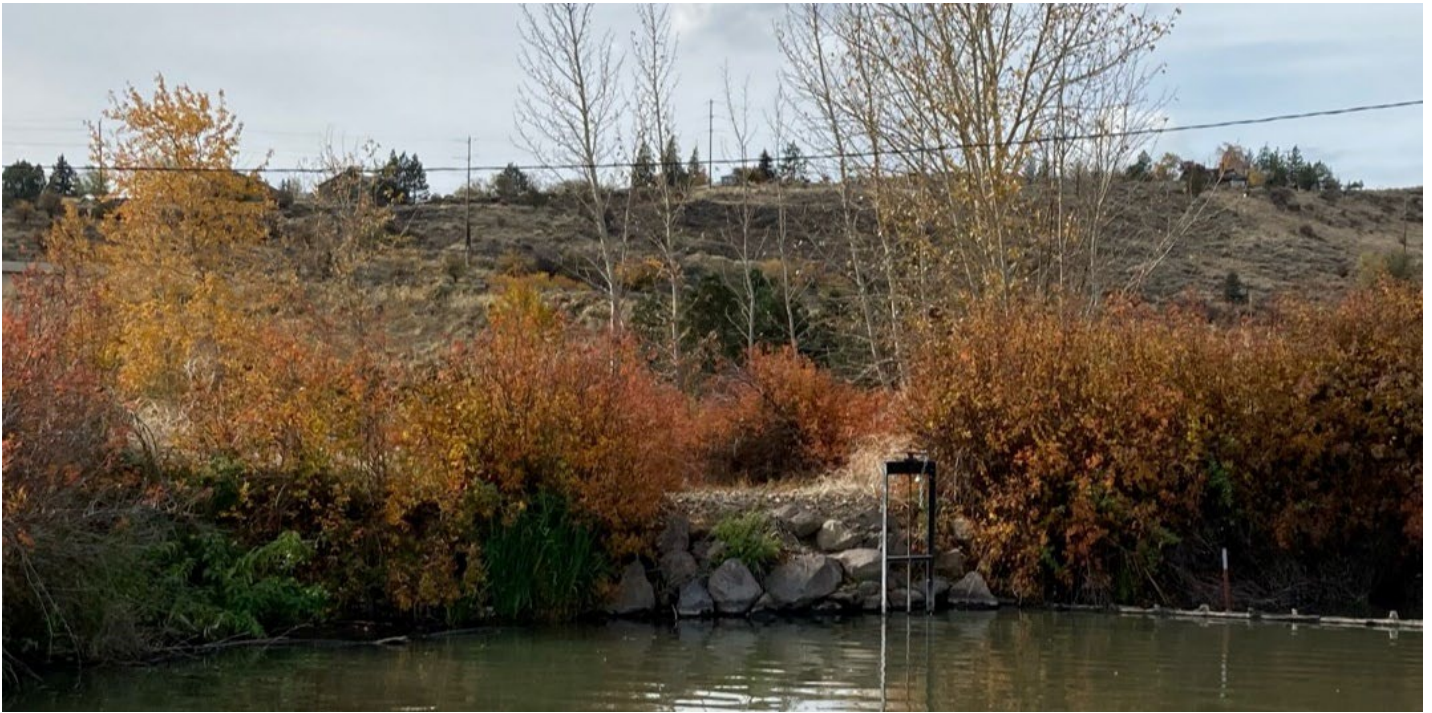
**Project# KENO-2**

Figure 17. Headgate at KENO-2, October 2021.

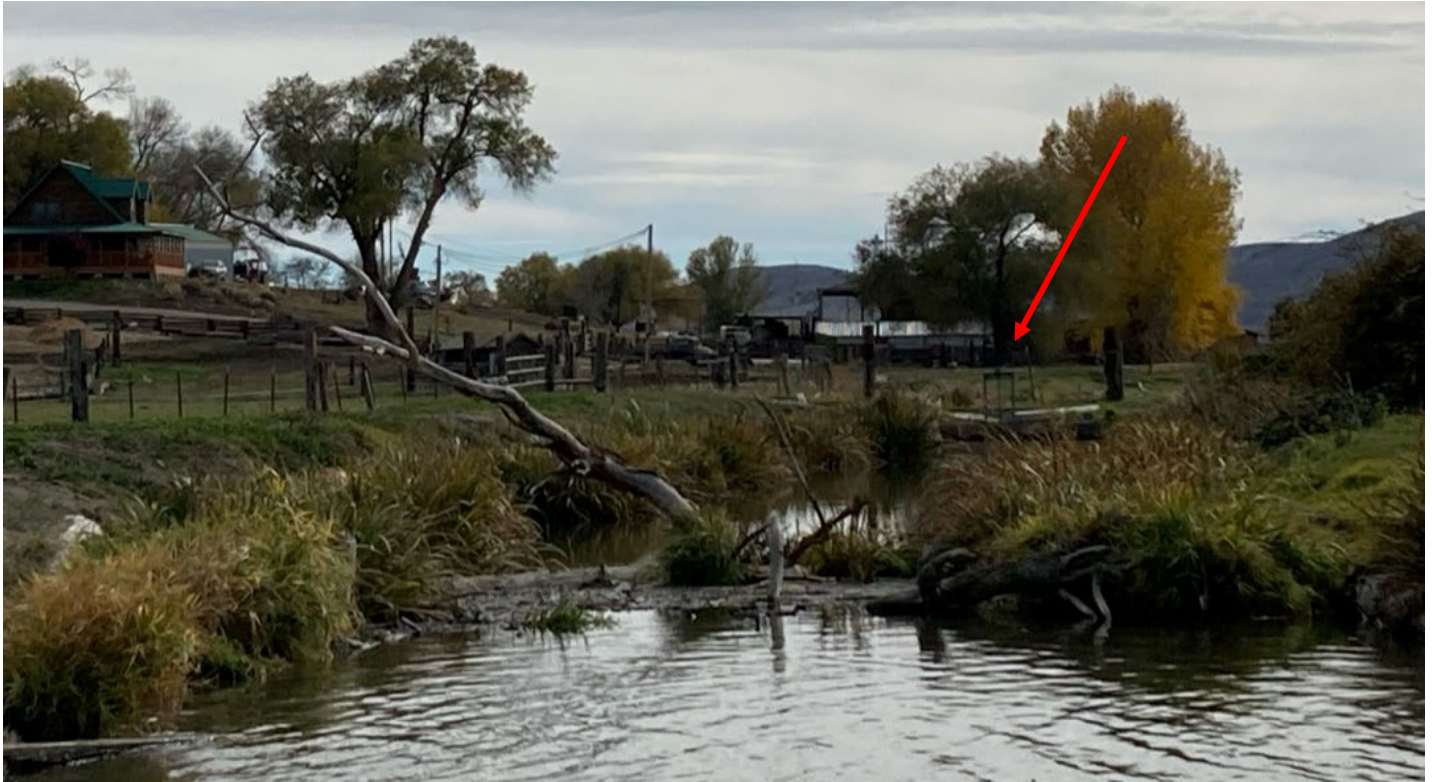
**Project# KENO-3**

Figure 18. Diversion KENO-3. Arrow points to headgate at end of ditch. October 2021

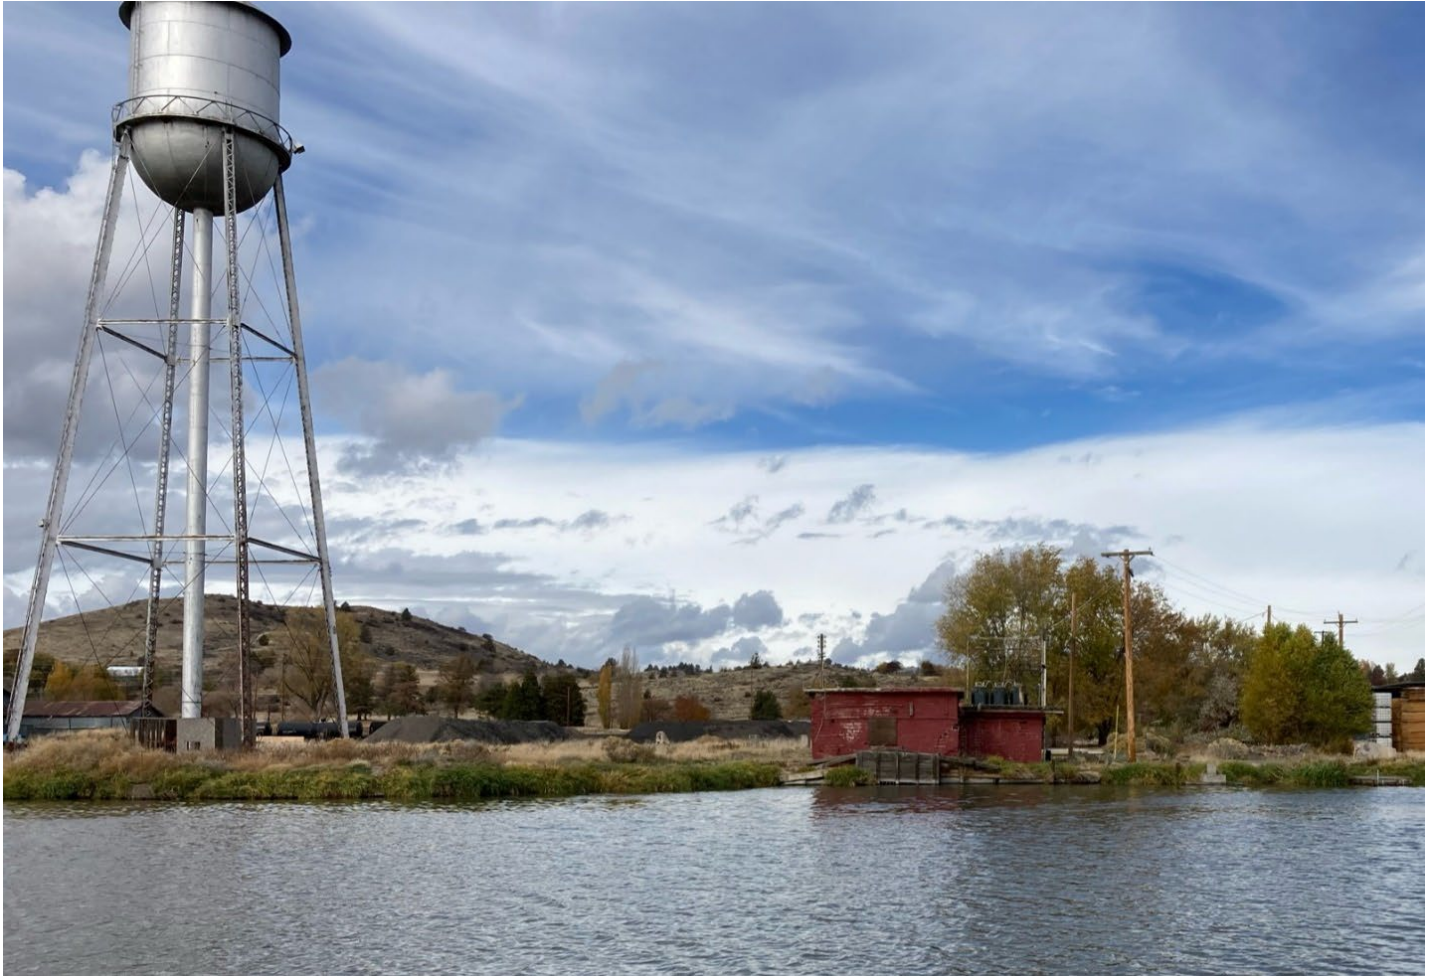
**Project# KENO-4**

Figure 19. KENO-4 location. Diversion is presumably located in red pumphouse. October 2021

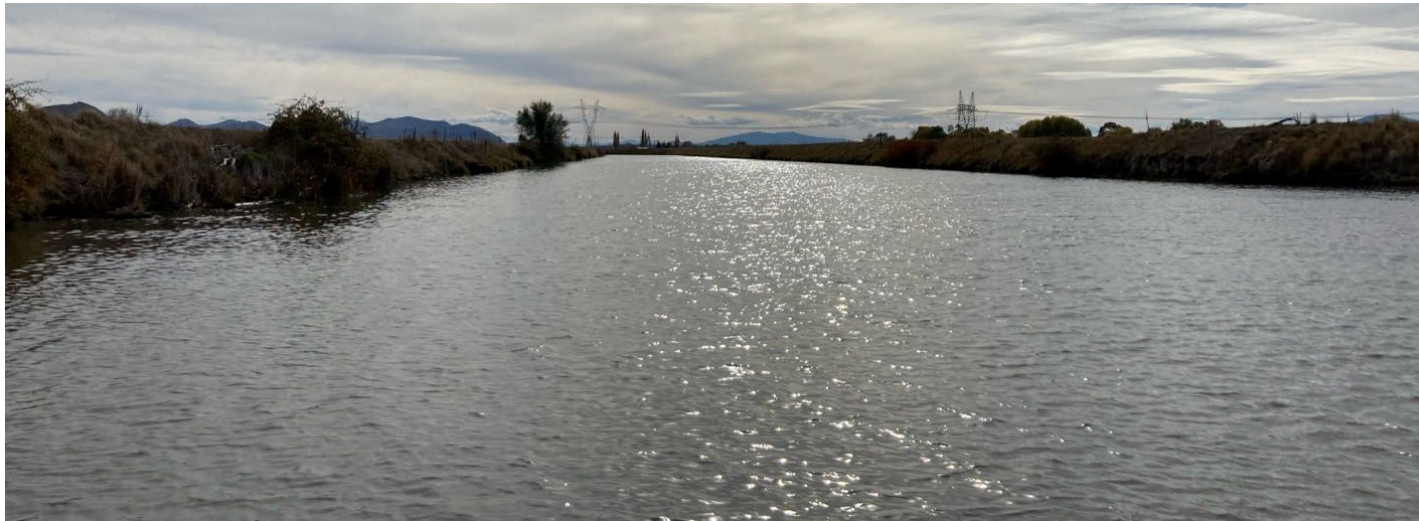
**Project# KENO-5, Lost River Diversion Ditch**

Figure 20. KENO-5, Lost River Diversion Ditch. Photo shows the entire width of the very wide diversion canal. The Klamath River flows to the right out of the photo. October 2021.

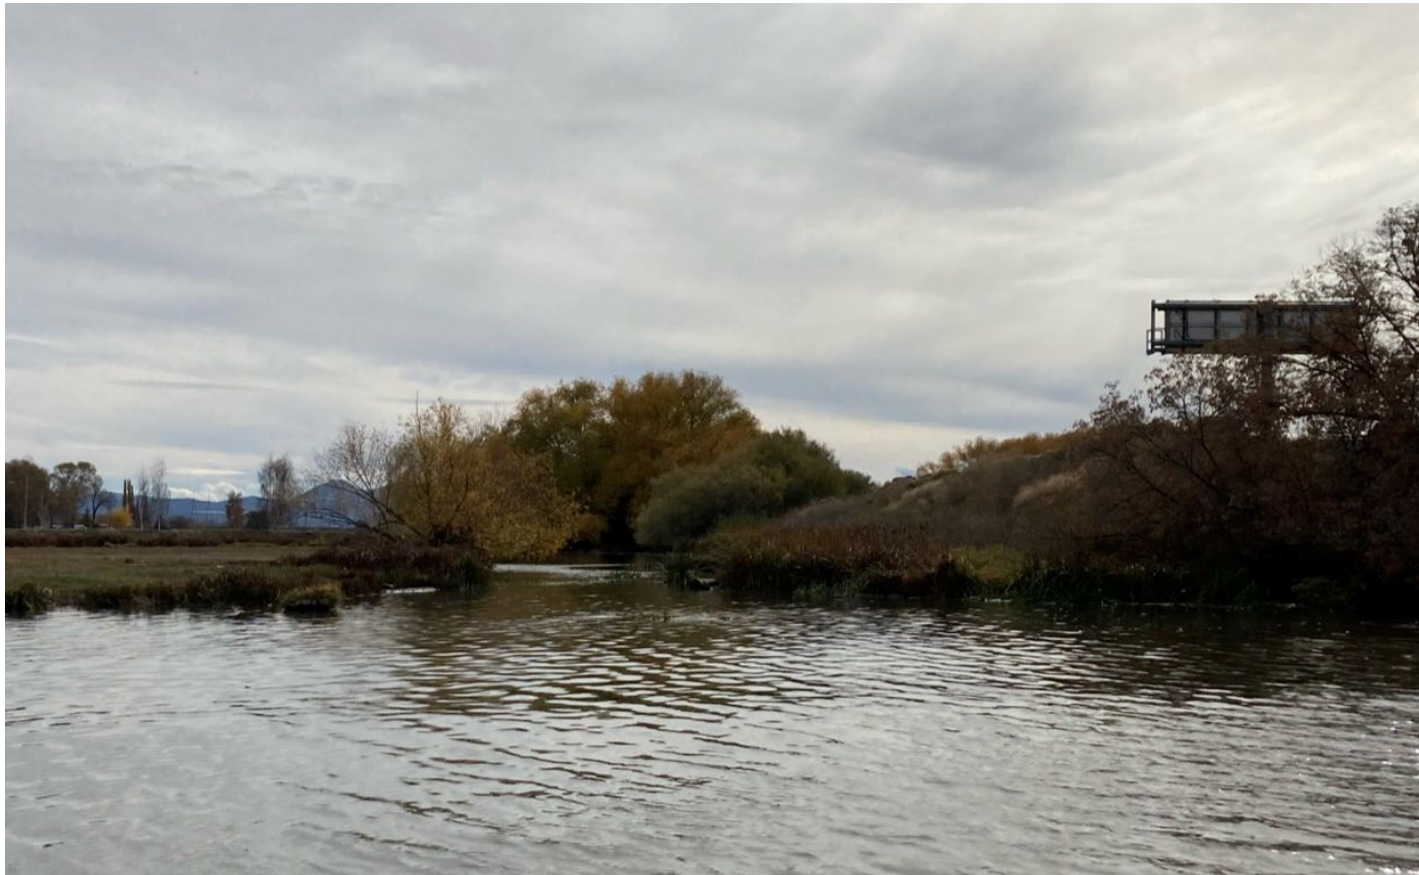
**Project# KENO-7**

Figure 22. Diversion at KENO-7. October 2021

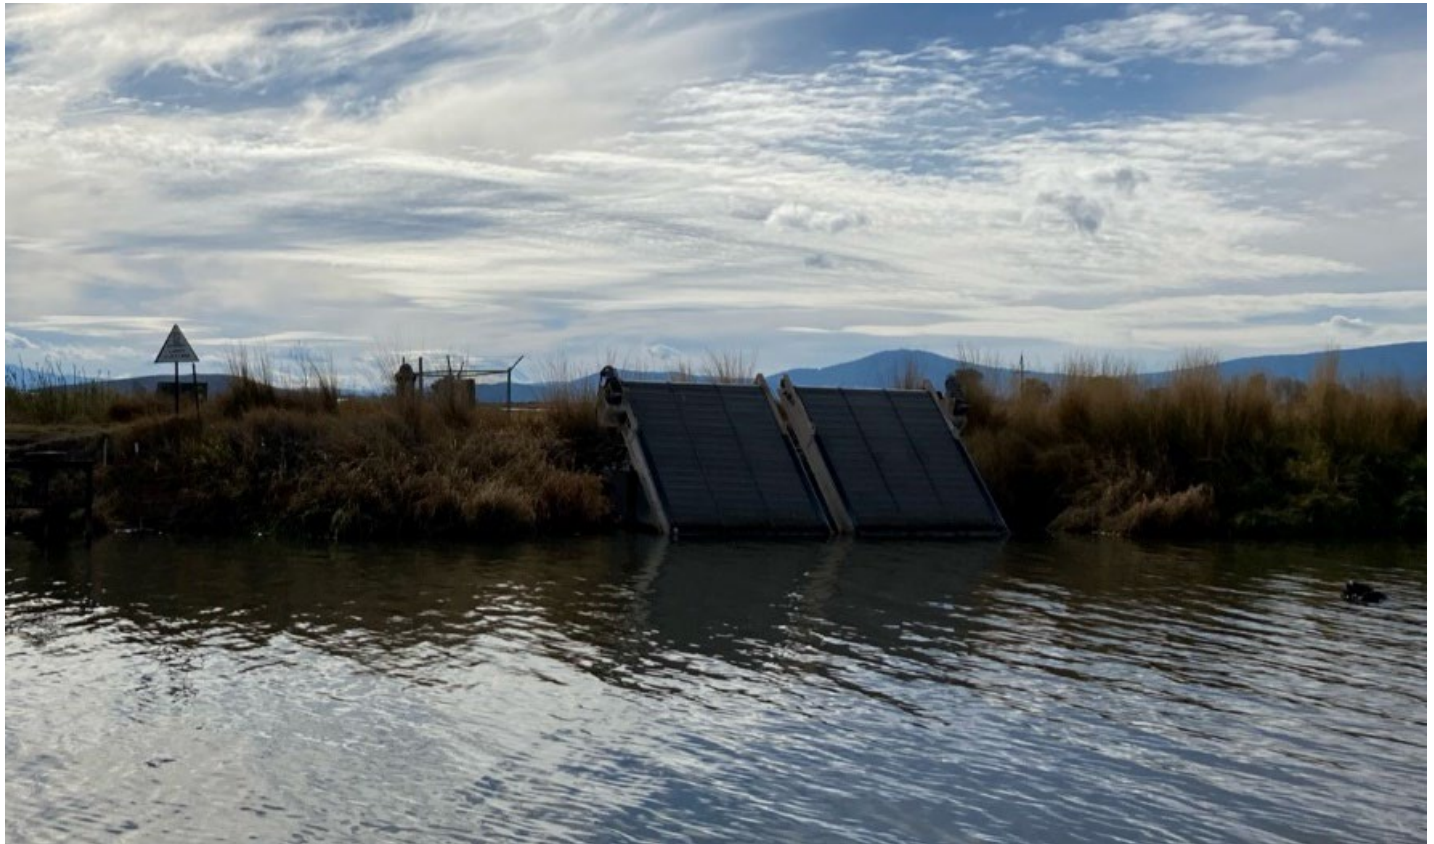
**Project# KENO-13**

Figure 27. Diversion and Fish Screen at KENO-13. October 2021.

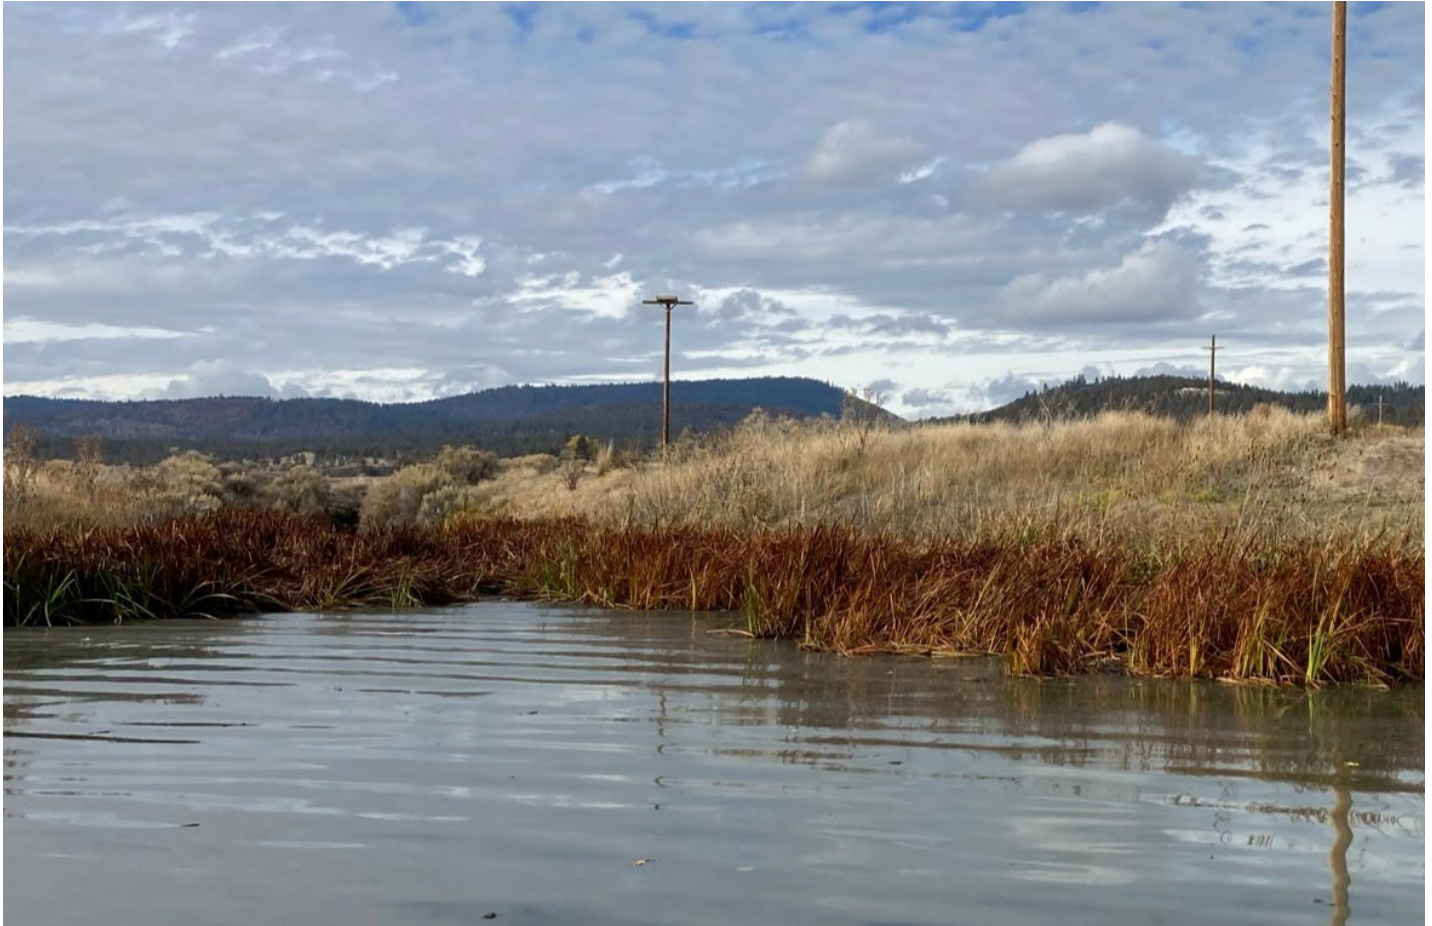
**Project# KENO-14**

Figure 28. Diversion at KENO-14. October 2021.

***(Identified in desktop analysis but during survey found that diversion is unused)***
