## **Appendix C: Fish Screening Project Descriptions**

### **Screening Project List**

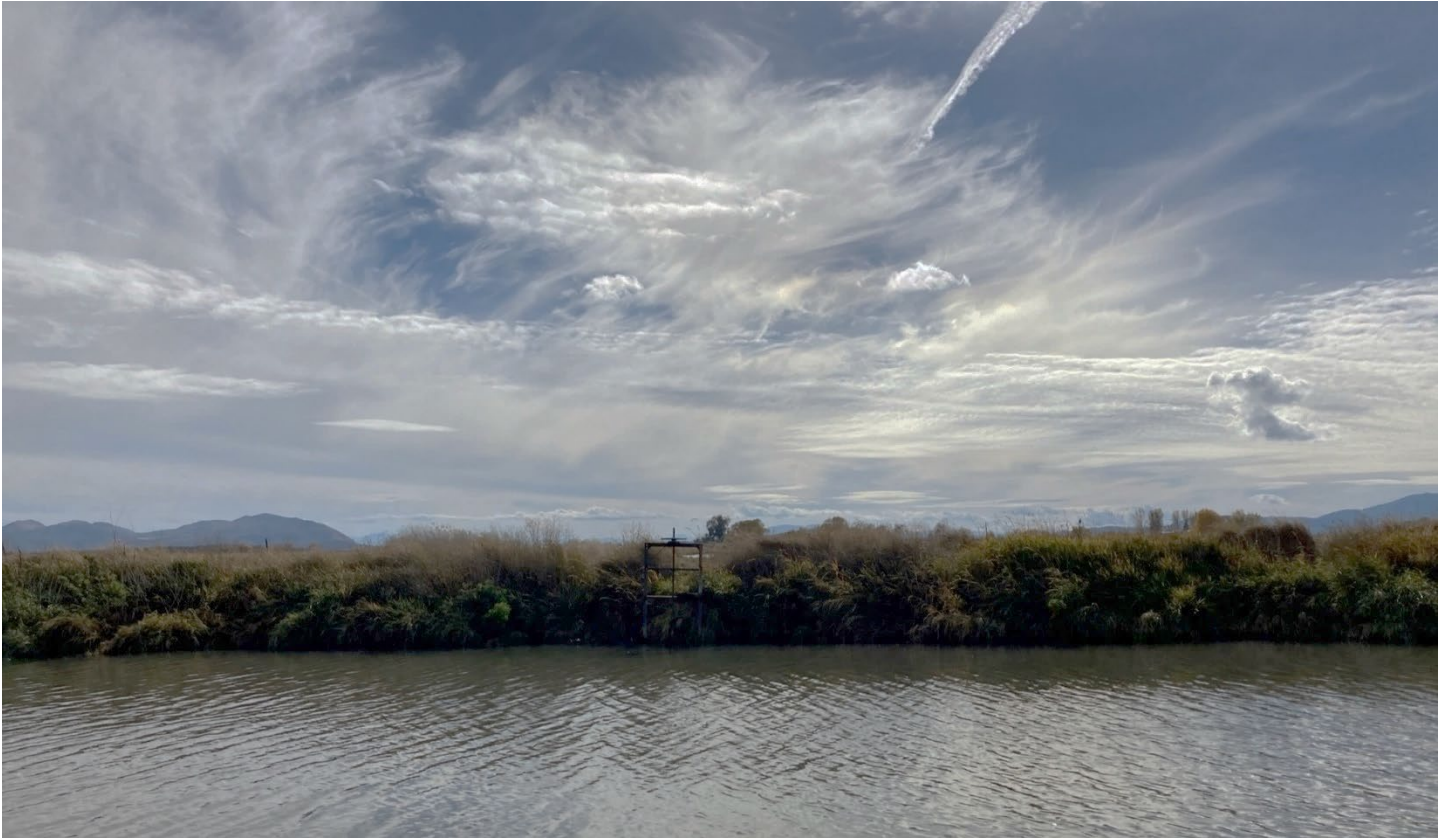
**Project# KENO-15**

***(Identified in desktop analysis but during survey found that diversion is unused)***

*Figure 29. Unused diversion at KENO-15. October 2021.*

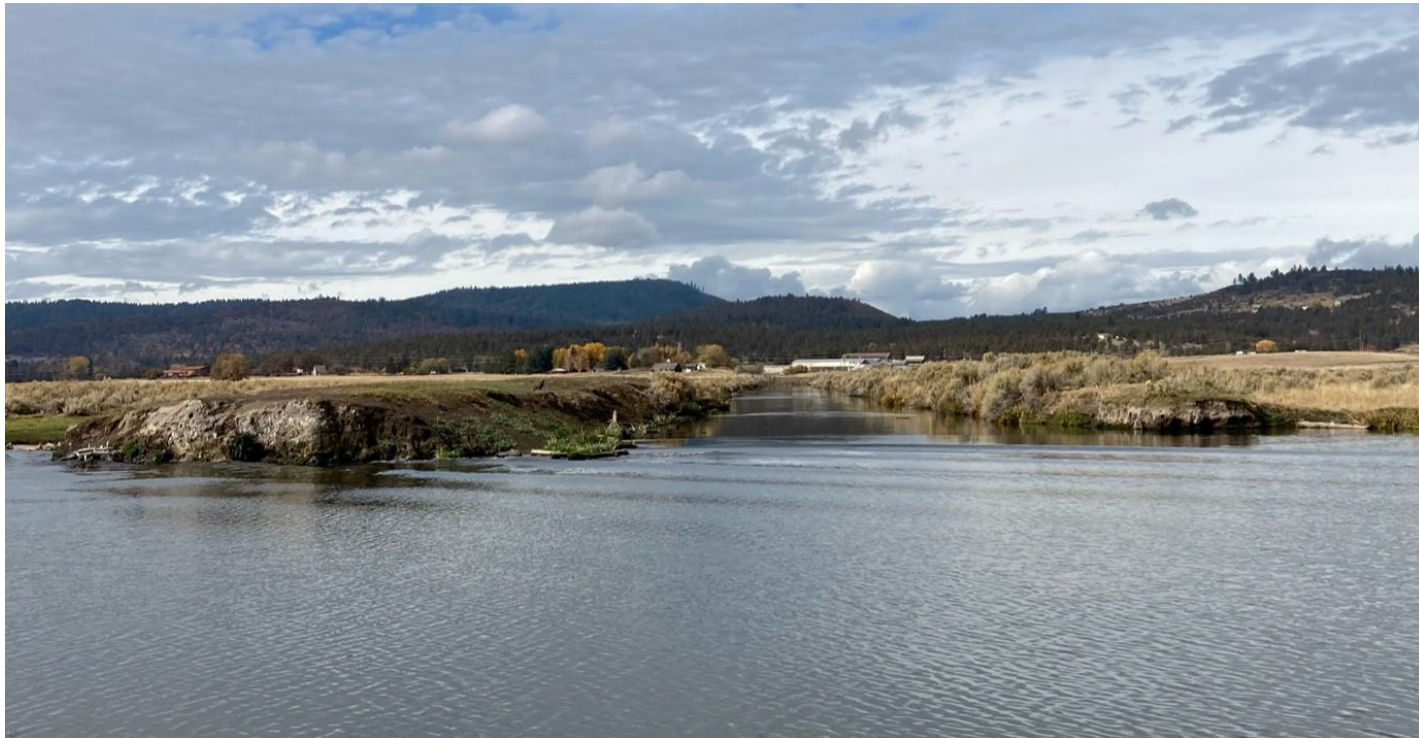
**Project# KENO-16**

Figure 30. Diversion at KENO-16. October 2021.

***(Identified in desktop analysis but during survey found that diversion is unused)***

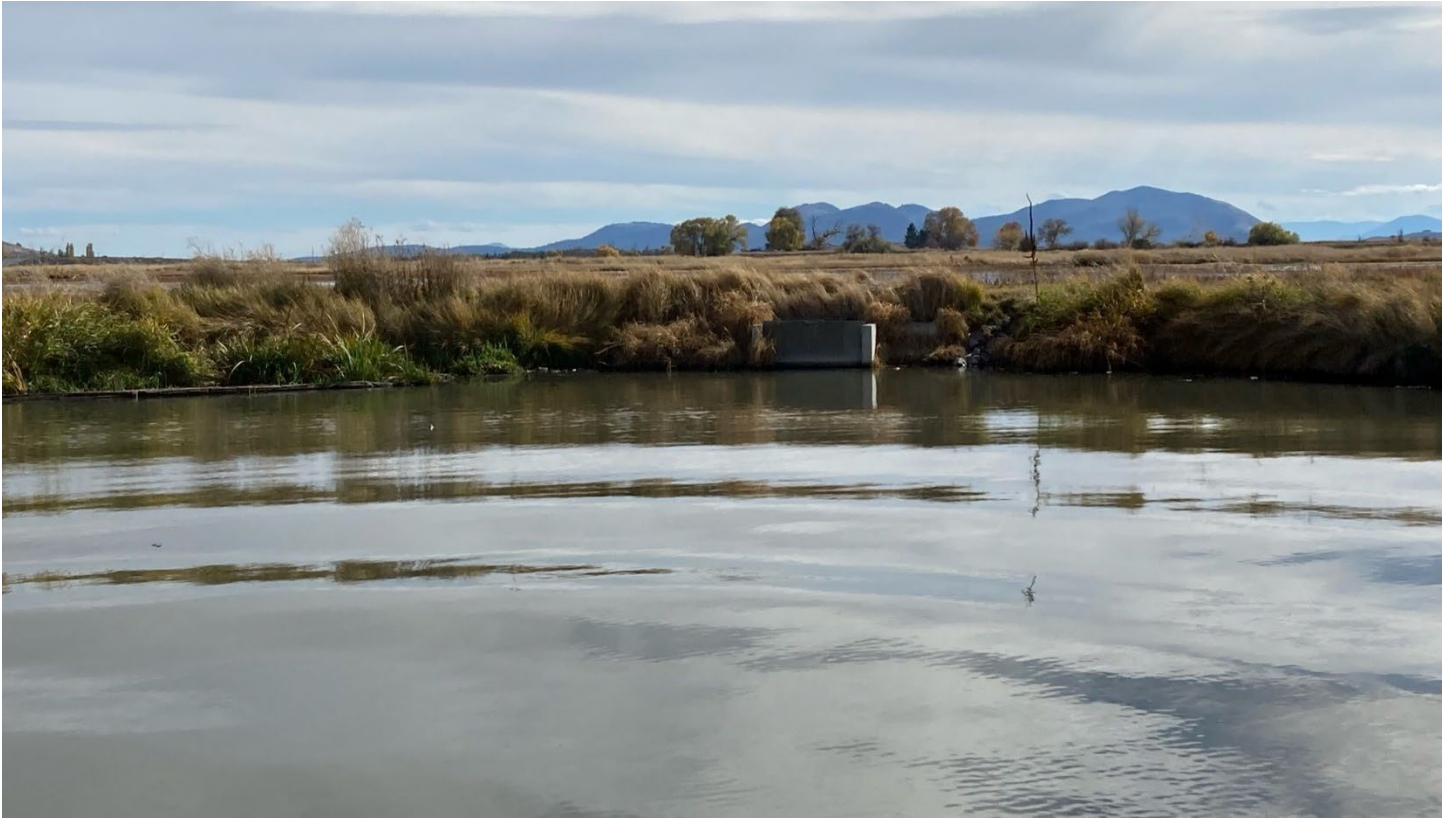
**Project# KENO-17**

*Figure 31. Unused diversion at KENO-17. October 2021.*

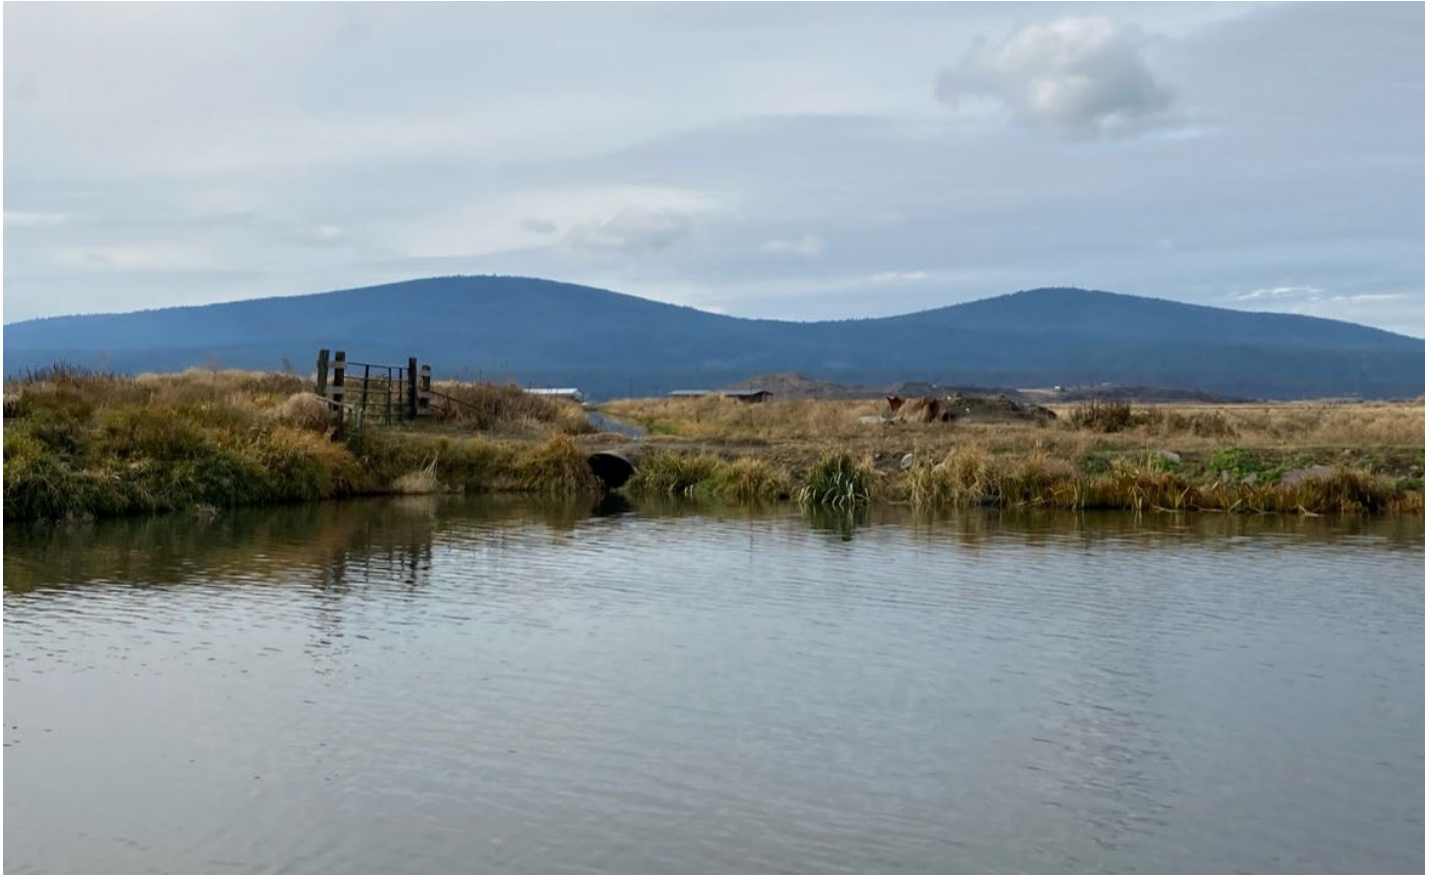
**Project# KENO-20**

Figure 34. Diversion at KENO-20. October 2021.

***(Identified in desktop analysis but during survey found that diversion is unused)***

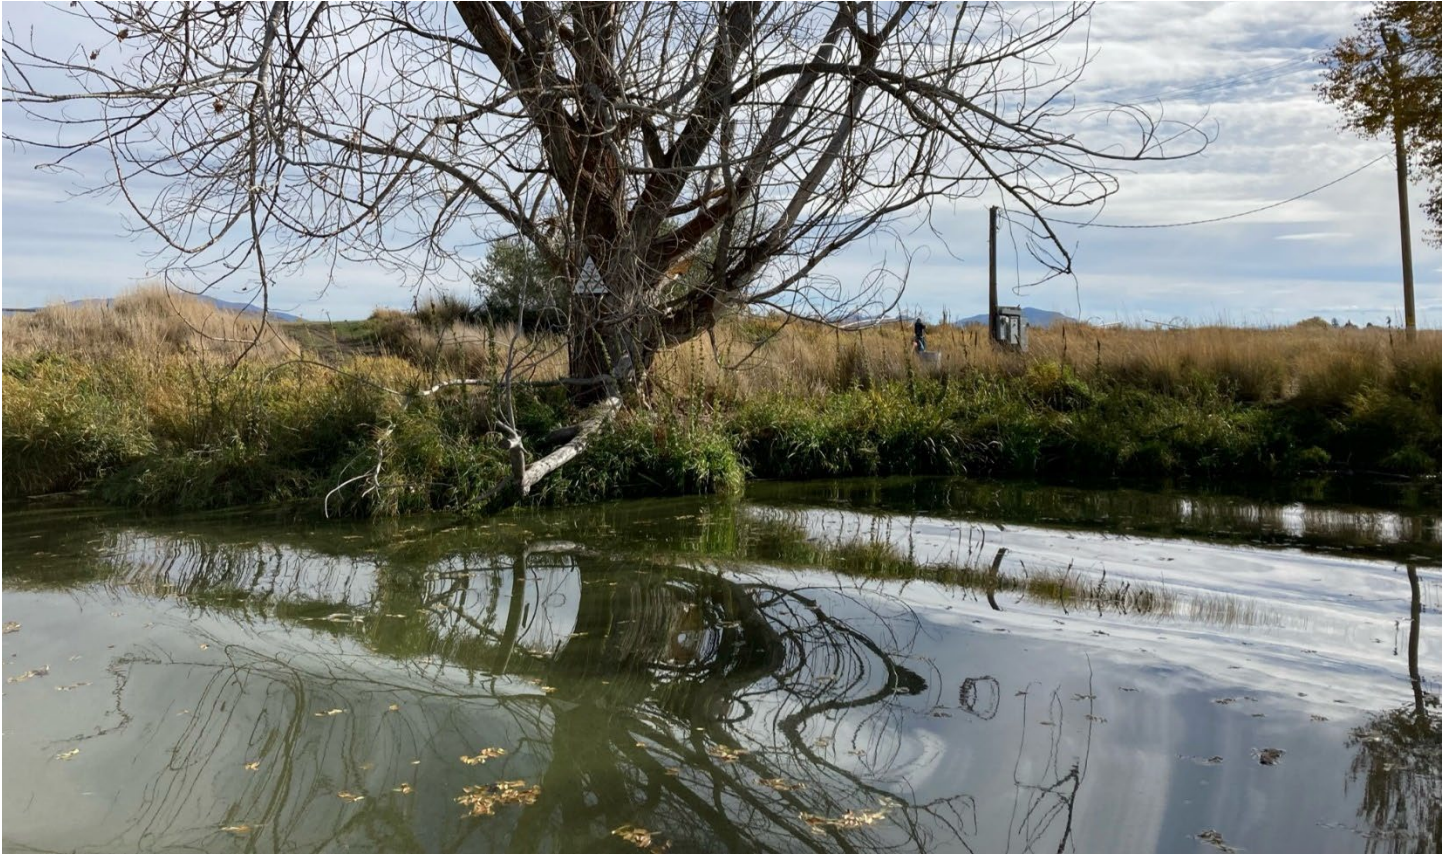
**Project# KENO-21**

*Figure 35. Unused diversion at KENO-21. October 2021.*

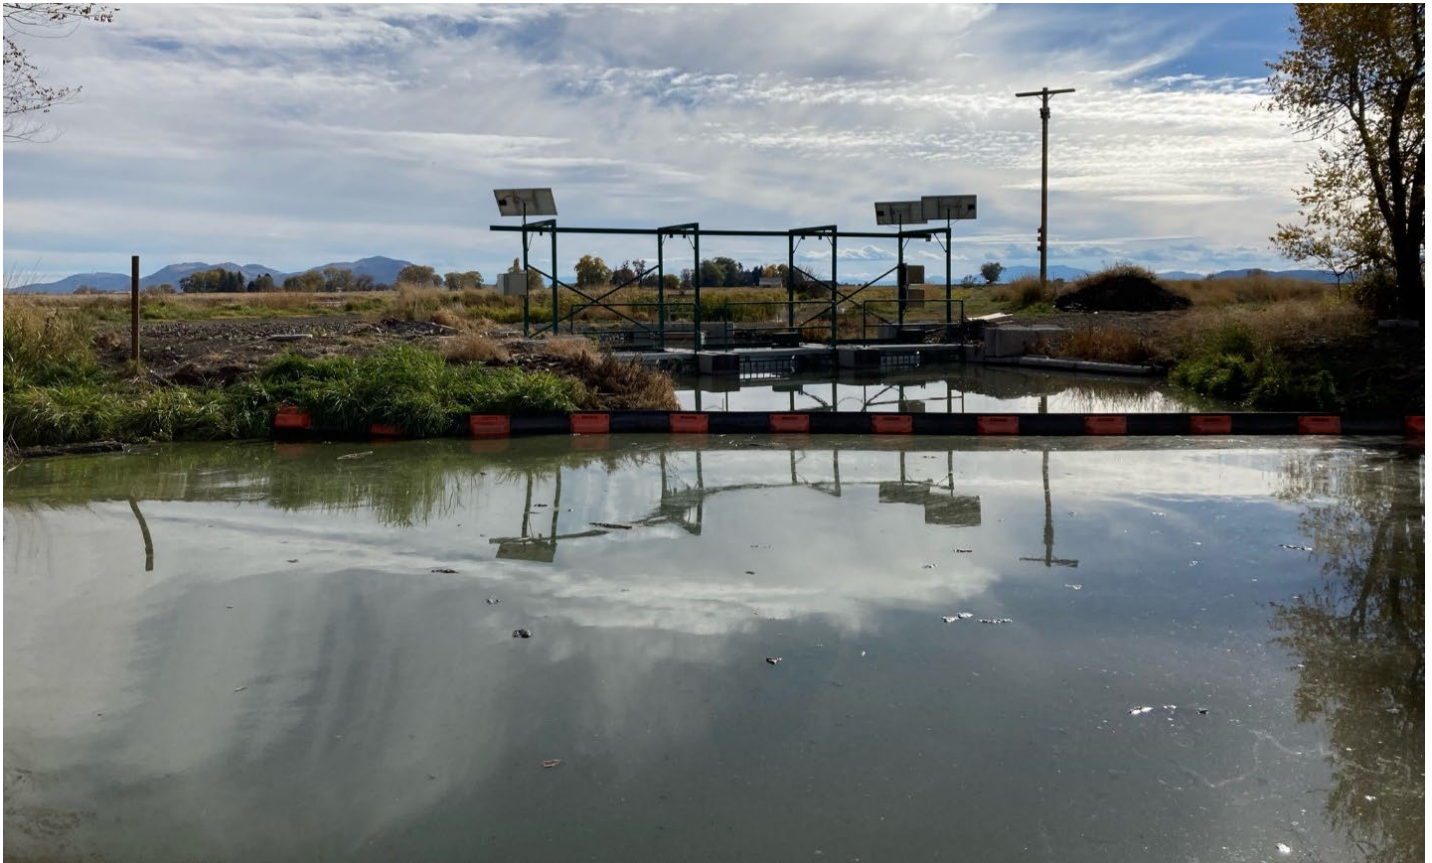
**Project# KENO-23**

Figure 37. Screen and diversion at KENO-23. October 2021.

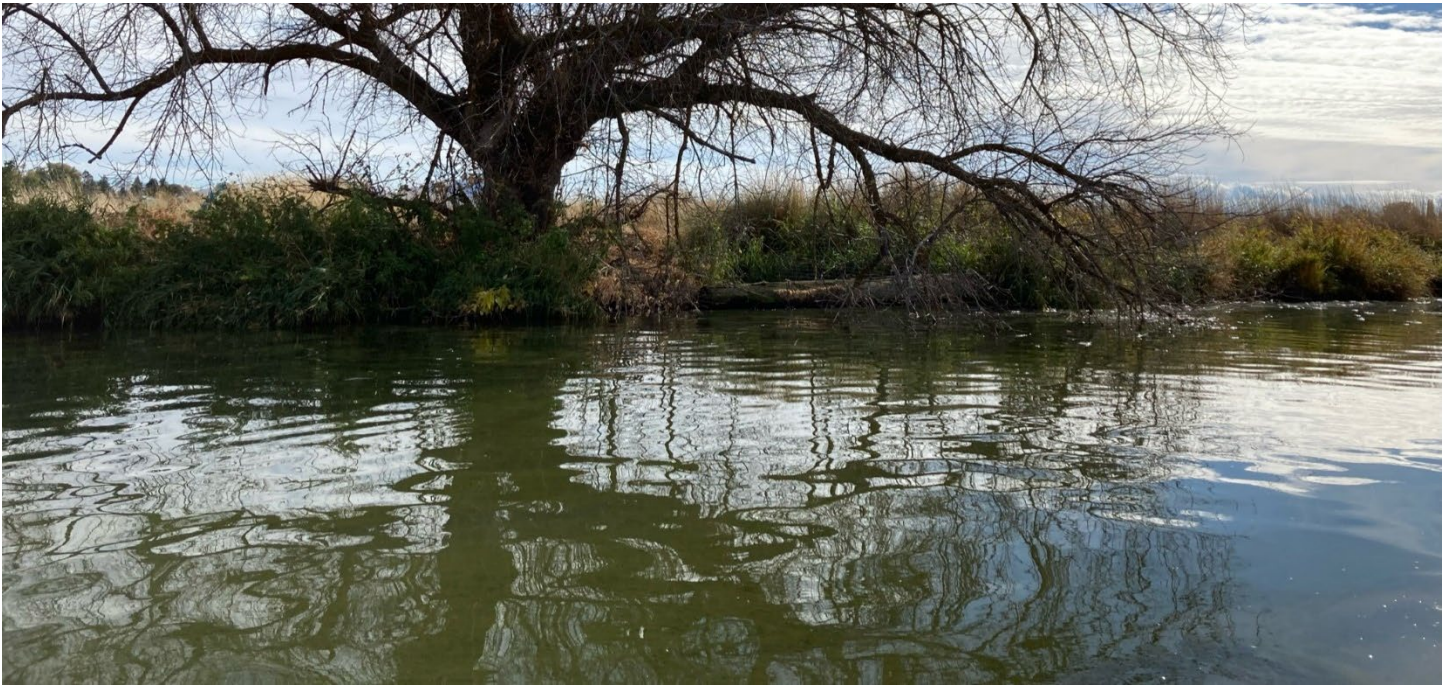
**Project# KENO-25**

*(Identified in desktop analysis but could not find during survey)*

*Figure 39. Unused diversion at KENO-25. October 2021.*

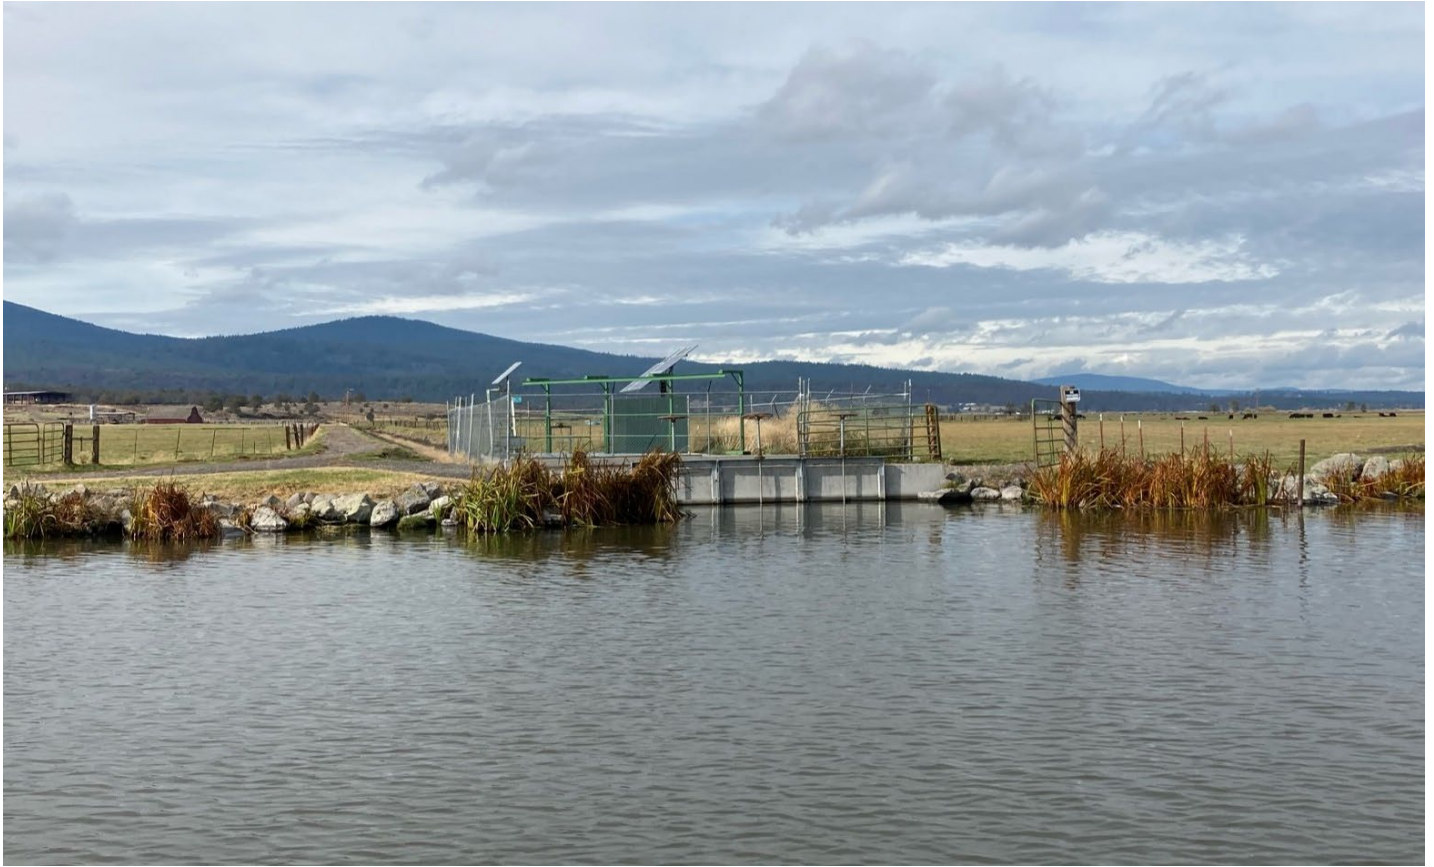
**Project# KENO-32**

Figure 44. Screen and diversion at KENO-32. October 2021.

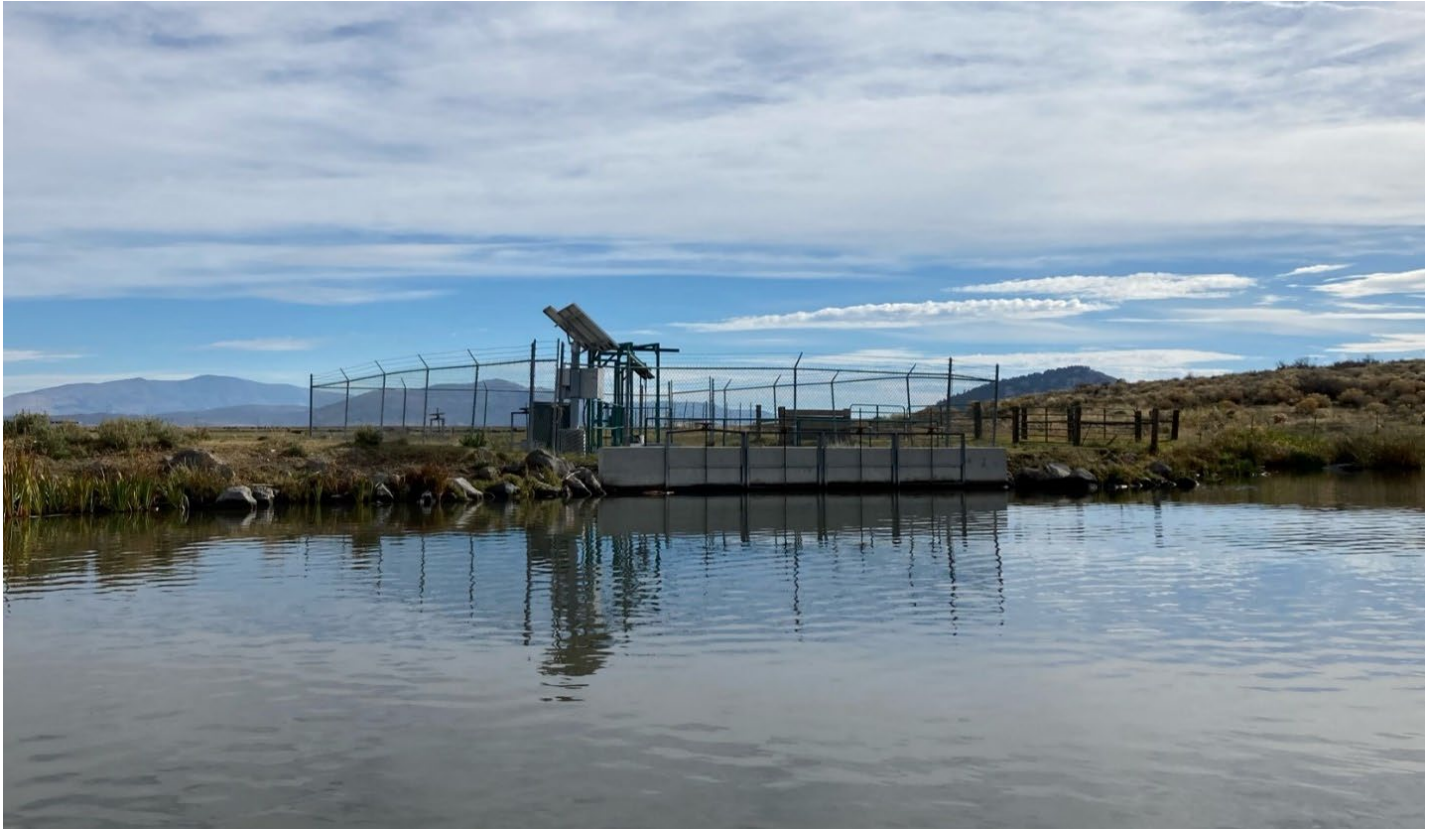
**Project# KENO-36**

Figure 48. Screen and diversion at KENO-36. October 2021.

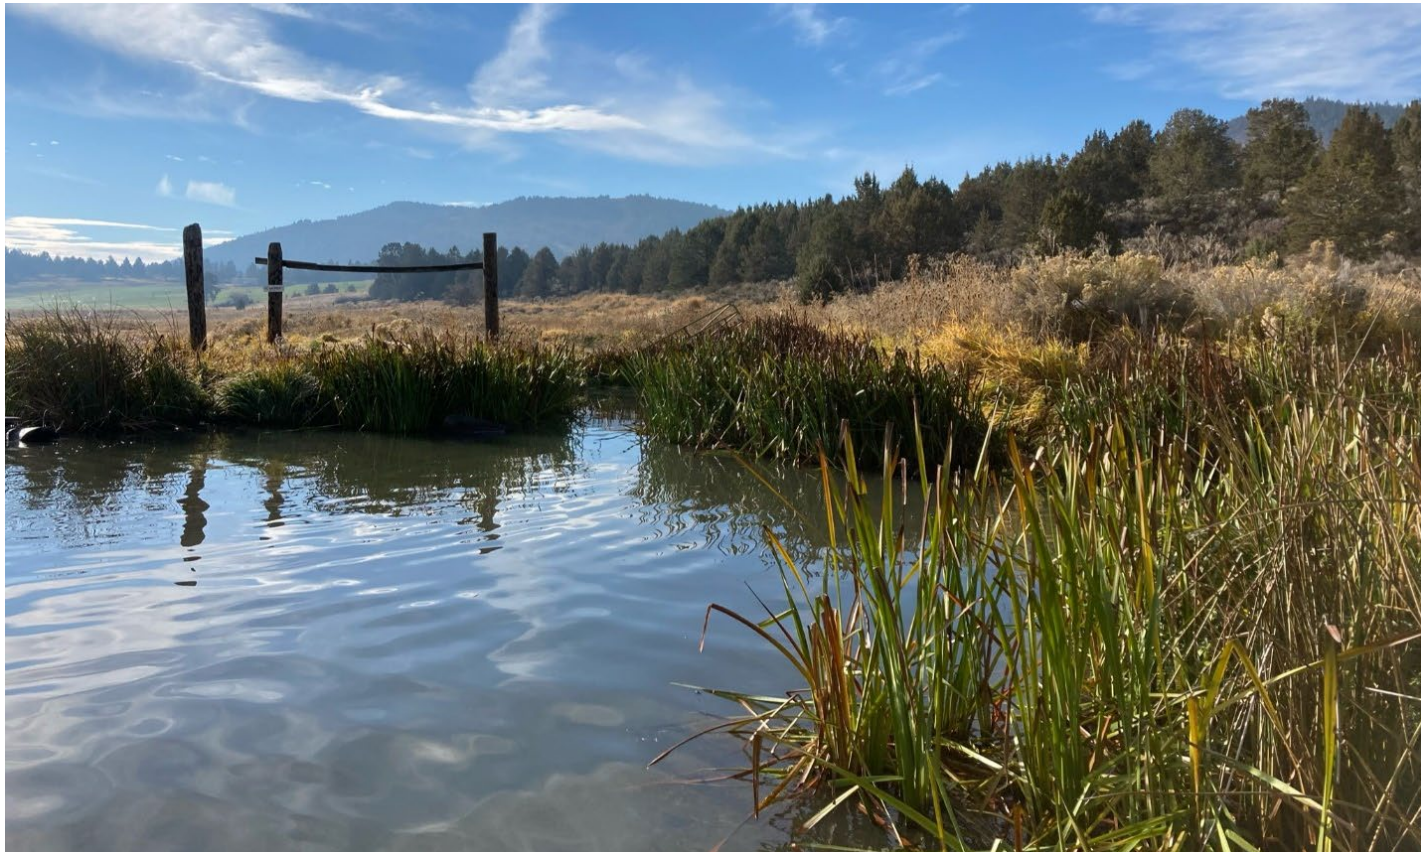
**Project# KENO-45**

Figure 57. Diversion at KENO-45. October 2021.

**Screen:** No

**Size score:** 3      **Benefit score:** 4      **Total score:** 3.5      **Priority Tier:** High

**Notes:** 24" headgate

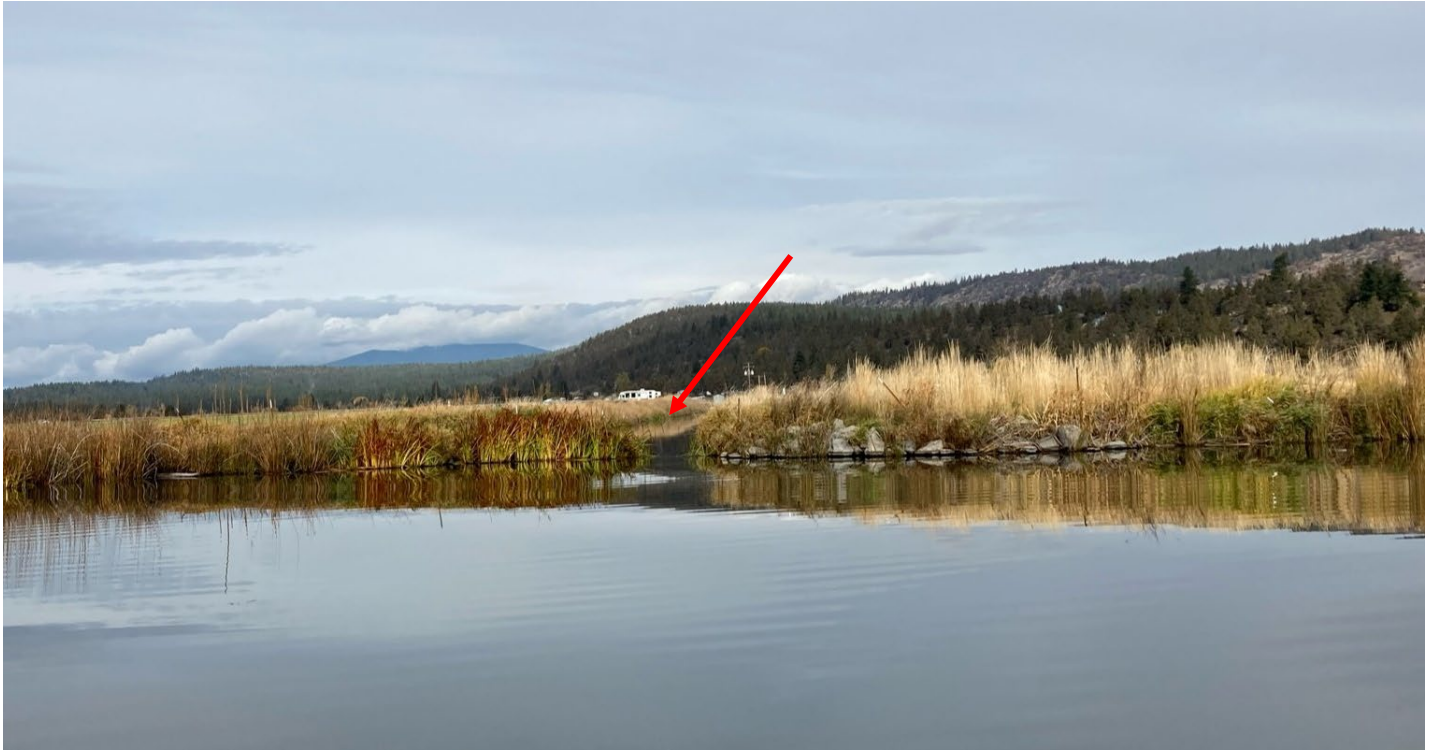
**Project# KENO-46**

Figure 58. Diversion at KENO-46. October 2021.

**Screen:** Unknown

**Size score:** 1      **Benefit score:** 4      **Total score:** 2.5      **Priority Tier:** Low

**Notes:** Open canal at river, no screen at river, pump visible at end of canal approximately 1000' from river

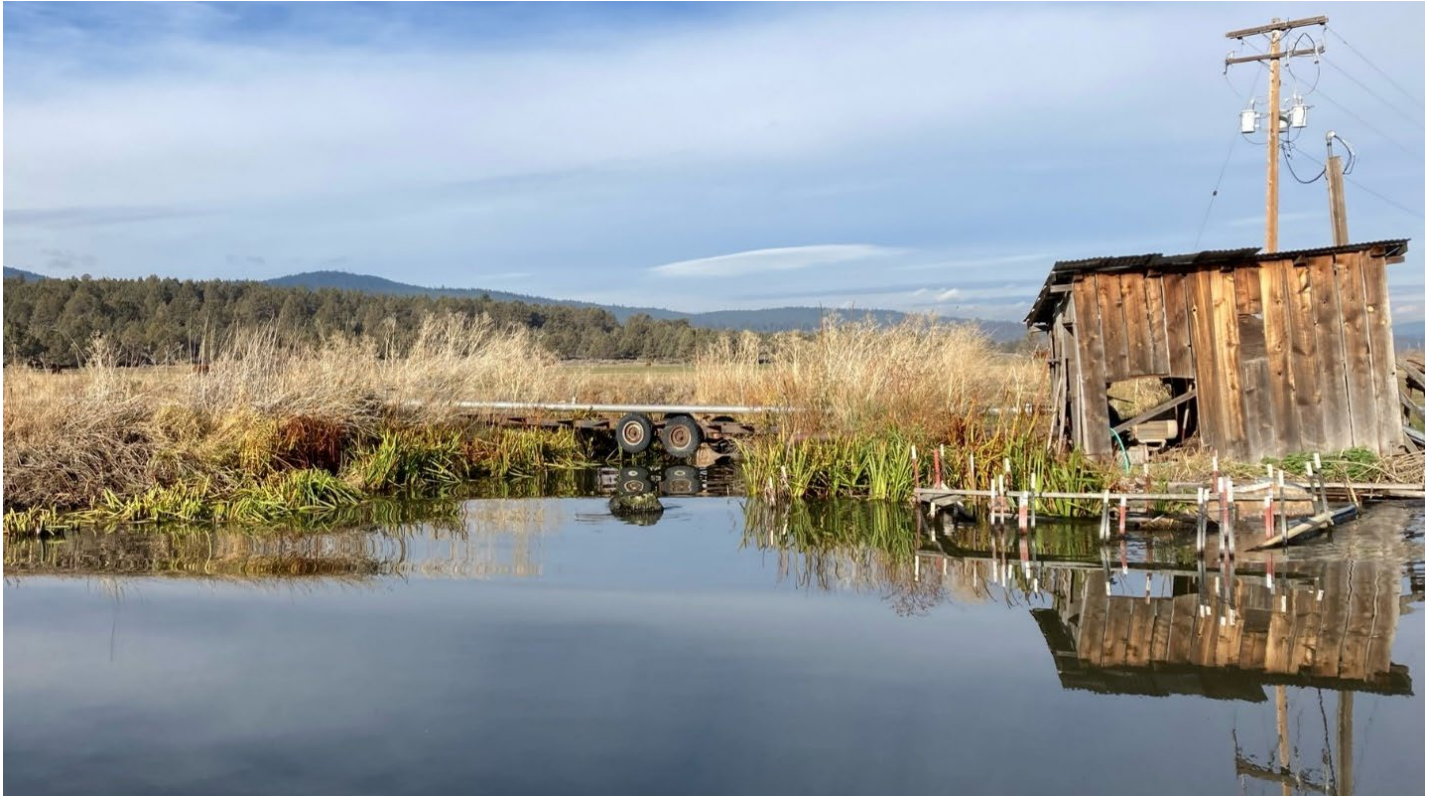
**Project# KENO-47**

Figure 59. Diversion at KENO-47. October 2021.

**Screen:** No

**Size score:** 1      **Benefit score:** 4      **Total score:** 2.5      **Priority Tier:** Low

**Notes:** Pump

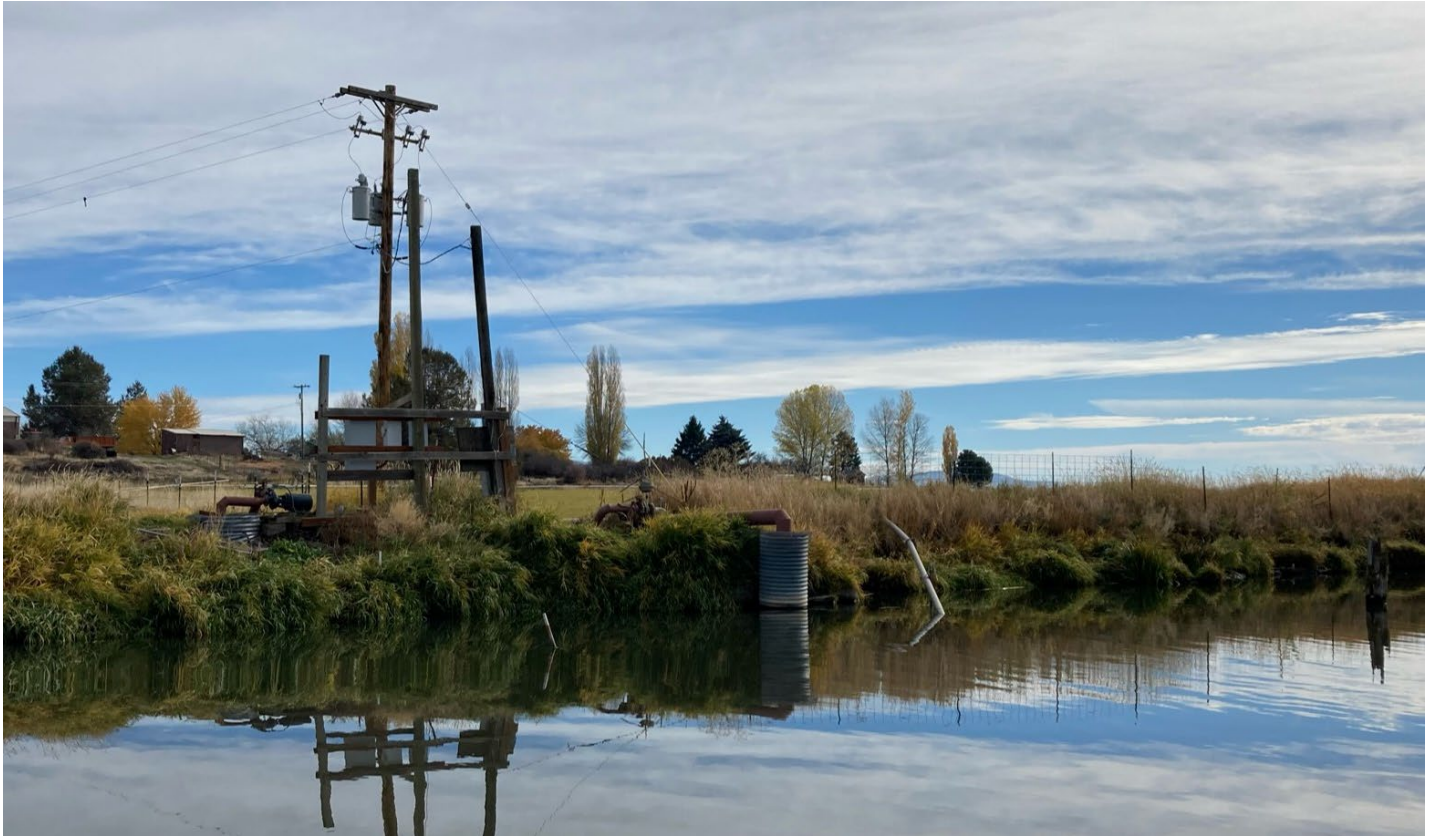
**Project# KENO-48**

Figure 60. Diversion at KENO-48. October 2021.

**Screen:** No

**Size score:** 1      **Benefit score:** 4      **Total score:** 2.5      **Priority Tier:** Low

**Notes:** 2 pumps next to each other

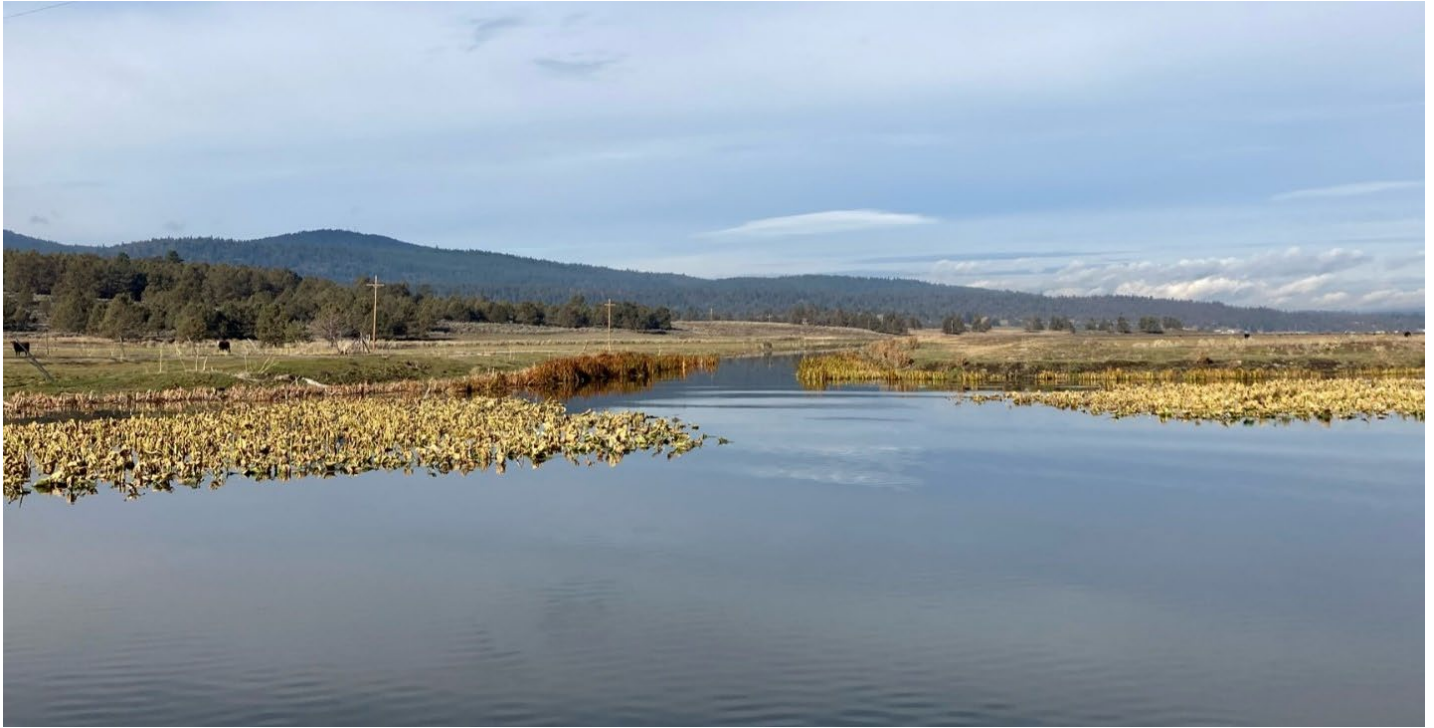
**Project# KENO-49**

Figure 61. Diversion at KENO-49. October 2021.

**Screen:** No

**Size score:** 3      **Benefit score:** 4      **Total score:** 3.5      **Priority Tier:** High

**Notes:** Open canal at river

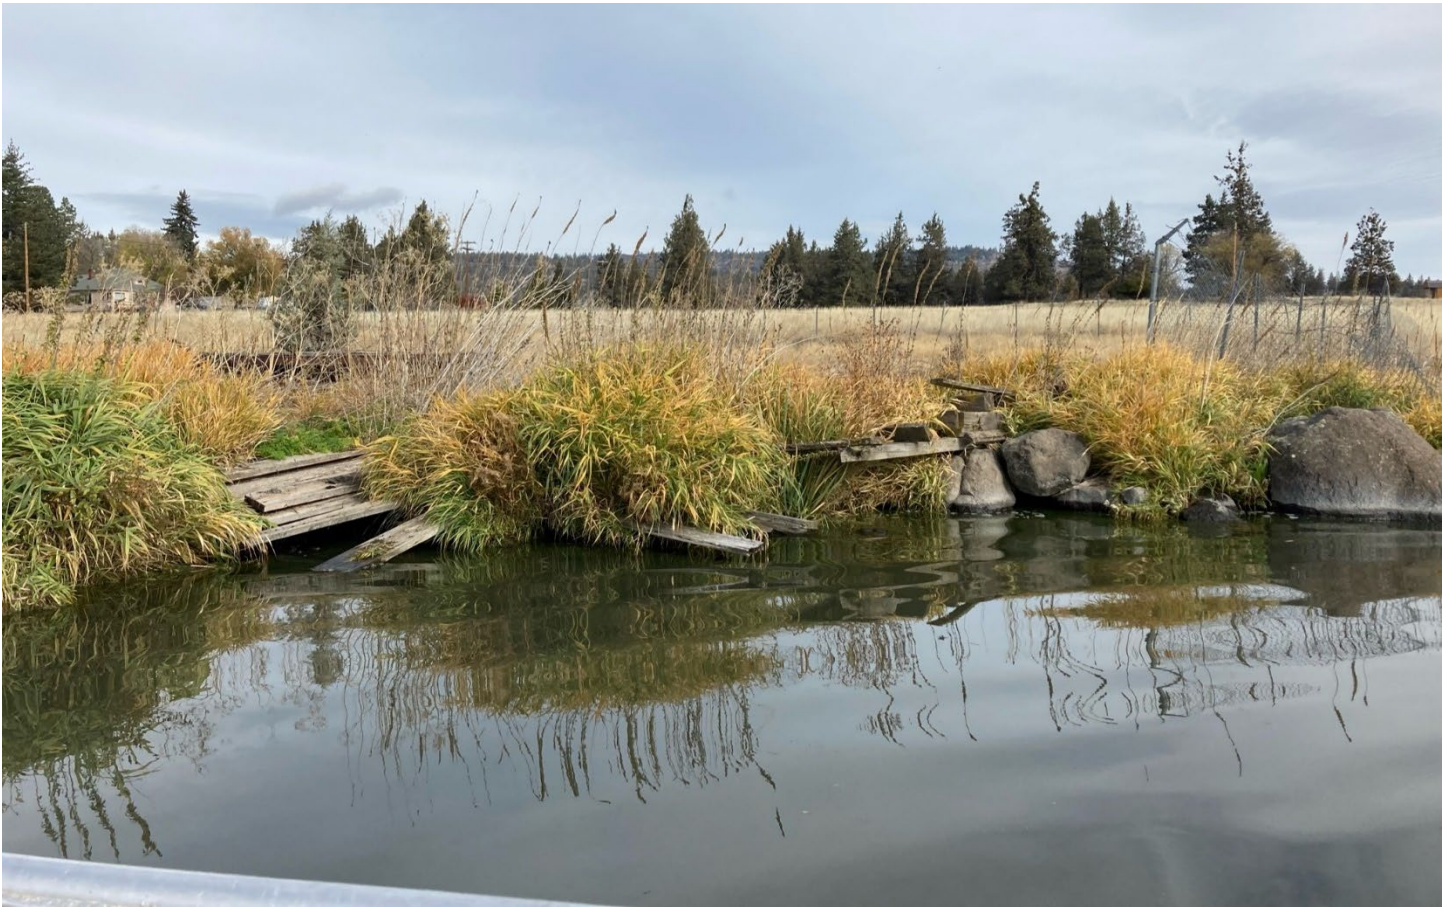
*(Identified in desktop analysis but could not find during survey)*

*Figure 62. No diversion at KENO-50. October 2021.*

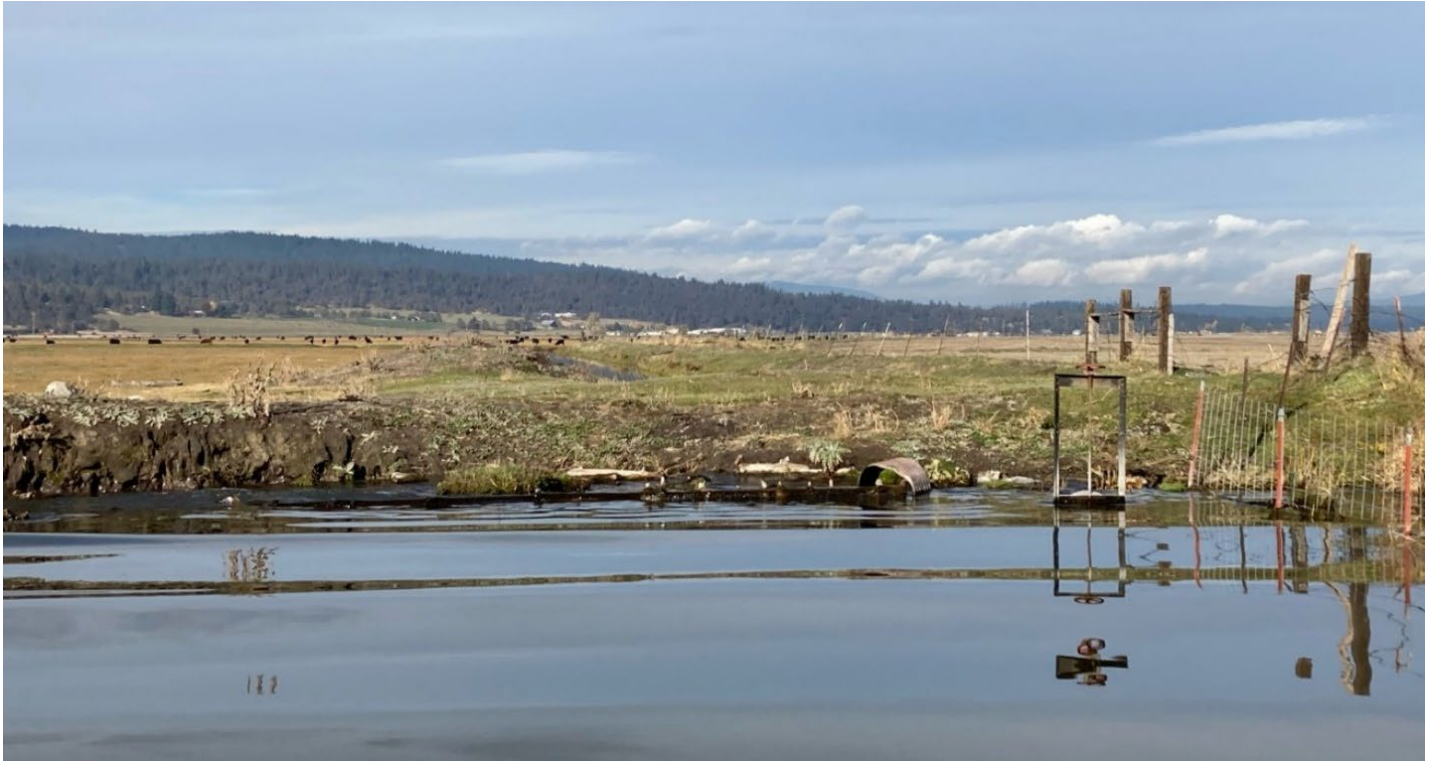
**Project# KENO-51**

Figure 63. Diversion at KENO-51. October 2021.

**Screen:** No

**Size score:** 3      **Benefit score:** 4      **Total score:** 3.5      **Priority Tier:** High

**Notes:** 24" headgate

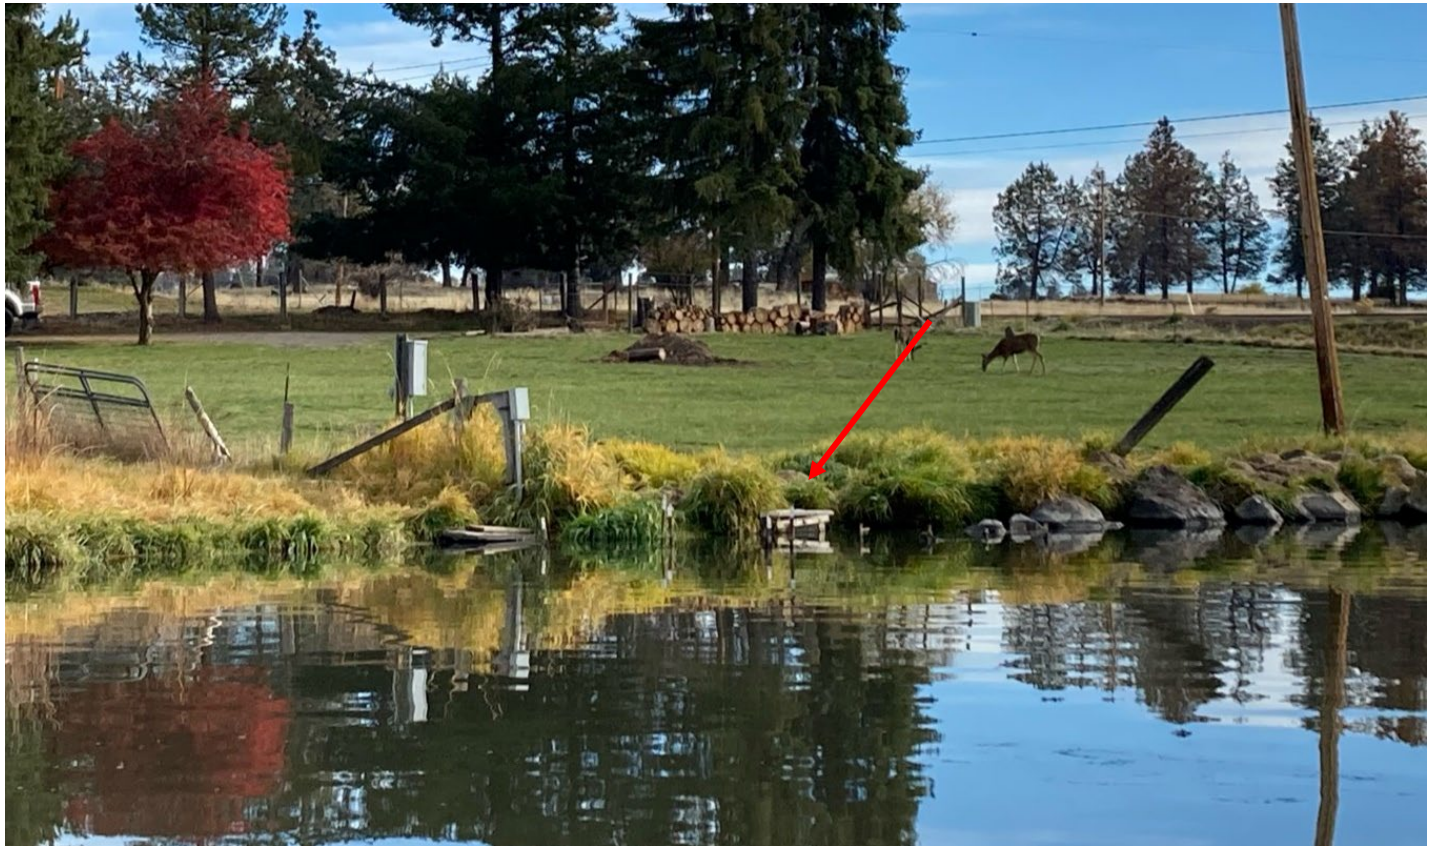
**Project# KENO-52**

Figure 64. Diversion at KENO-52. October 2021.

**Screen:** No

**Size score:** 1      **Benefit score:** 4      **Total score:** 2.5      **Priority Tier:** Low

**Notes:** Small domestic pump

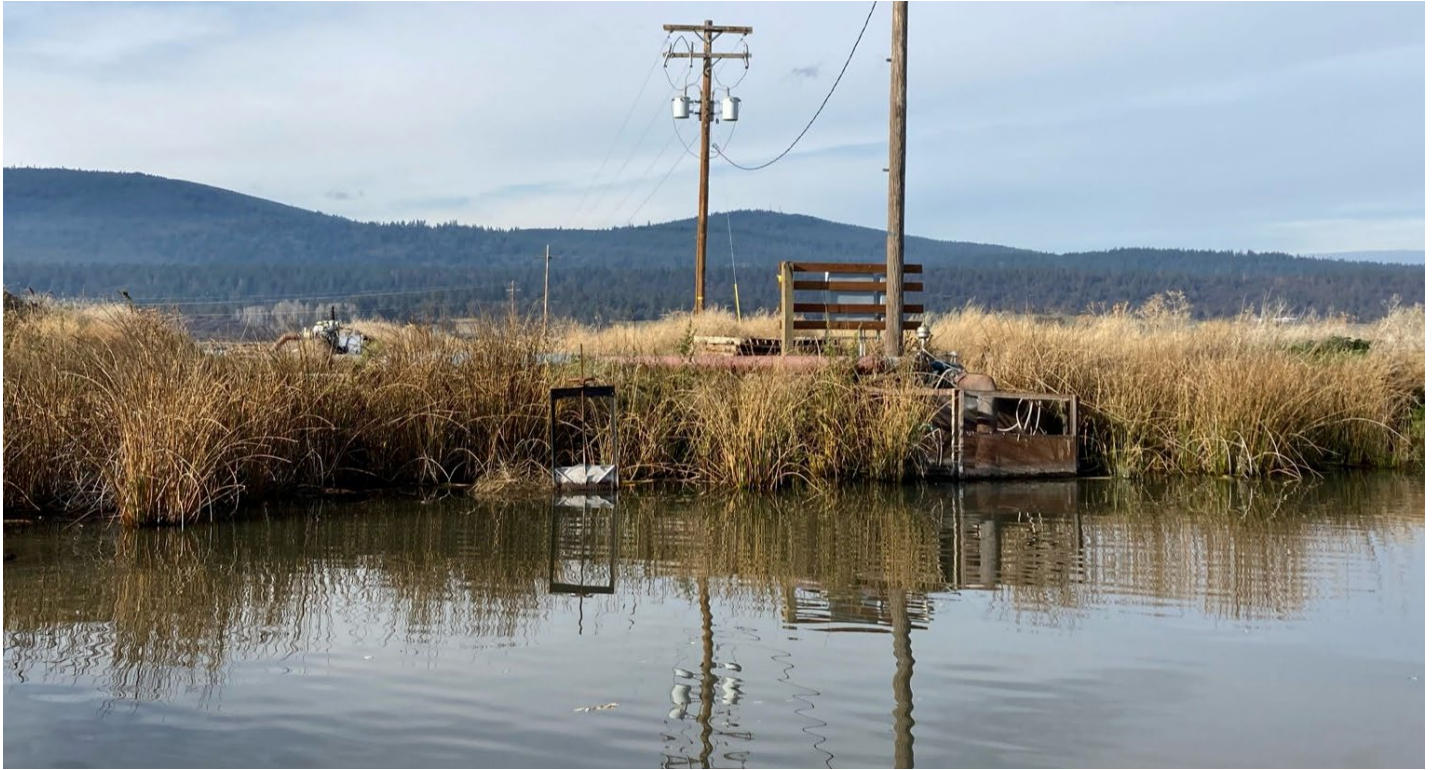
**Project# KENO-53**

Figure 65. Diversion at KENO-53. October 2021.

**Screen:** No

**Size score:** 3      **Benefit score:** 4      **Total score:** 3.5      **Priority Tier:** High

**Notes:** 24" headgate and pump

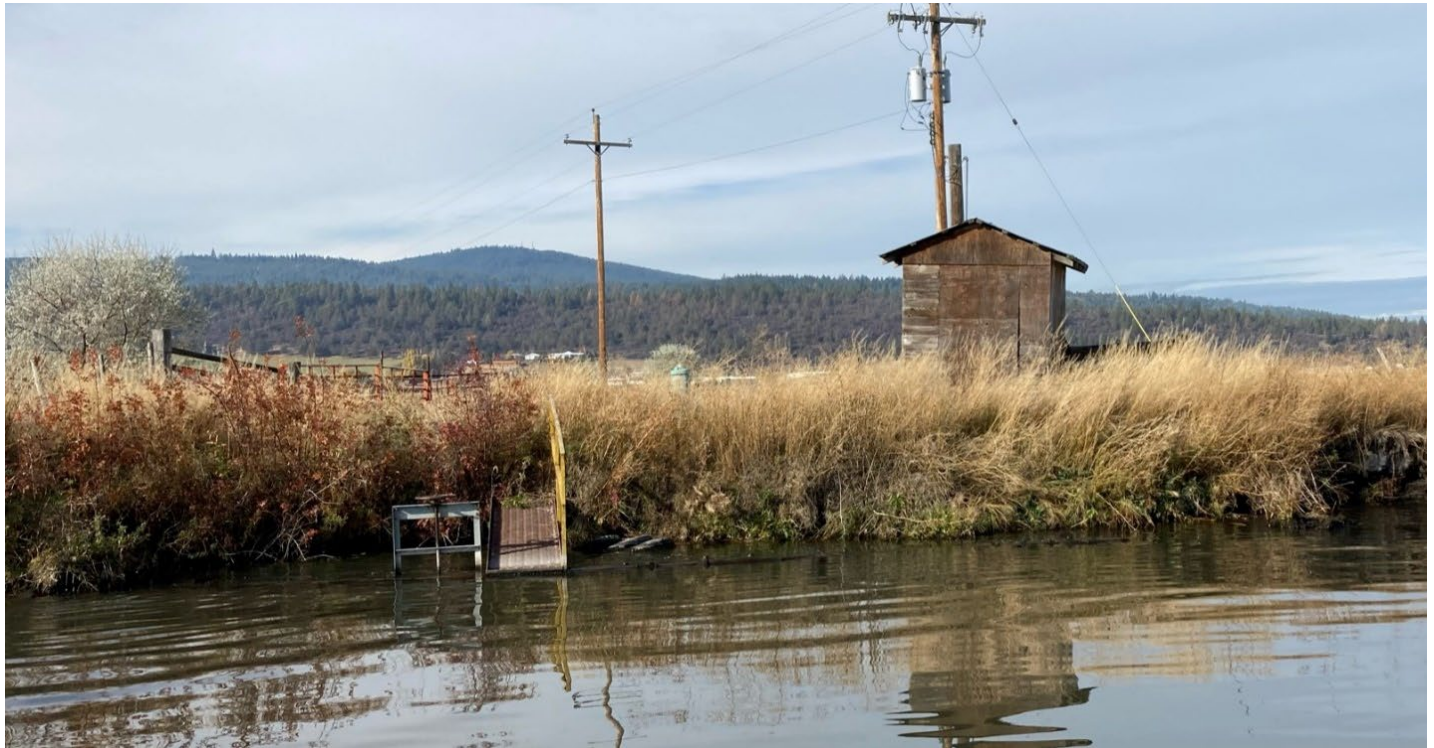
**Project# KENO-55**

Figure 66. Diversion at KENO-55. October 2021.

**Screen:** No
