## **Appendix C: Fish Screening Project Descriptions**

### **Screening Project List**

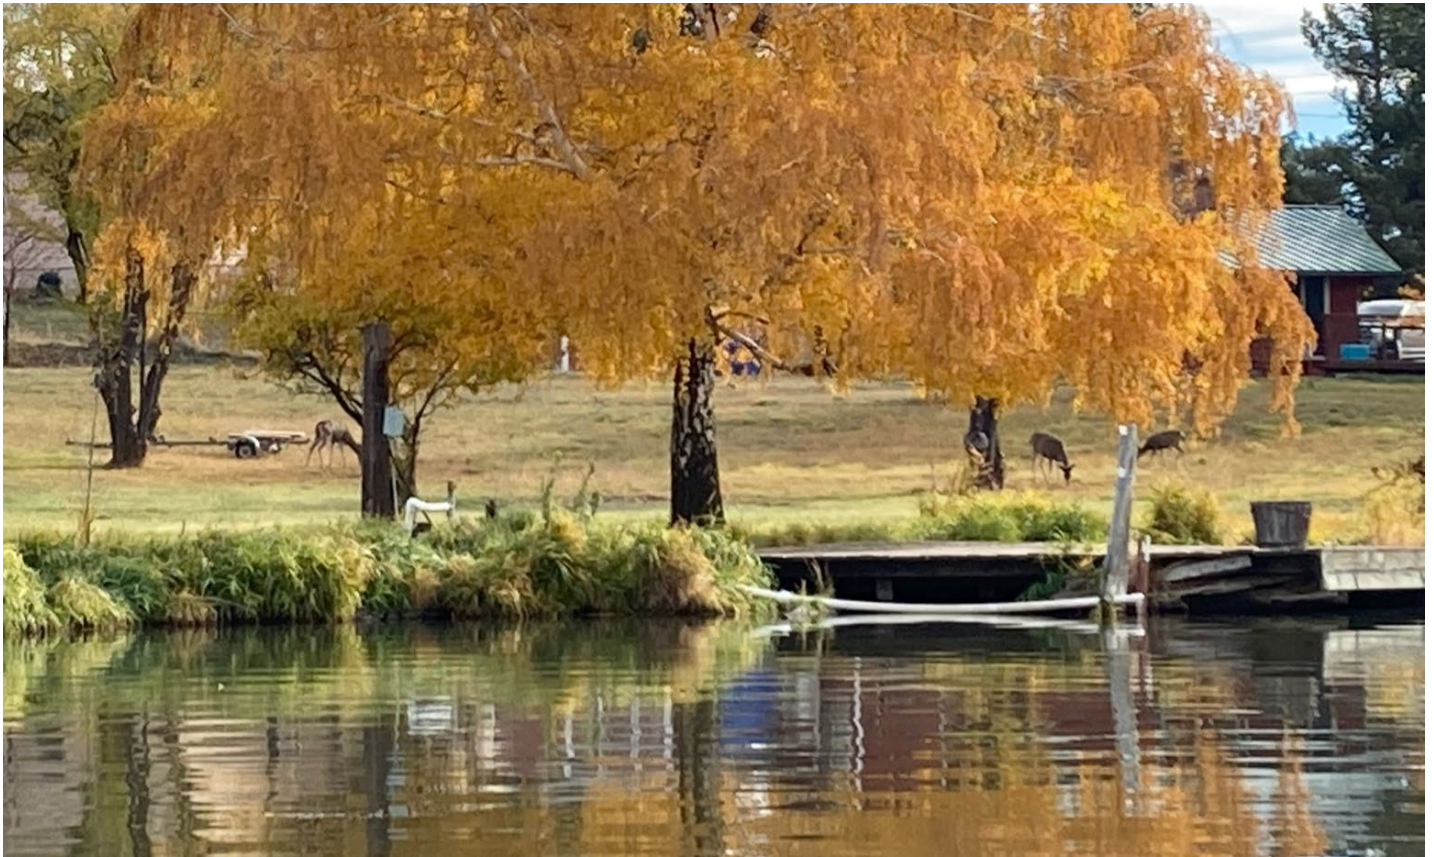
**Project# KENO-56**

Figure 67. Diversion at KENO-56. October 2021.

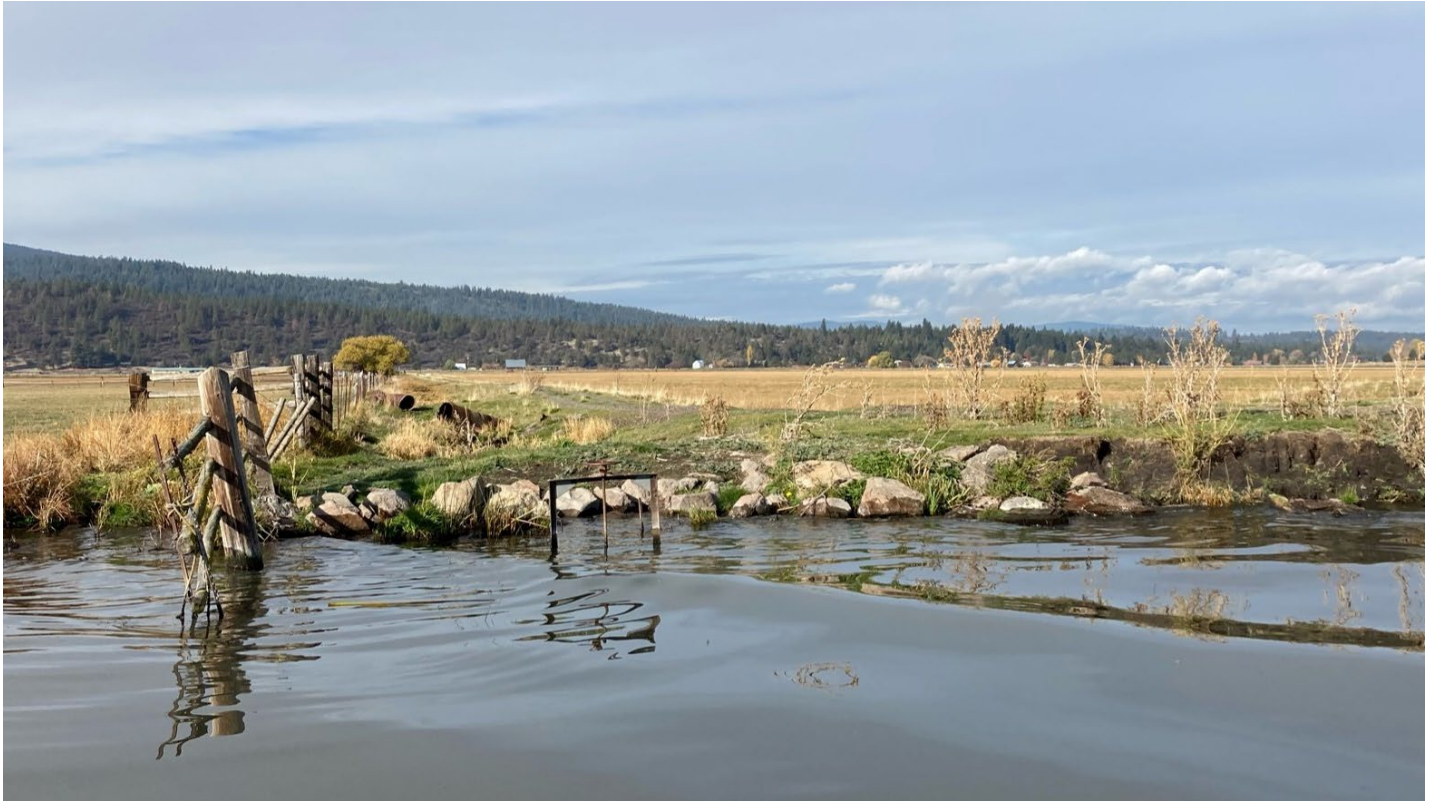
**Project# KENO-57**

Figure 68. Diversion at KENO-57. October 2021.

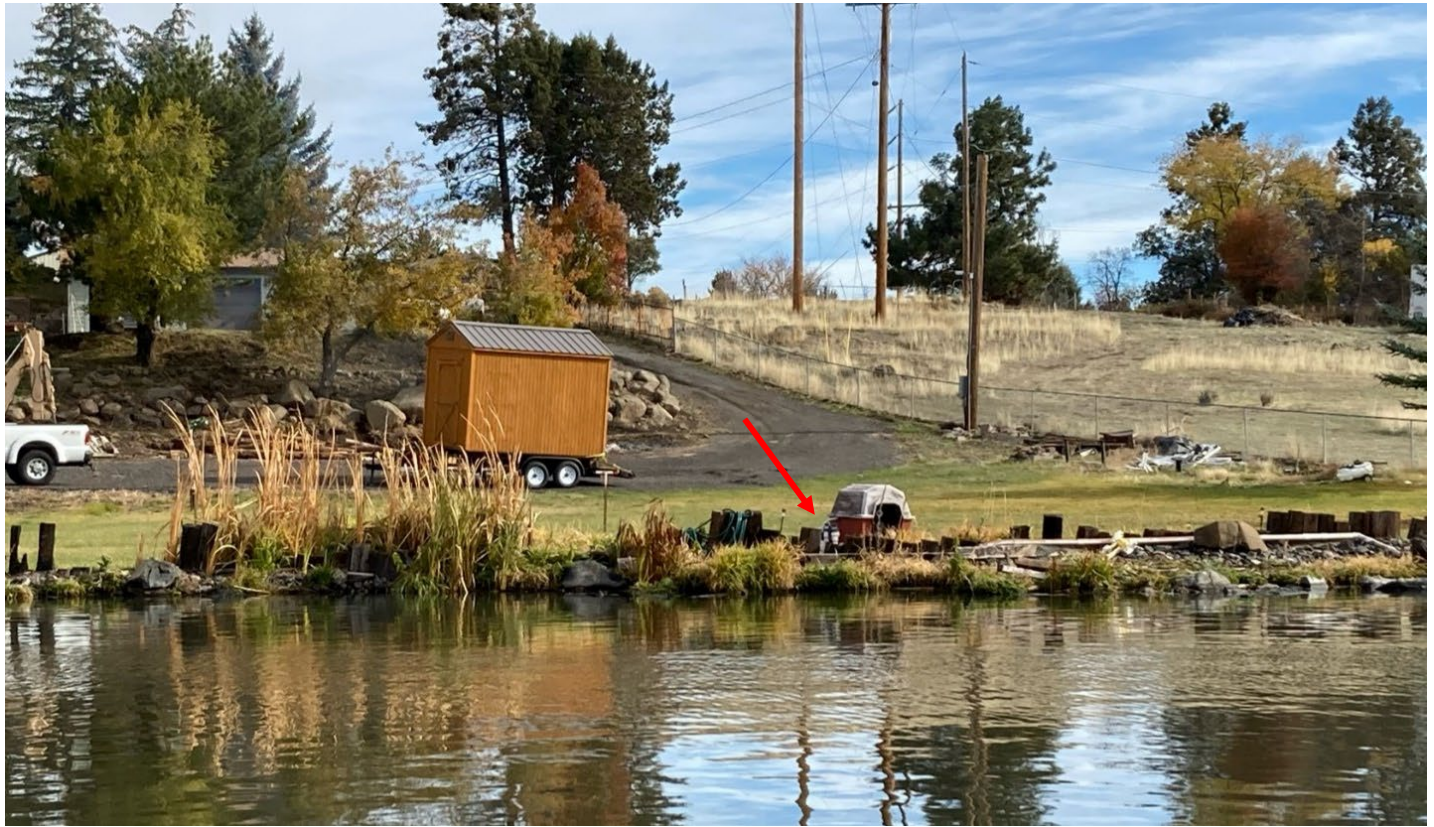
**Project# KENO-58**

Figure 69. Diversion at KENO-58. October 2021.

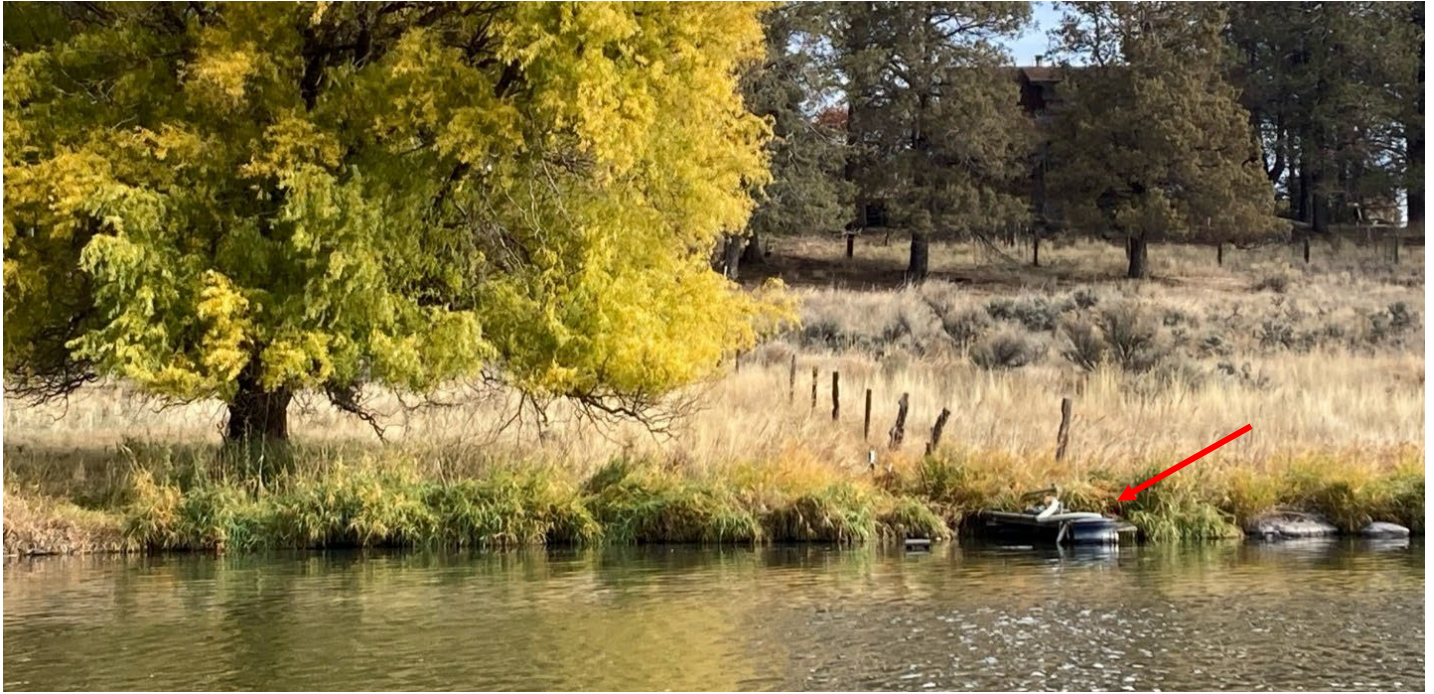
**Project# KENO-60**

Figure 70. Diversion at KENO-60. October 2021.

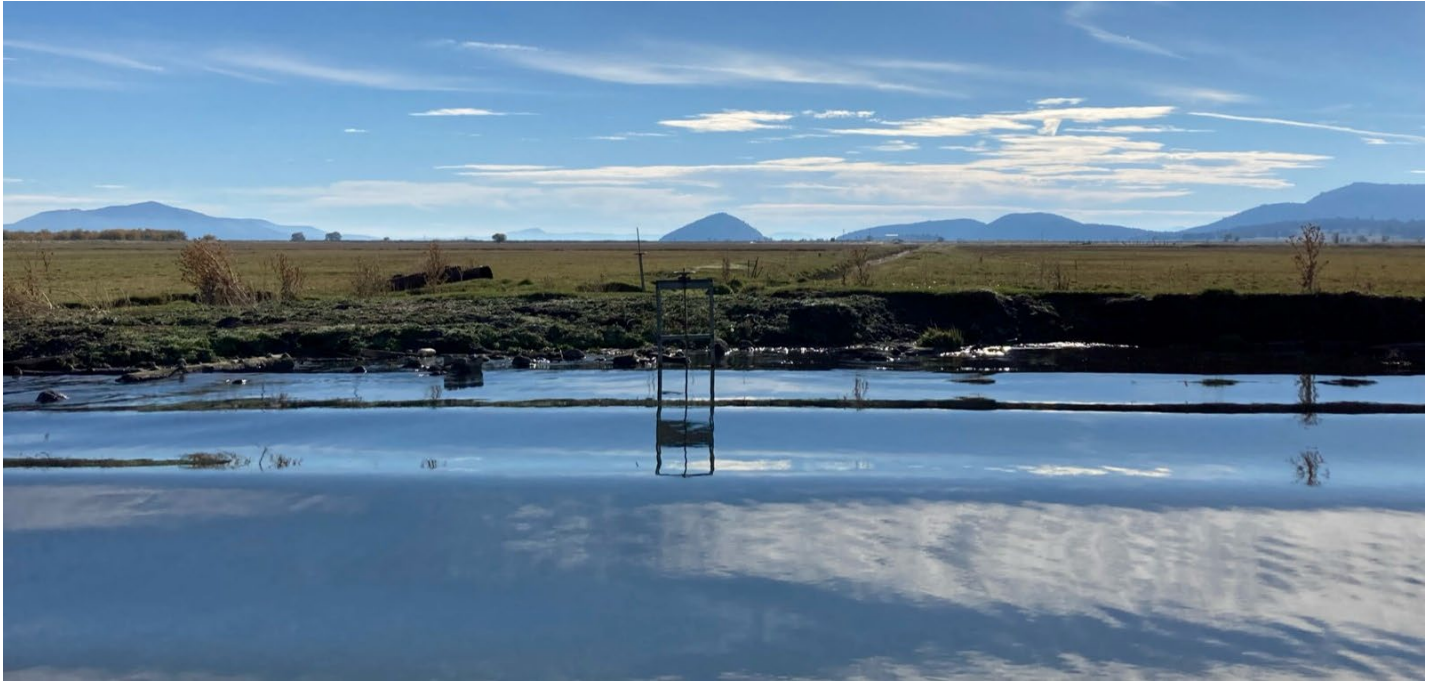
**Project# KENO-61**

Figure 71. Diversion at KENO-61. October 2021.

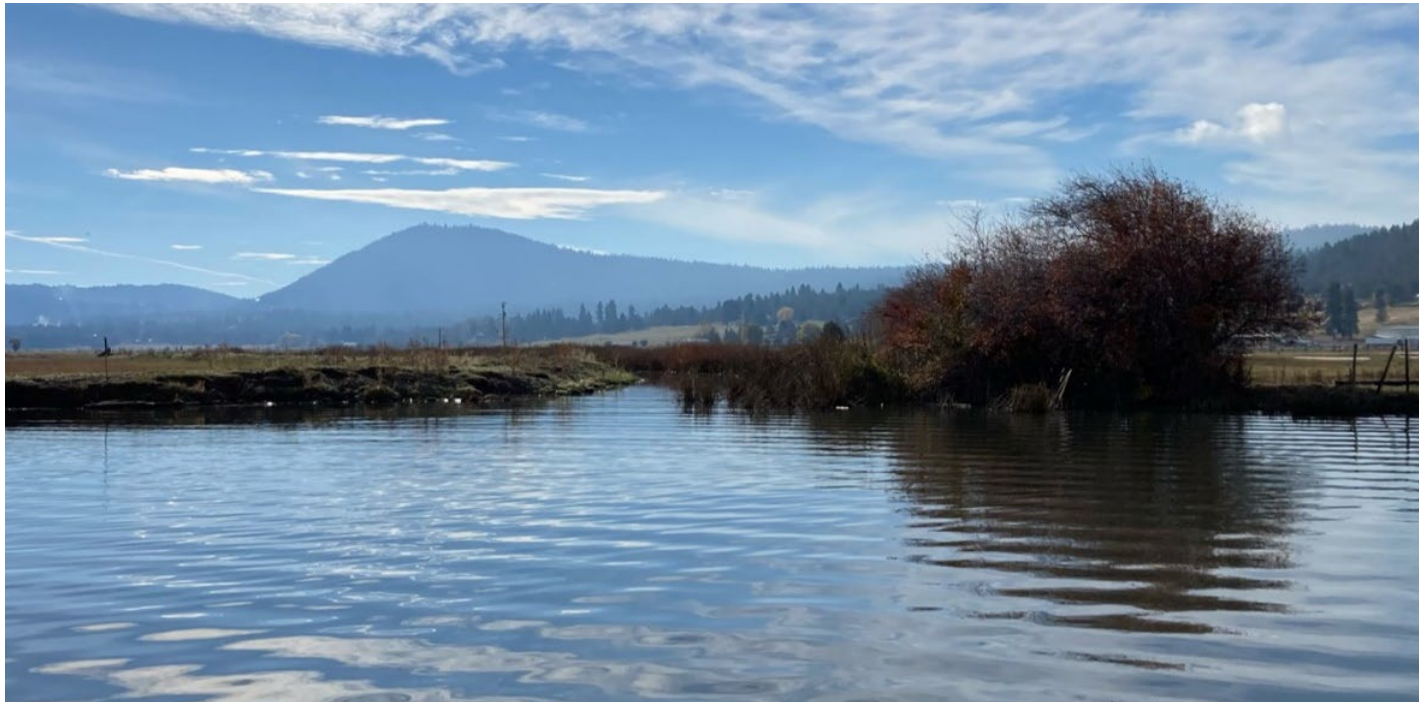
**Project# KENO-63**

Figure 72. Diversion at KENO-63. October 2021.

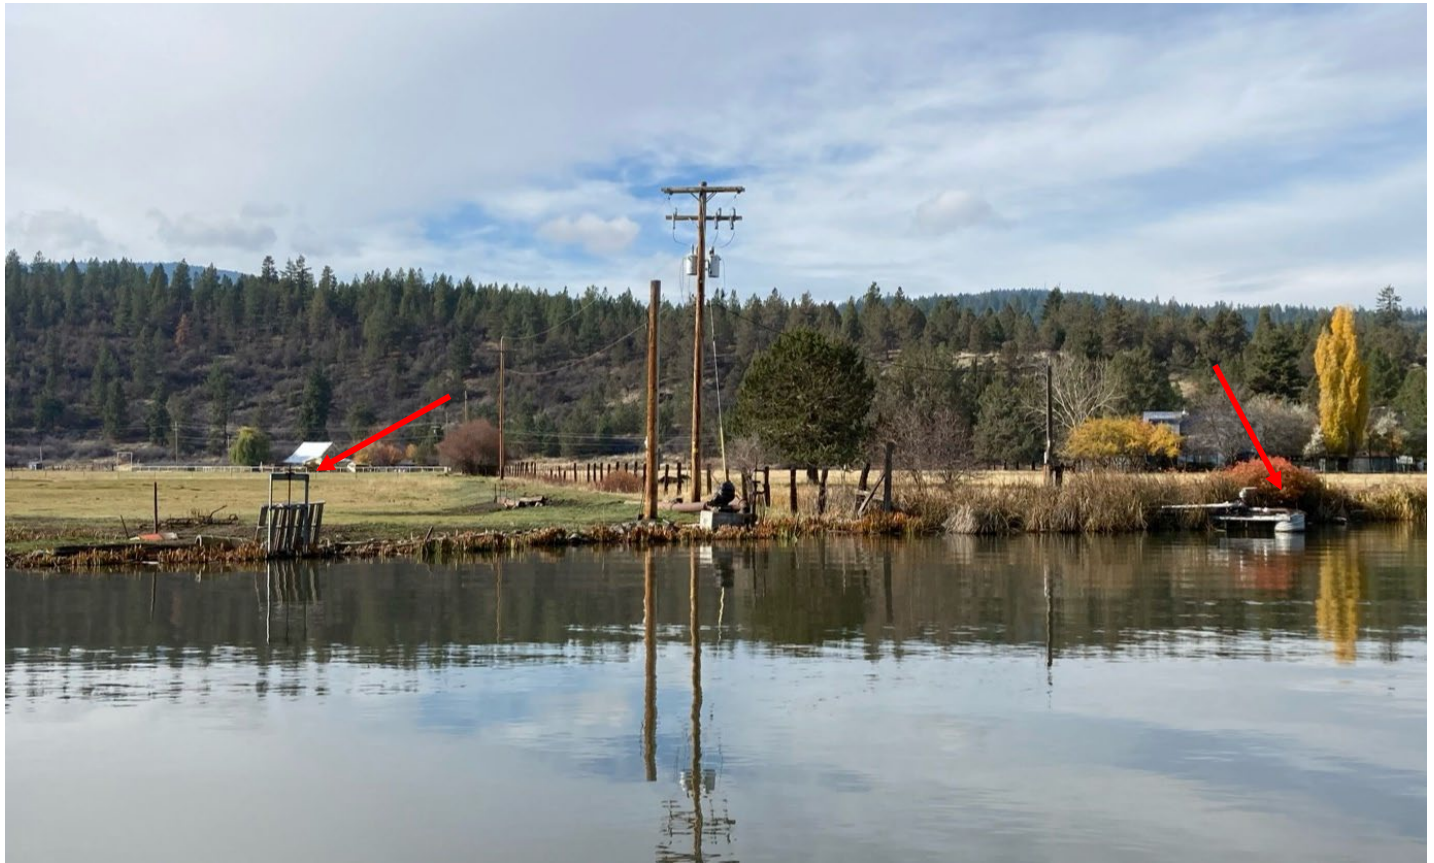
**Project# KENO-65**

Figure 73. Diversions at KENO-65. October 2021.

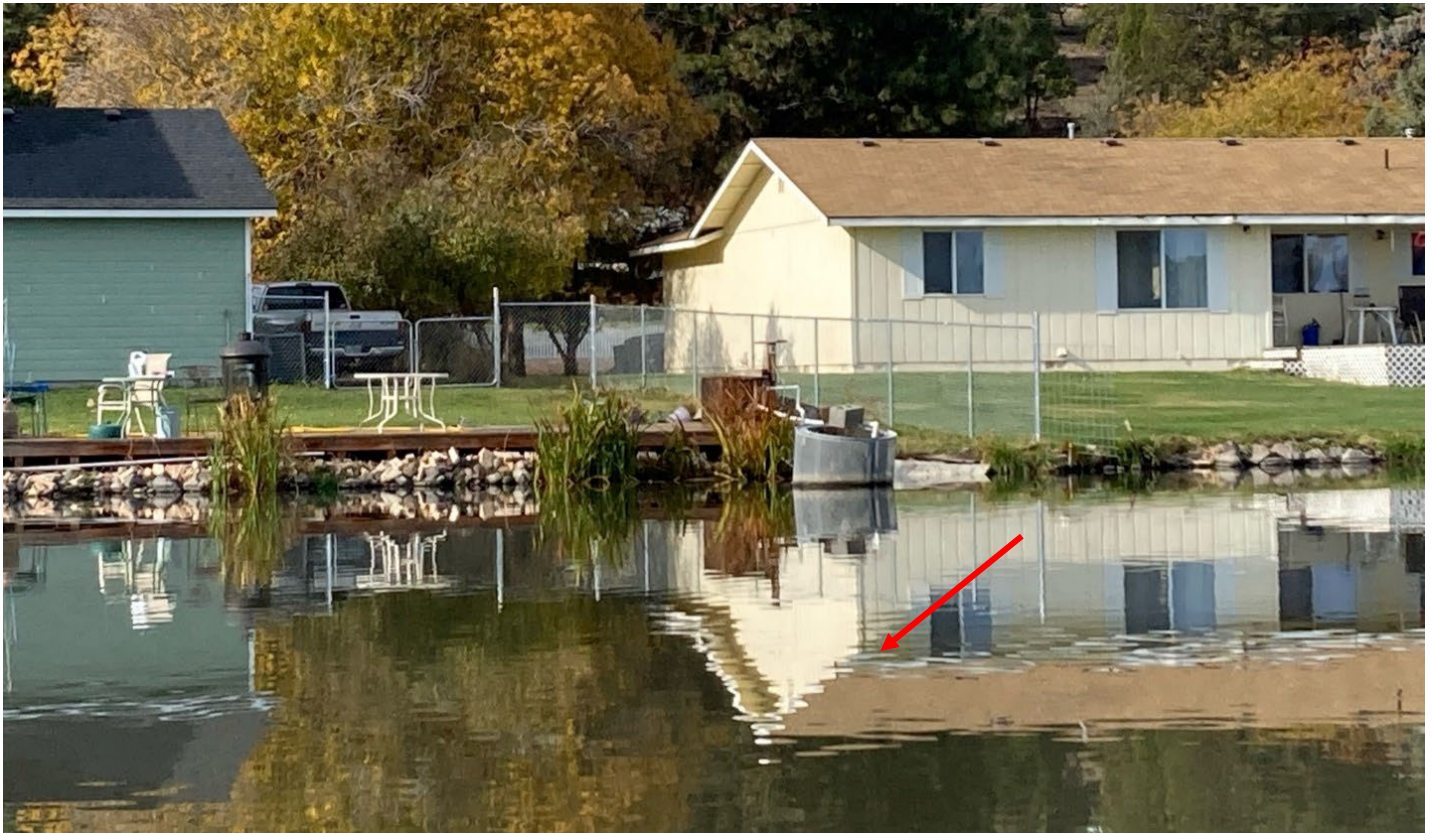
**Project# KENO-67**

Figure 74. Diversion at KENO-67. October 2021.

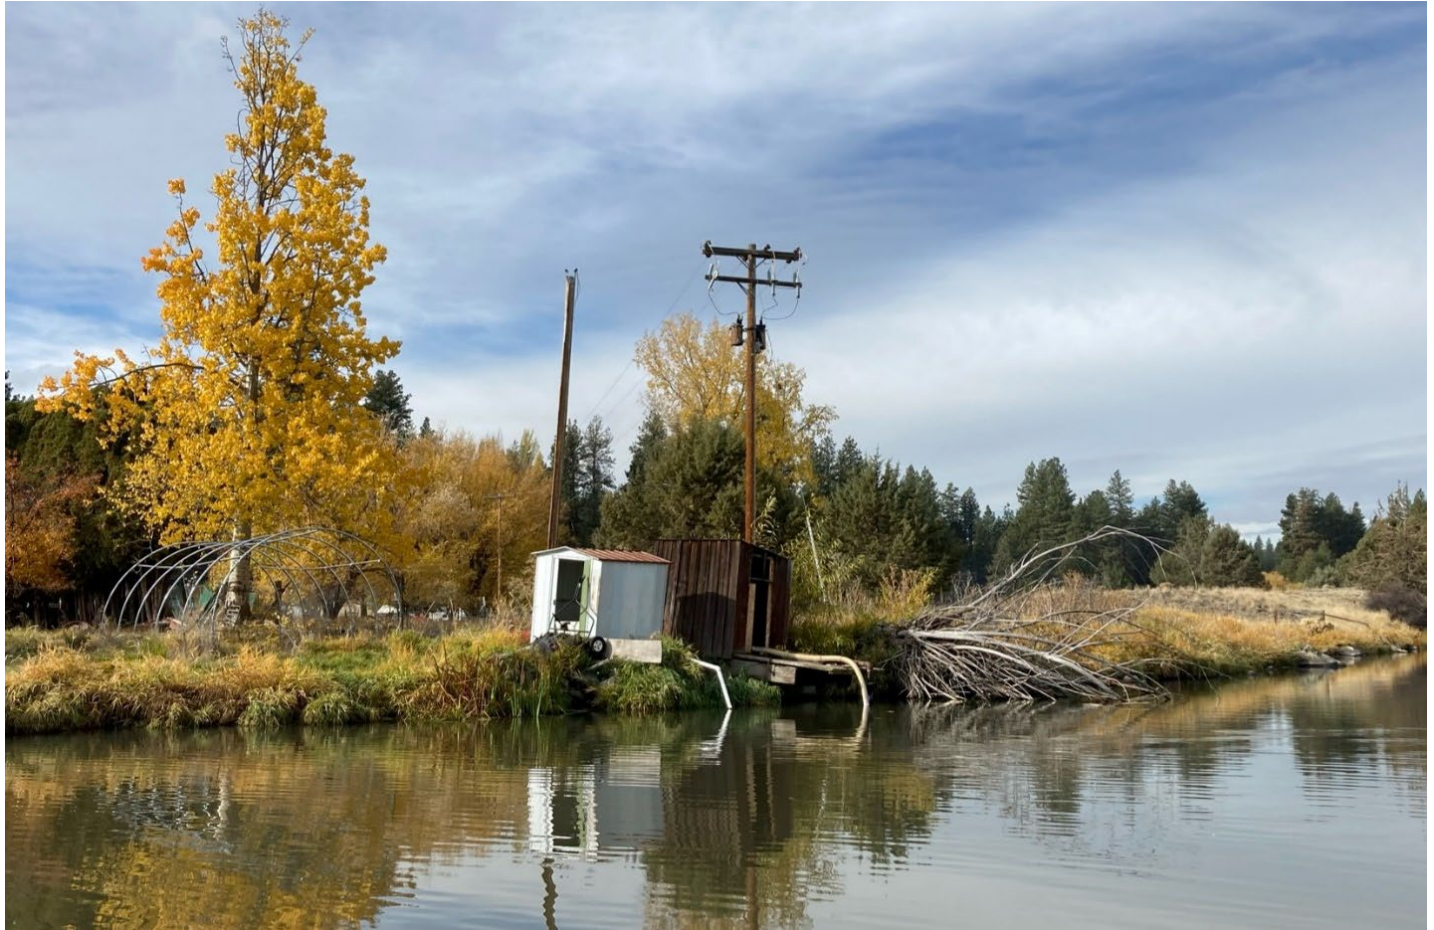
**Project# KENO-69**

Figure 75. Diversion at KENO-69. October 2021.
