RoadSense AI

Road Inspection Report

Road Name	Wit collage	Timestamp	2026-02-26 13:17:42
GPS	17.668755, 75.923294	Source	Citizen
Severity	10.0/10	Level	Emergency
Action	Immediately — Today	Economic Risk	■ 22,500,000

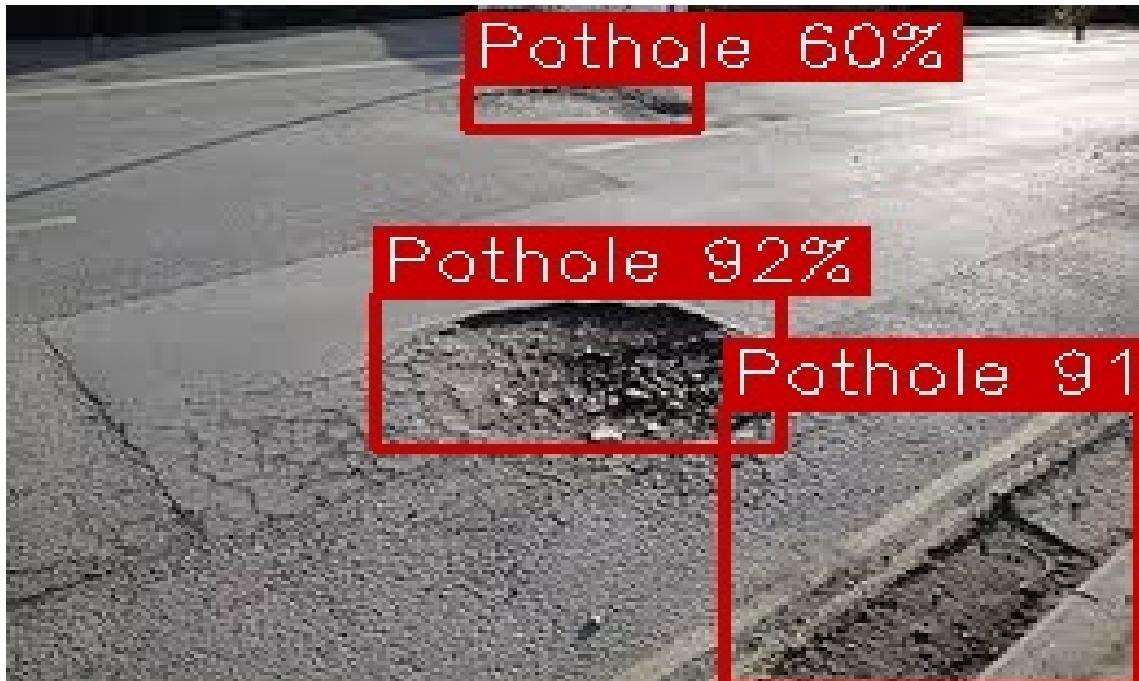
Annotated Detection Image

#	Type	Confidence	Score	Size
1	Pothole	92%	10.0	93x44px
2	Pothole	91%	10.0	95x79px
3	Pothole	60%	6.3	53x13px
