RoadSense AI

Road Inspection Report

Road Name	MG Road	Timestamp	2026-02-26 00:17:27
GPS	17.6868, 75.9079	Source	Video
Severity	9.86/10	Level	Emergency
Action	Immediately — Today	Economic Risk	■ 22,185,000

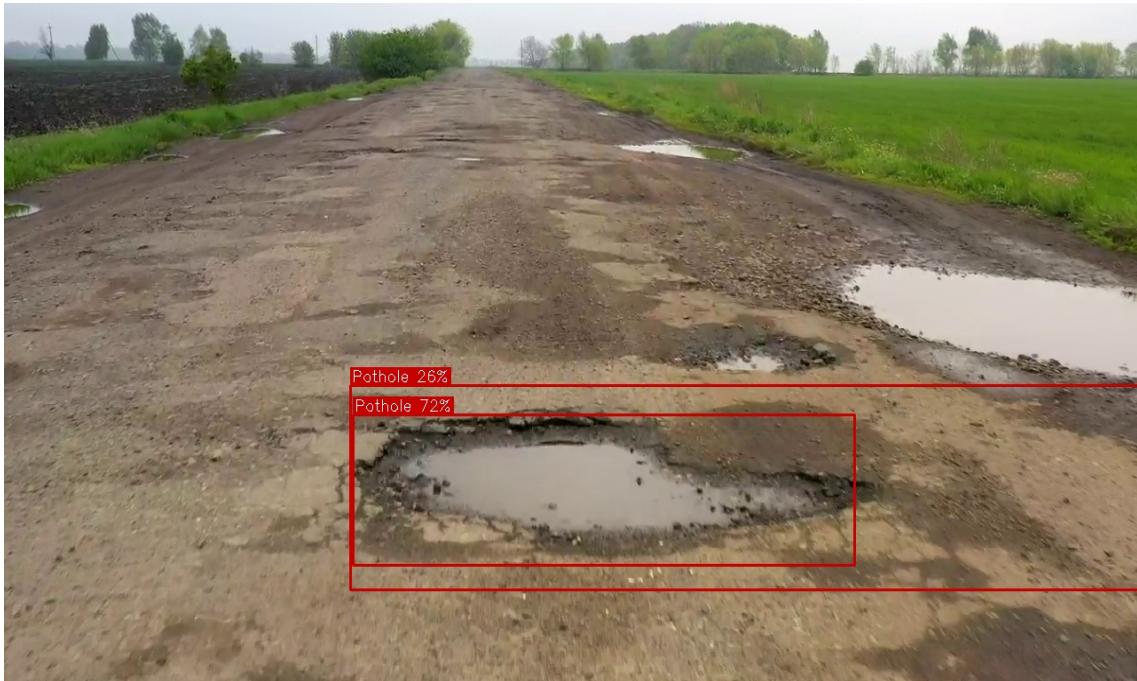
Annotated Detection Image

#	Type	Confidence	Score	Size
1	Pothole	72%	10.0	565x158px
2	Pothole	26%	7.92	888x215px
