# ECE 557 MEMS Report

The purpose of this project was to understand and manufacture a micro-electrical mechanical system or MEMS device on a silicon wafer. The MEMS for this project is undergoing the switch fabrication procedure. The devices are single and double anchor cantilever devices made of Gold and Titanium in the micrometer size. The procedure in this project is similar to Module 1, 2 and 3 where photolithography, etching and electrical characterization were done to analyze the final structure and properties of the MEMS devices.

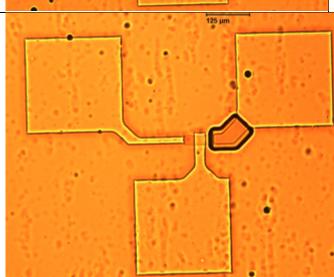
- This device has a deformed contact pad at the bottom, caused probably from the development and exposure of the pattern. The UV light probably did not exposure through the photoresist clear enough that the pattern is slightly uneven.

- Black dots are signs of residue photoresist as likely during rinsing in the mixture; it remained stuck on the wafer
- The etching and development were done twice due to no changes to wafer in etchant solution.
