Automating Unsolicited Richard Pics; Pwning 60,000 Digital Picture Frames

November 26, 2022

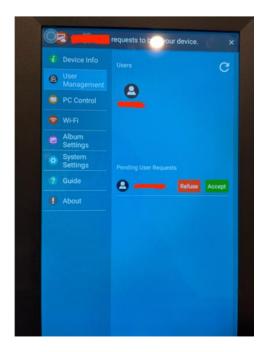
So, binding my user account through the Ourphoto mobile application to someone else's picture frame is no problem. No let's look at accepting that bind request on the picture frame without having physical access to it. When the request comes it to the picture frame it looks like the screenshot below.

Once the user clicks on the "Accept" button, the picture frame issues a web request to the /device/AcceptBind endpoint. This end-point also does not require authentication, and only requires the user_id and device_id for information. We have both pieces of information needed to accept our own bind request.
