PoC: Rittal CMC PU III – Stored XSS

Application: Rittal CMC PU III Web management

Devices: CMC PU III 7030.000

Attack type: Stored XSS

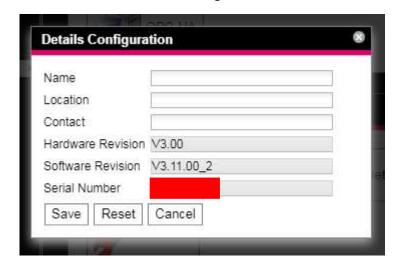
PROCESSING UNIT > Configuration Tab > Details

The vulnerability is located in the authenticated area of the web application. In order to trigger the vulnerability, the attacker should navigate to:

The fields "Name", "Location" and "Contact" are vulnerable to XSS attacks. These fields seem to be sanitized for some XSS strings, however we found effective payloads through SVG tags, i.e:

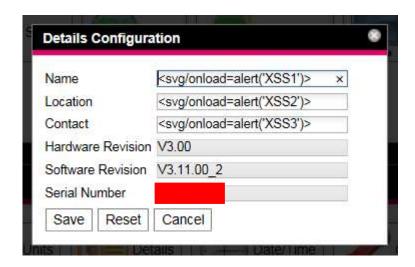
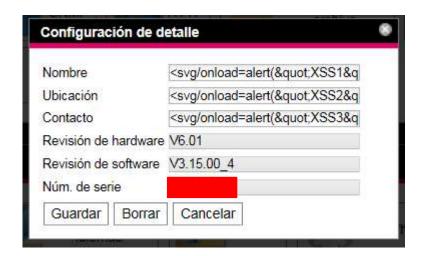
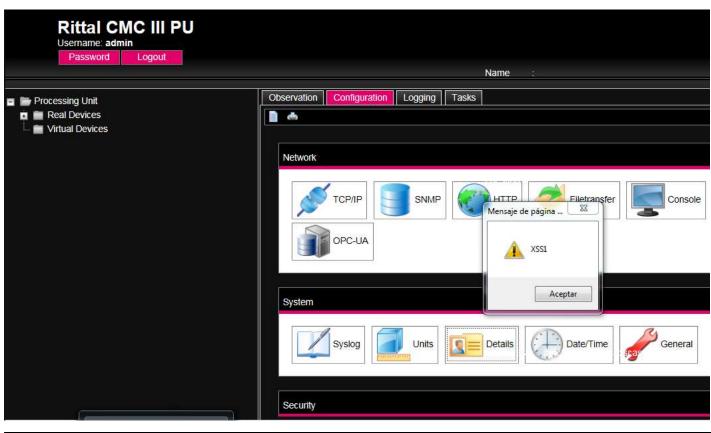
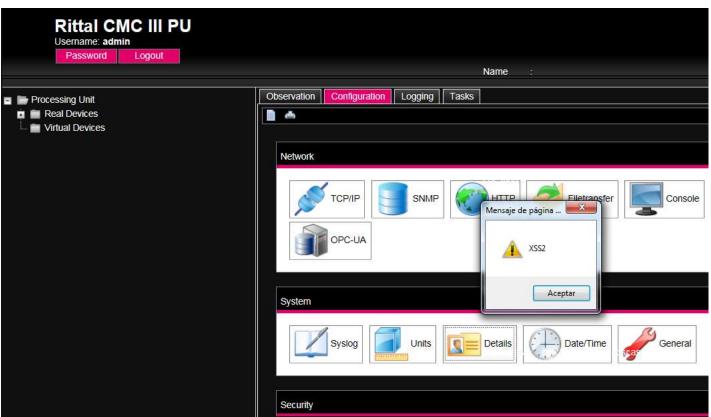
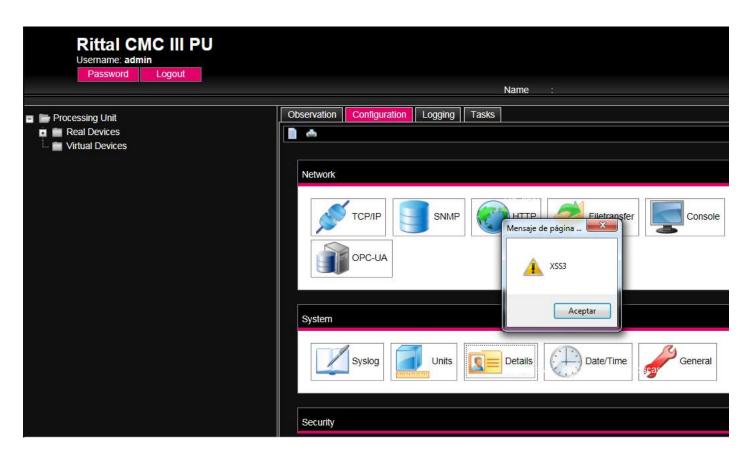
Below we show the result of the XSS attack:

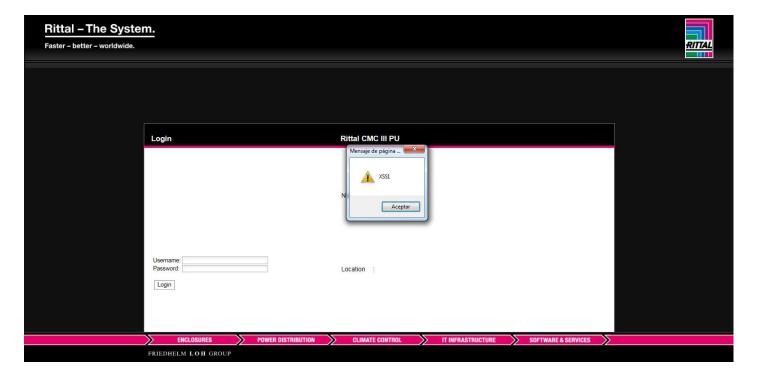
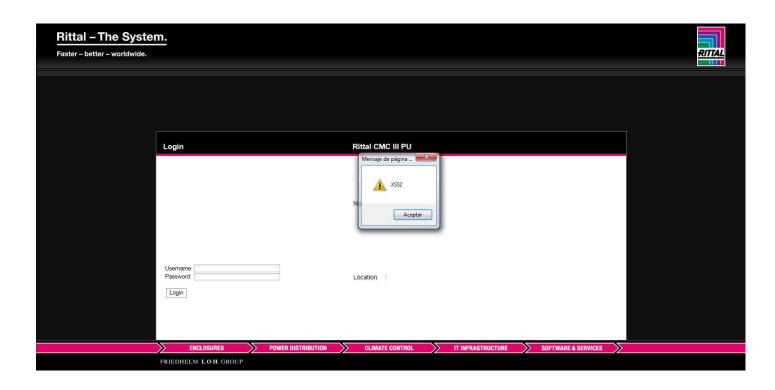
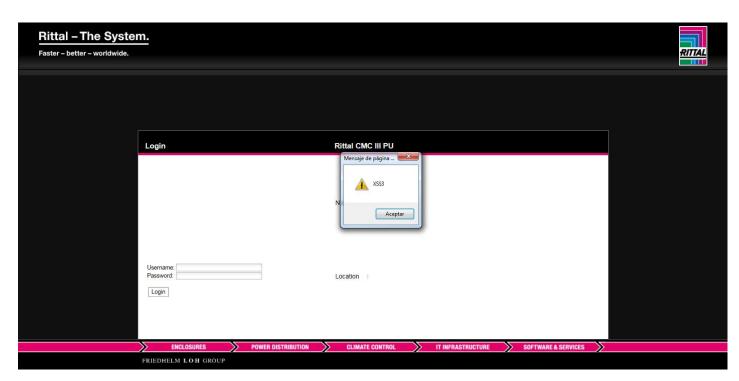
Since the XSS payloads are stored in variables shown in the login form, this XSS could be used to attack non-authenticated clients:

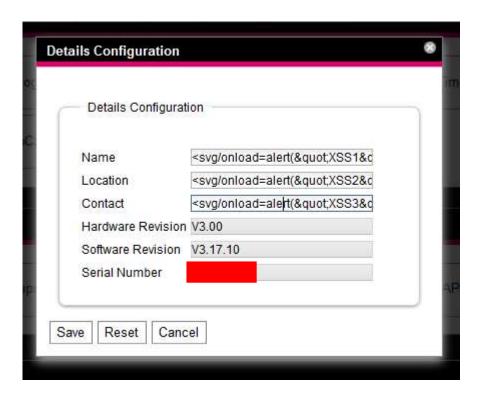
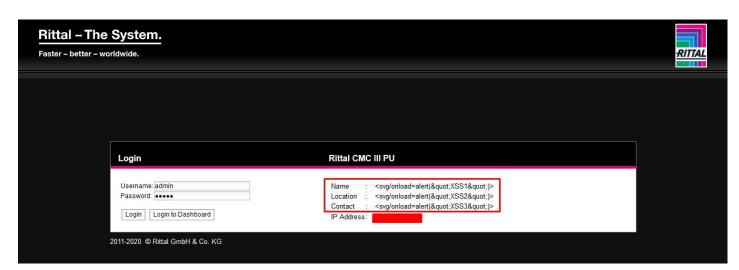
From *Software Revision* **V3.17.10 the vulnerability is properly patched,** as result the JS code is presented in the browser as a merely string and consequently is not interpreted.

Solution: Update to Software Revision **V3.17.10 or later**
