DI23H-04

B26 11

Telescopic Position Sensor or Telescopic Motor Circuit Malfunction

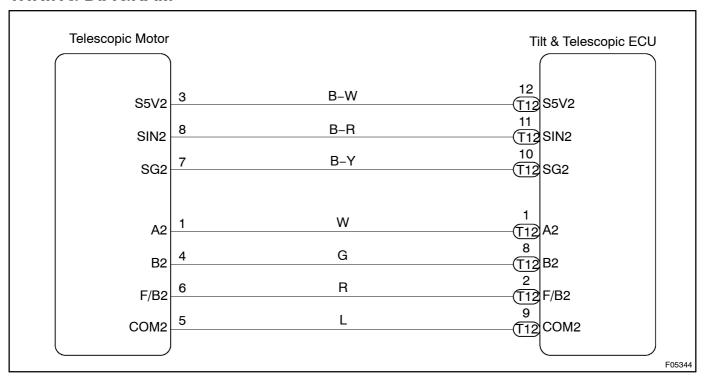
WIRING DIAGRAM

Telescopic motor is operated by the power voltage supplied from tilt and telescopic ECU and makes the steering column slide forward and rearward. Telescopic position sensor (Hole IC) in the telescopic motor detects the sliding position of the forward and rearward direction of the steering column and outputs the signal to the CPU in response to that sliding amount. HINT:
