CEBU INSTITUTE OF TECHNOLOGY - UNIVERSITY
ELECTRICAL ENGINEERING DEPARTMENT

ENHANCING ENERGY EFFICIENCY THROUGH MODIFICATION OF ELECTRICAL PLANS: Addressing Power Instability and Improving Power Consumption in SAL, LRAC, Clinic, and T-Room Buildings at Cebu Institute of Technology - University

RESEARCHERS:
DAMUAG • OBISO • PACRES • VILLASENCIO • VIRTUDAZO

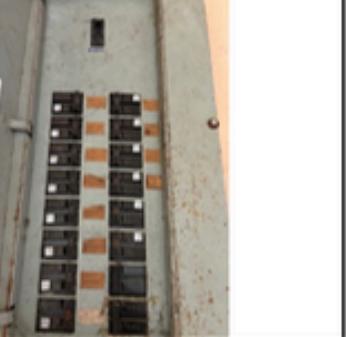
4.8.1.4	• Label all breakers clearly
• Rust and corrosion

1.10.1.11 and 1.10.1.13	• Replace or repaint the panel to prevent further corrosion

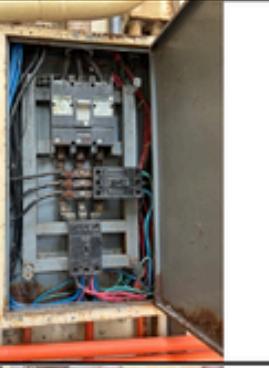
• Rusted panel components • Exposed live components • Disorganized and unsecured wiring • Lack of Circuit Identification

1.10.1.3, 1.10.1.11, 2.30.2.1, and 4.8.1.4	• Label all breakers clearly • Cover all exposed conductors with insulated barriers
• Lack of Circuit Identification • Disorganized and unsecured wiring • Corroded panelboard

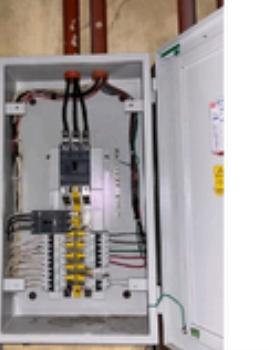
1.10.1.3, 1.10.1.11, and 4.8.1.4	• Label all breakers clearly • Clean corroded panel • Install a proper enclosure to protect the panel from environmental damage
• Lack of Circuit Identification

4.8.1.4	• Label all breakers clearly

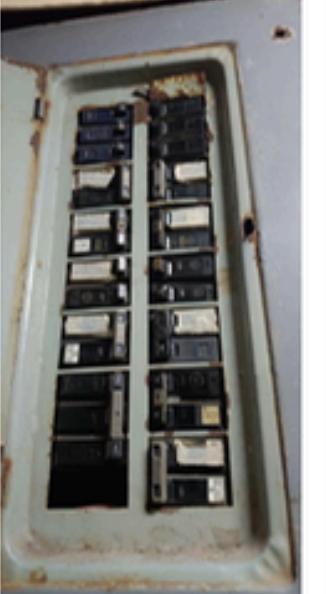
<ul style="list-style-type: none"> Improperly Installed or Mismatched Breakers Corrosion and Deterioration Lack of Circuit Identification 	T-room panelboard

1.10.1.3, 1.10.1.13, and 4.8.1.4	<ul style="list-style-type: none"> Replace improperly fitted breakers Install blank covers Tighten all connections Label all breakers clearly
<ul style="list-style-type: none"> Exposed Wiring Mechanical Execution of Work 	T-room panelboard

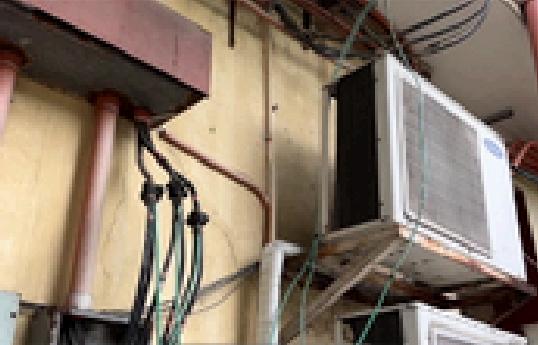
Observation of non-compliance, PEC code violations, hazardous conditions, and inefficient equipment in LRAC			
Assessed Violation	Pictures	PEC Article	Corrective Measures
<ul style="list-style-type: none">• Exposed and Poorly Secured Wires• Improper Cable Routing• Mechanical Execution of Work

1.10.1.3, 1.10.1.13, and 3.0.1.3	<ul style="list-style-type: none">• Use proper fasteners and supports to prevent wires from sagging• Place them in conduits to avoid potential harm
<ul style="list-style-type: none">• Lack of Circuit Identification• Overcrowded and Poorly Organized Wiring

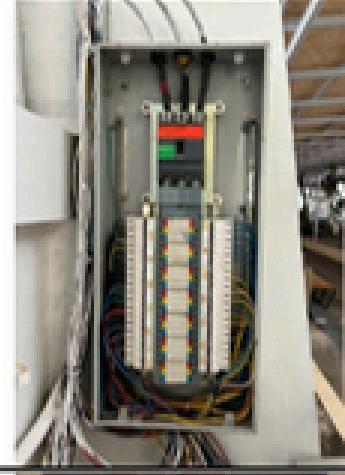
<ul style="list-style-type: none">• Lack of Circuit Identification• Overcrowded and Poorly Organized Wiring

1.10.1.3, 1.10.1.13, 3.0.1.3, and 4.8.1.4	<ul style="list-style-type: none">• Organize and bundle wires properly outside and inside the panel• Label all breakers clearly
<ul style="list-style-type: none">• Corroded panelboard• Exposed Wiring• Lack of Circuit Identification

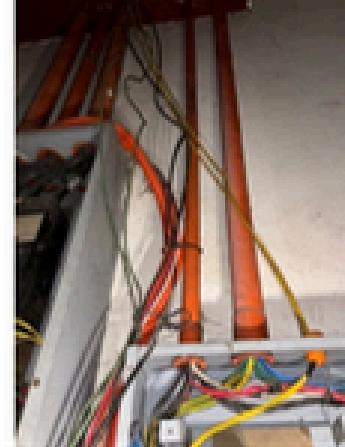
1.10.1.3, 1.10.1.11, 1.10.1.13, and 4.8.1.4	<ul style="list-style-type: none">• Ensure all panel doors remain secured• Properly install conduits to enclose and protect wiring• Label all breakers clearly
<ul style="list-style-type: none">• Lack of Proper Conduit Support• Exposed and Unprotected Wiring• Improper Bending Radius of Cables• Improper Mechanical Execution of Work

1.10.1.3, 1.10.1.13, 3.0.2.4, and 4.8.1.4	<ul style="list-style-type: none">• Secure conduits properly with appropriate fasteners at required intervals• Ensure all cables are enclosed• Maintain the required bending radius for cables

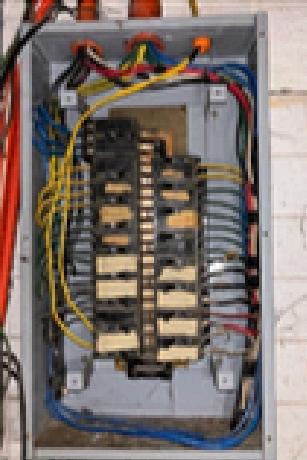
<ul style="list-style-type: none">• Overcrowding of Conductors• Missing Panel Cover• Improper Mechanical Execution of Work

1.10.1.3, 1.10.1.13, and 4.8.1.4	<ul style="list-style-type: none">• Arrange wiring properly to allow air circulation and avoid overheating• Install a properly secured panelboard cover
<ul style="list-style-type: none">• Improper Cable Routing and Hanging Wires• Improper Bending Radius of Cables• Lack of Circuit Identification• Improper Mechanical Execution of Work

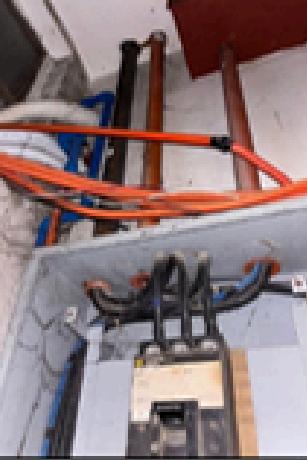
1.10.1.3, 1.10.1.13, 3.0.2.4, and 4.8.1.4	<ul style="list-style-type: none">• Secure all the panel covers to enclose• Organize and properly fasten cables to avoid entanglement and mechanical strain• Install a proper grounding system• Label all breakers clearly
<ul style="list-style-type: none">• Improper Bending Radius of Cables• Improper Mechanical Execution of Work

1.10.1.13 and 3.0.2.4	<ul style="list-style-type: none">• Organize and properly fasten cables
