# AWG / DDS Function Generator

Engineering Process Report

Current build: **v1.2** — working, characterised

Three PCB revisions; two arrived dead

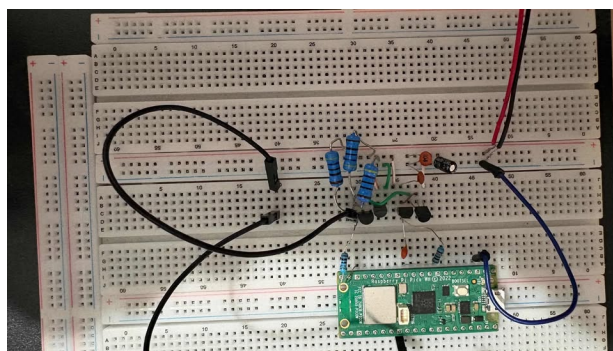
- **13 March.** First working square-wave buffer prototype, limited to below  $\sim 50$  kHz with rounded edges. Source: EngLog 13-03-26 2007.txt
- **25 March.** An unconventional totem-pole push-pull stage reaches a 1 MHz square wave — noisy, with a duty-cycle asymmetry the log calls “duty cycle variety”, and limited by a  $\sim 1$  k $\Omega$  input impedance, visible heating in the transistors and resistors, and the battery’s own current capacity. Source: EngLog 25-03-2026 1739.txt
- **27 March.** The duty-cycle and frequency-mismatch bugs are traced to the first PNP pair’s 9 V rail, and removing it fixes the 1 MHz case — but only at high frequency; the fix did not carry down to the low-frequency case. Source: EngLog 27-03-26 0031.txt

**Figure 5:** The discrete-transistor square-wave buffer on breadboard, from this detour — the circuit itself, not a captured output waveform.

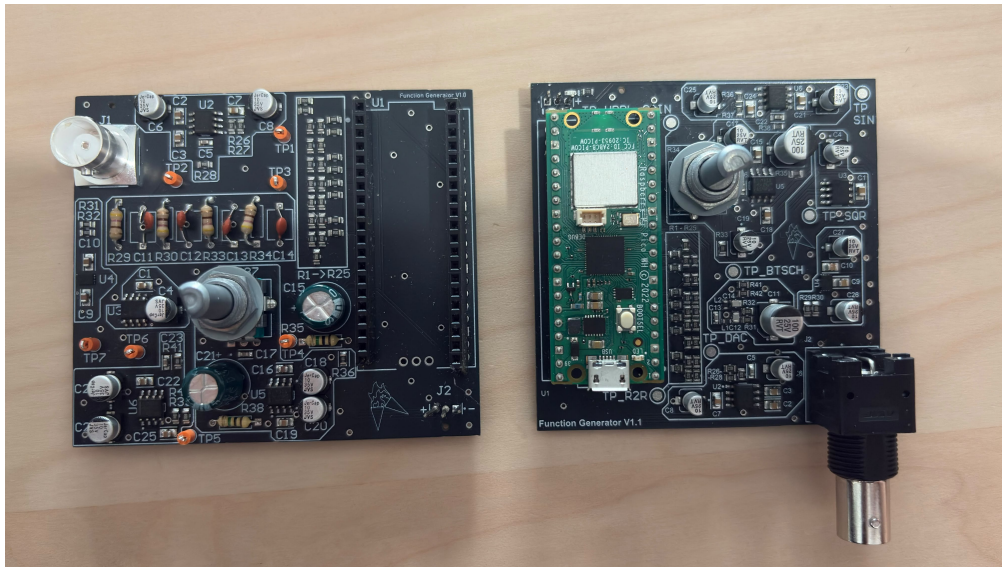
The board arrived, and the failure was immediate and total. The BOM matcher had substituted 2.21  $\Omega$  resistors for 2.21 k $\Omega$  across the entire R-2R ladder: three orders of magnitude off, on every rung. This is Lesson 1 in Section 6.

**Figure 6:** v1.0 (left) and v1.1 (right) side by side — the two boards that arrived dead. v1.0's  $2.21\ \Omega$  ladder and cascaded-RC filter section are visible at top left; v1.1 already carries the LC Butterworth (L1/L2), the soldered-down Pico and the panel-mount BNC that would carry through to v1.2.

Going over the board repeatedly turned up the cause: a stray trace, left behind during the KiCad-to-Altium migration, shorting the two inputs of the first-stage LM318. The board's layout, combined with not having a hot-air rework station on hand, made it impractical to confirm that this was the *only* fault by reworking and re-testing in place. After signal insertion at the DAC test point, the rest of the board proved functional at the lower frequencies the available handheld generator could produce. With the schematic fix in place, v1.2 was ordered directly.

The same log entry records the immediate pivot: send the board for a respin, replace the four cascaded RC stages with a 5th-order doubly-terminated LC Butterworth filter ( $\sim 1.5$  MHz cutoff, C0G capacitors, 0603 inductors), and move to a fully SMD, JLCPCB-assembled board. The RC cascade was already a known amplitude bottleneck by this point — each stage ate into the signal well before its own corner — and researching filter topologies at the time made the Butterworth's flatter passband and steeper rolloff the obvious replacement, independent of the BOM failure that forced the respin anyway.

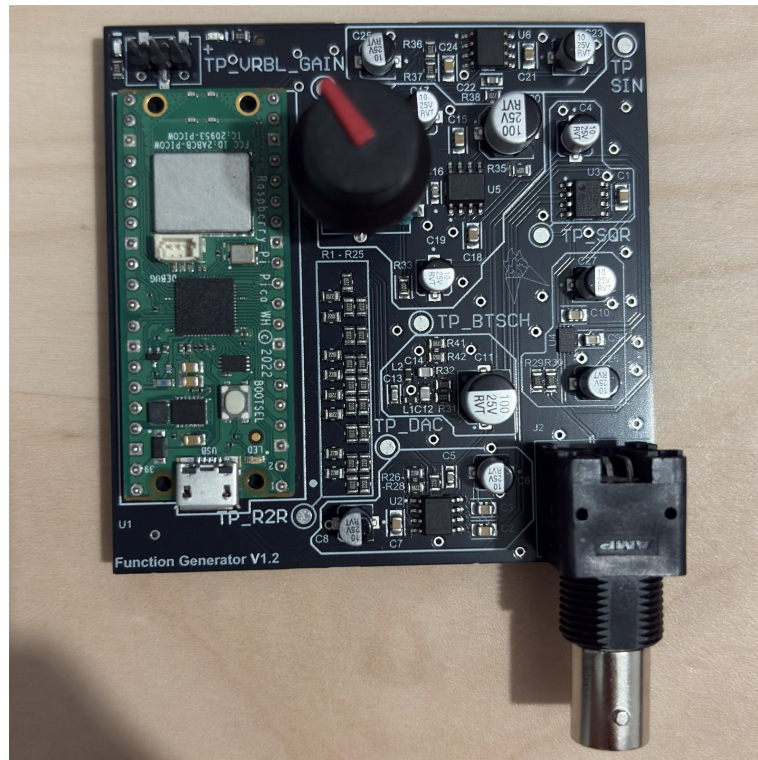
**Figure 8:** v1.2 as built: the board that arrived, assembled, with the Pico soldered directly on and the gain pot and BNC hand-fitted.

measurements surface a  $-3.1$  dB droop at 1 MHz, and scaling the DAC lookup table by four in firmware eliminates it entirely with no hardware change — which is what pins the cause on inductor saturation rather than on the filter design or op-amp bandwidth (Lesson 3, Section 6). It is diagnosed cleanly and, so far, patched only in firmware; the real fix is expected to be small, swapping L1/L2 for parts with adequate saturation current, likely reworkable on the existing board rather than the kind of fault that forces another respin. A firmware fix for the square wave's duty-cycle asymmetry is logged in the same entry. Source: EngLog 01-09-2026 1436.txt
