# AWG / DDS Function Generator

Engineering Process Report

Current build: **v1.2** — working, characterised

Three PCB revisions; two arrived dead

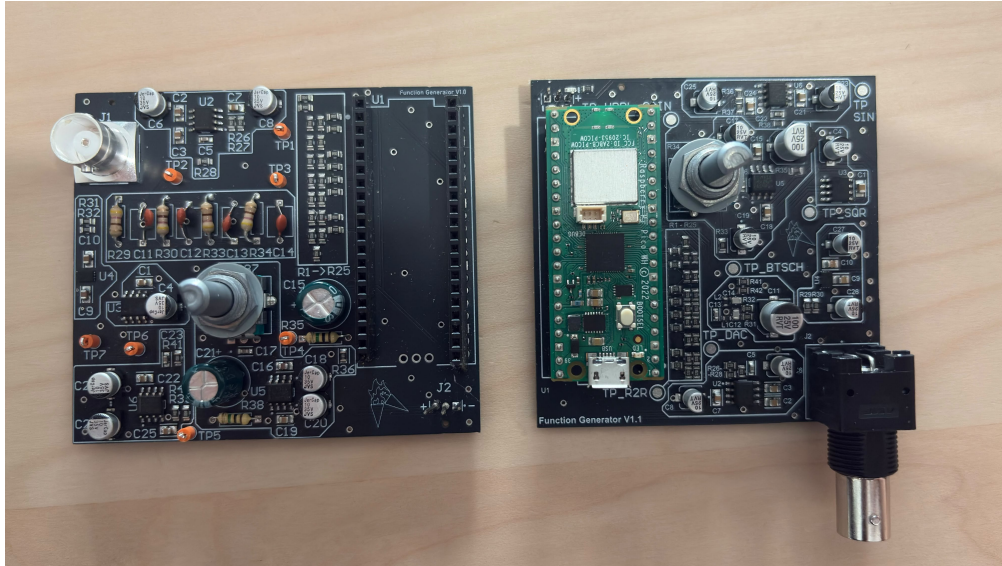
The board arrived, and the failure was immediate and total. The BOM matcher had substituted 2.21  $\Omega$  resistors for 2.21 k $\Omega$  across the entire R-2R ladder: three orders of magnitude off, on every rung. This is Lesson 1 in Section 6.

**Figure 6:** v1.0 (left) and v1.1 (right) side by side — the two boards that arrived dead. v1.0's  $2.21\ \Omega$  ladder and cascaded-RC filter section are visible at top left; v1.1 already carries the LC Butterworth (L1/L2), the soldered-down Pico and the panel-mount BNC that would carry through to v1.2.

Going over the board repeatedly turned up the cause: a stray trace, left behind during the KiCad-to-Altium migration, shorting the two inputs of the first-stage LM318. The board's layout, combined with not having a hot-air rework station on hand, made it impractical to confirm that this was the *only* fault by reworking and re-testing in place. After signal insertion at the DAC test point, the rest of the board proved functional at the lower frequencies the available handheld generator could produce. With the schematic fix in place, v1.2 was ordered directly.

The same log entry records the immediate pivot: send the board for a respin, replace the four cascaded RC stages with a 5th-order doubly-terminated LC Butterworth filter ( $\sim 1.5$  MHz cutoff, C0G capacitors, 0603 inductors), and move to a fully SMD, JLCPCB-assembled board. The RC cascade was already a known amplitude bottleneck by this point — each stage ate into the signal well before its own corner — and researching filter topologies at the time made the Butterworth's flatter passband and steeper rolloff the obvious replacement, independent of the BOM failure that forced the respin anyway.
