JAMES COOK UNIVERSITY  
COLLEGE OF SCIENCE &  
ENGINEERING

EG4011  
Civil Engineering

**A STUDY OF THE EFFECTS OF  
NOTCHING ON RECTANGULAR  
AND ROUND TIMBER GIRDERS**

LARA MULLAMPHY

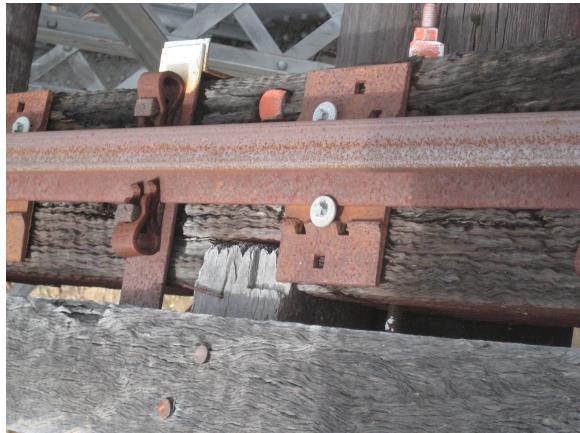
Weathering and rotting occur in timber members due to exposure to a combination of wind, wetting, drying and UV radiation [6,16]. The appearance of the weathering damage depends on the elements the timber is exposed to. Exposure to high wind speeds can cause dints/abrasions from small pebbles or embedded sand particles [17], whereas exposure to a combination of running water and sun light can cause a ripple effect, as shown on a rail bridge longitudinal girder in the Figure 2.

Figure 2: Weathering

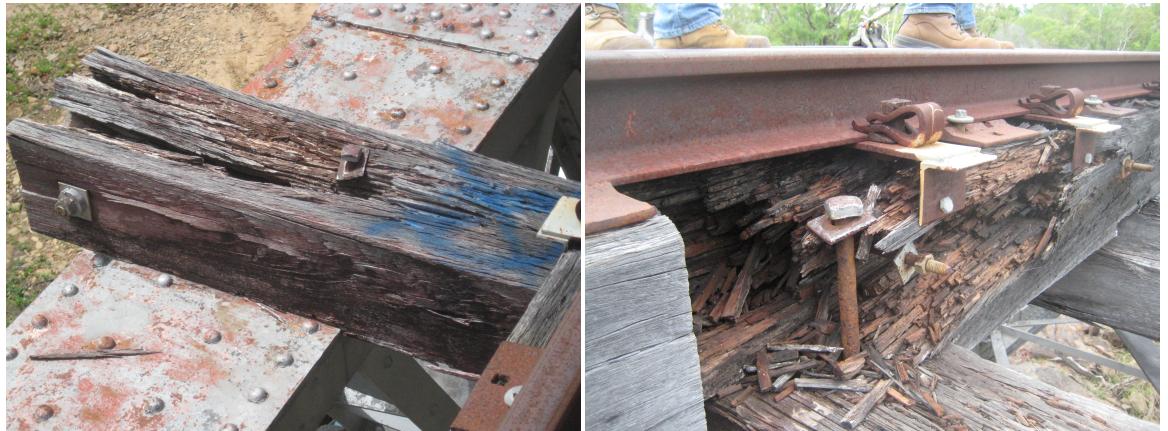
Rotting occurs in areas where moisture is allowed to penetrate the wood and can lead to core rotting as shown in Figure 3 which severely reduces the strength of the member. The most vulnerable areas for rotting occur at bolt holes and cut sections (i.e. notches) where moisture can easily penetrate the timber [6, 18].

Figure 3: Core and Notch Rotting

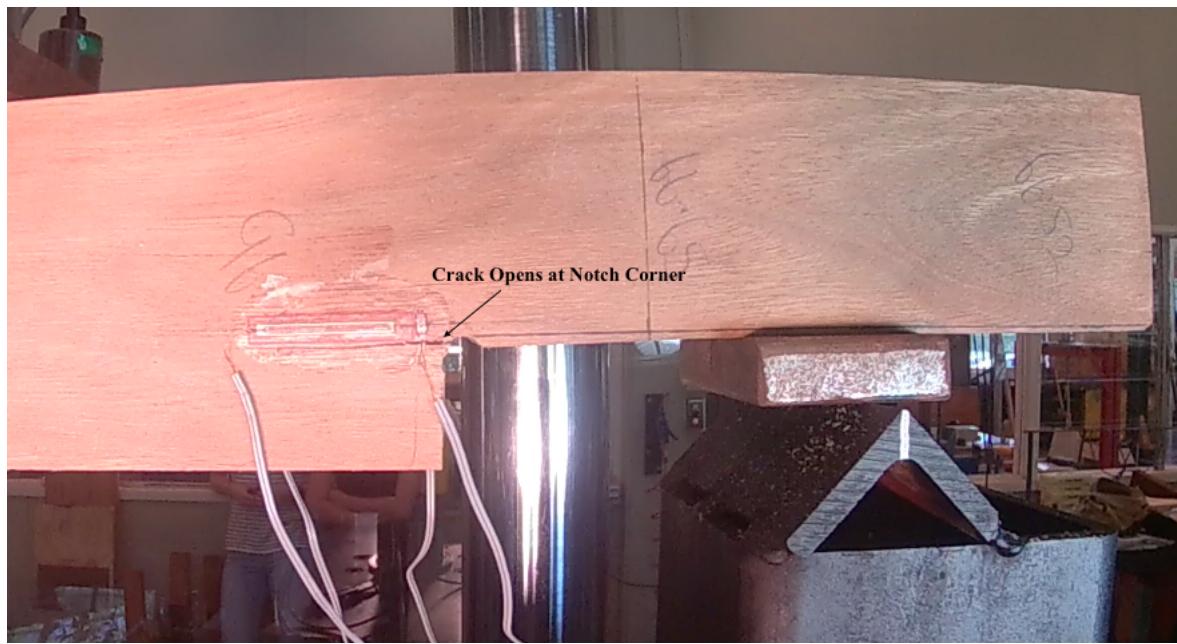
Throughout all rectangular experiments, there was a definite pattern in the types of failure that occurred; first a crack initiated from the notch corner, which propagated just past the centre of the beam, then ultimate failure occurred. The crack would initiate by first opening perpendicular to the grain at the notch corner (notch failure mode 1), due to excessive tensile forces, which can be seen in Figure 27.

Figure 27: Specimen 4 notch 1:0, notch crack opening

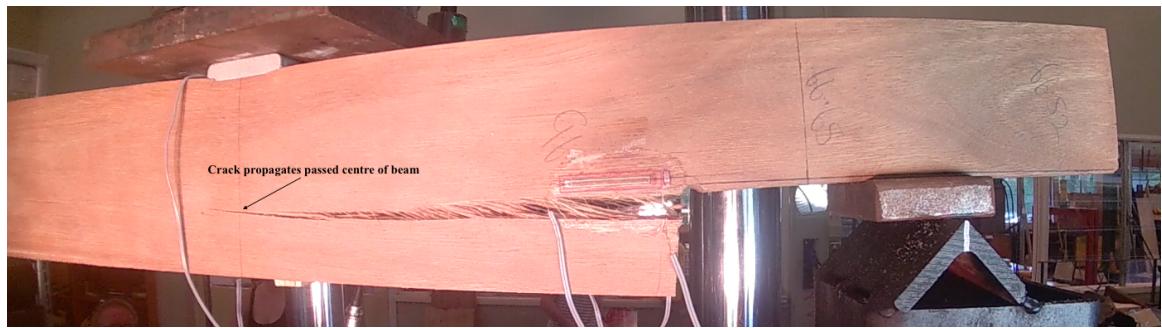
Then the crack would shear through the member (notch failure mode 2) and propagate to just passed the centre of the beam, as can be seen in Figure 28. It can also be seen in Figure 28 that the notch corner crack opened (failure mode 3), due to a combination of the tensile and shear forces, which began to occur after the crack initially sheared.

Figure 28: Specimen 4 notch 1:0, notch crack shearing and opening

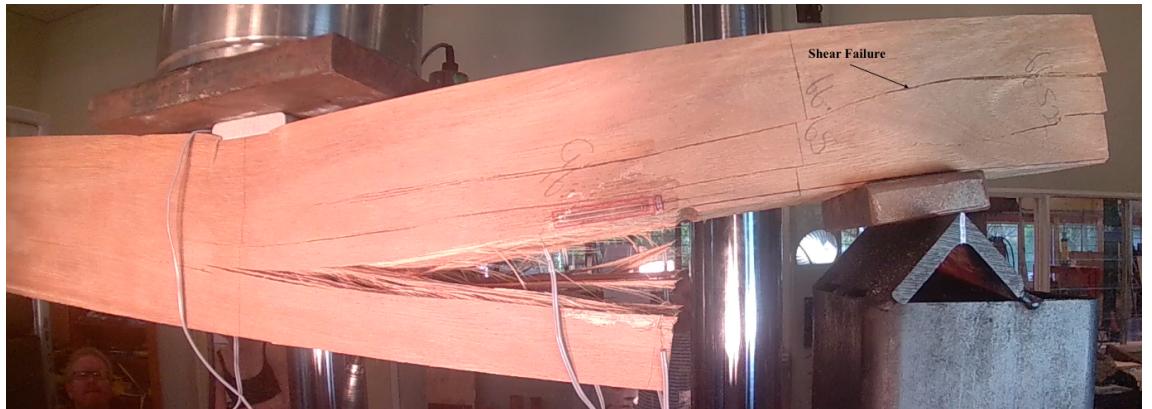
After the notch crack had fully propagated passed the centre of the beam and began to open, the specimens then ultimately failed in shear as can been seen in Figure 29.

Figure 29: Specimen 4 notch 1:0, Shear Failure

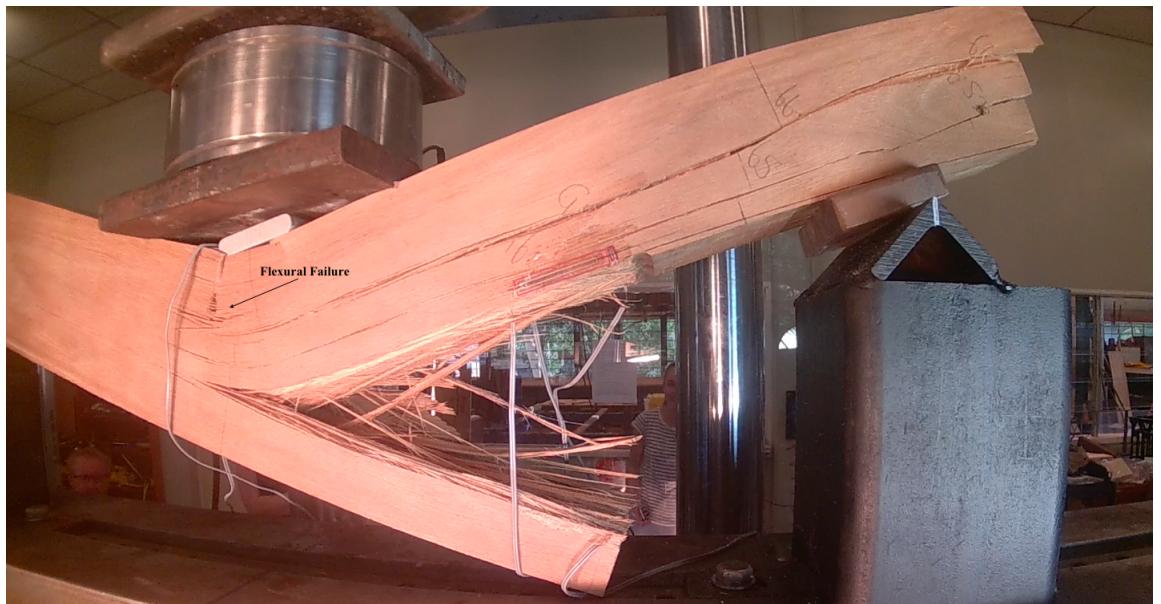
Almost immediately after ultimate shear failure occurred, the specimens then failed in flexure at the centre of the beam, as shown in Figure 30. The overall succession of notch failure and ultimate failure occurred as expected; sequencing through the notch failure modes and ultimately failing in shear or flexure.

Figure 30: Specimen 4 notch 1:0, Flexural Failure

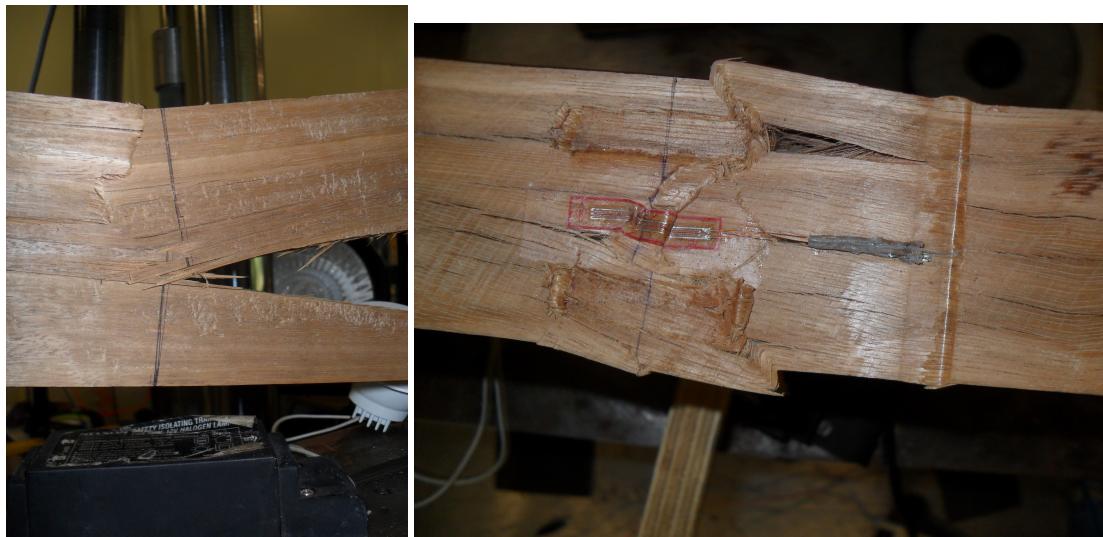
All rectangular specimens ultimately failed in shear and then flexure, apart from specimen 2 of the 1:0 slope notch, which only failed in flexure, as shown in Figure 31.

Figure 31: Specimen 2 notch 1:0 failure; side view left, top view right

The reason that this specimen did not fail in shear is overall unknown. There were no obvious defects present on or in the specimen on inspection. A possible reason would be the specimen had a very high water content at the centre of the beam, which significantly decreased it's flexural capacity in this region. The possible clause for this theory can be observed in Figure 32, where the specimen appears to be very wet in this specified area. However, the water content was not taken for this specific specimen, thus this theory can not be verified.

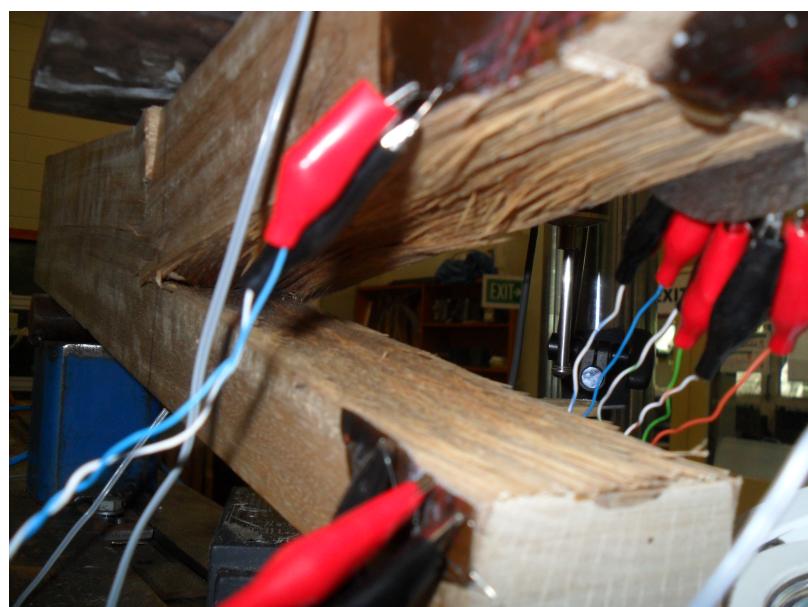
Figure 32: Specimen 2 notch 1:0; inside centre of beam
