## RACK INSPECTION REPORT FOR:

INFRATEC UK LTD

MIDDLESBROUGH

29<sup>TH</sup> MAY 2024

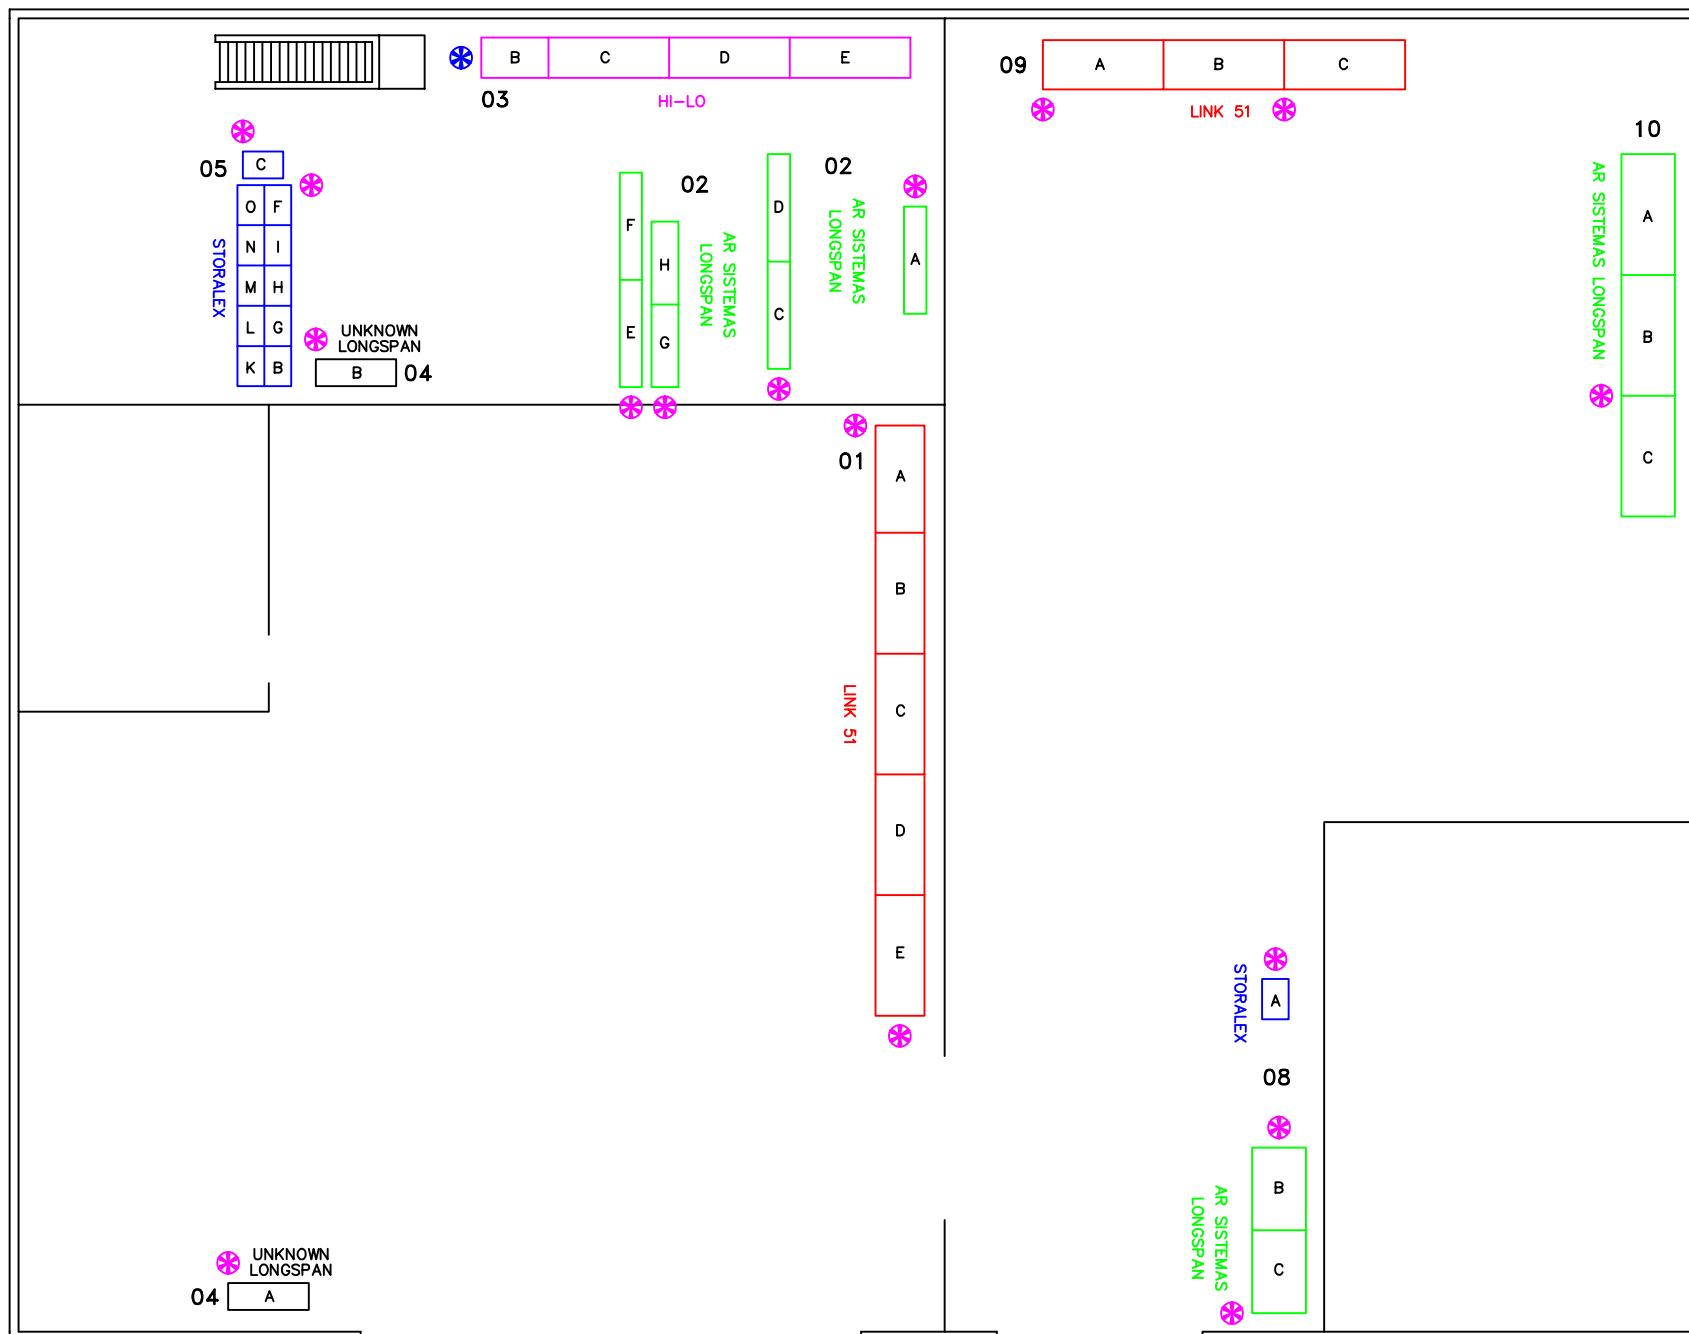
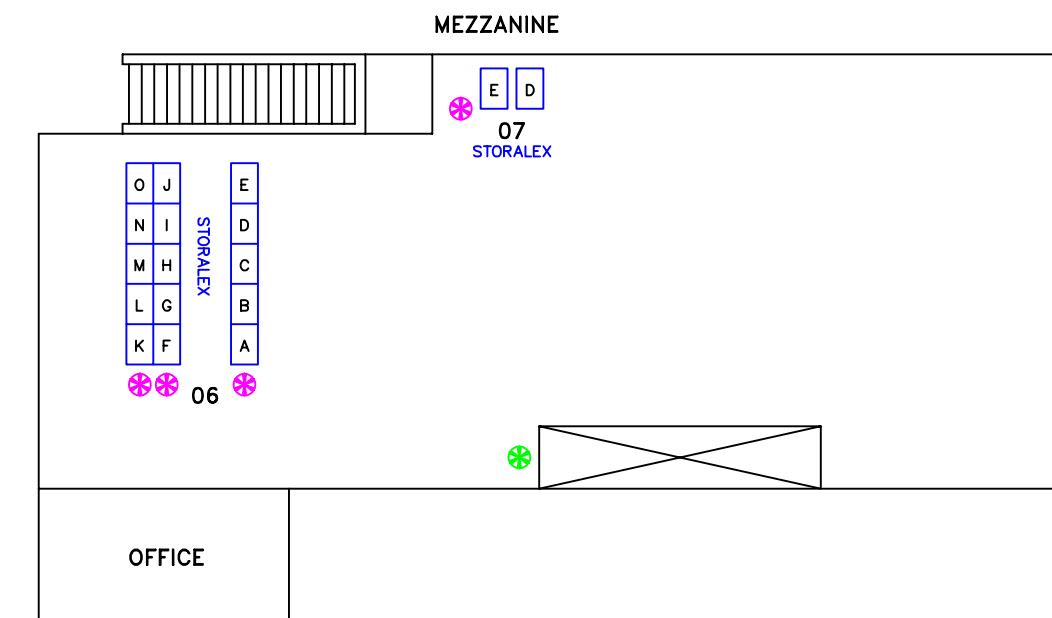
= LOAD NOTICE FITTED  
INADEQUATE
-
