# Microduck

## Cables & connections / 线缆与连接

**Review stage — do not power the robot from this guide yet.**

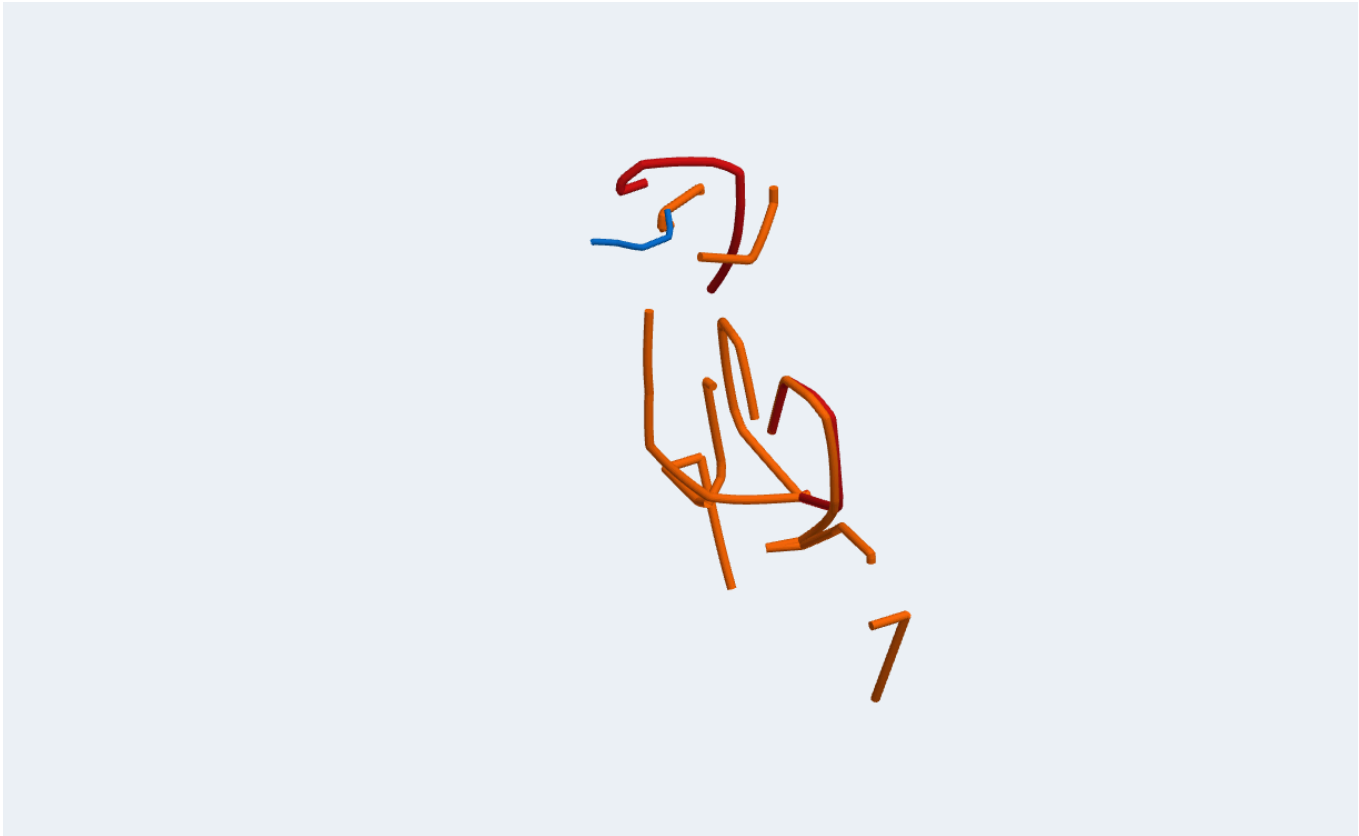
These are the 16 saved candidate cable solids, with no new routes invented for missing wires.  
本图为16根已保存候选线缆，没有虚构缺失线缆。 [Turn this view / 旋转查看](#)

1. Confirm the exact HAT, IMU, camera and ToF board revisions against their drawings. 确认各板卡实际版本。
2. Verify each connector pin number, voltage and polarity with the matching source drawing; label both cable ends. 按对应图纸核对针脚、电压、极性，并标记线缆两端。
3. Resolve the servo voltage mismatch before connecting the battery. 先解决舵机供电超压问题。
4. With power disconnected, check slack and pinching through the intended joint range; retain loops and strain relief only after clearance is measured. 断电检查全行程余量、夹线和固定位置。
5. Measure the actual routed lengths, then finalize cable cuts. The current pictures do not provide cut lengths. 实际走线测量后才能确定裁线长度。
