Bad News First 2023

Daily Monitoring Quality Performance

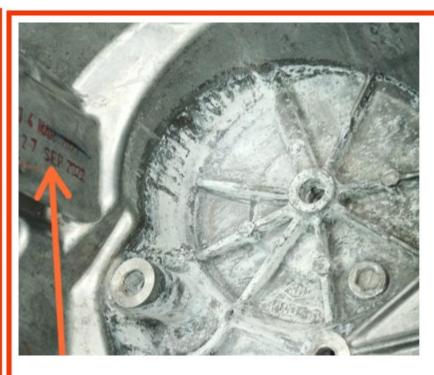
Cov R Kwb. Visual rust. AHM P2

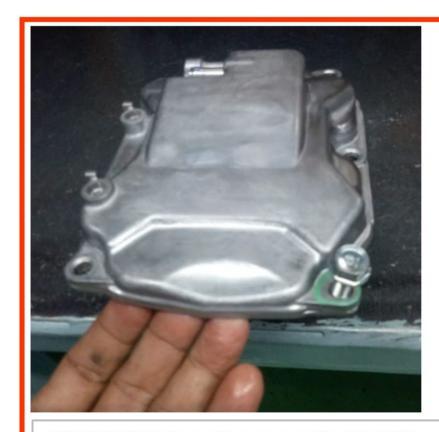
CAH K1ZG. Lubang baut sempit. AHM P1
