# **Special Crash Investigations On-Site Ambulance Crash Investigation**

**Vehicle: 2016 Ford E-350 Type III  
Ambulance**

**Location: Georgia**

**Crash Date: June 2017**

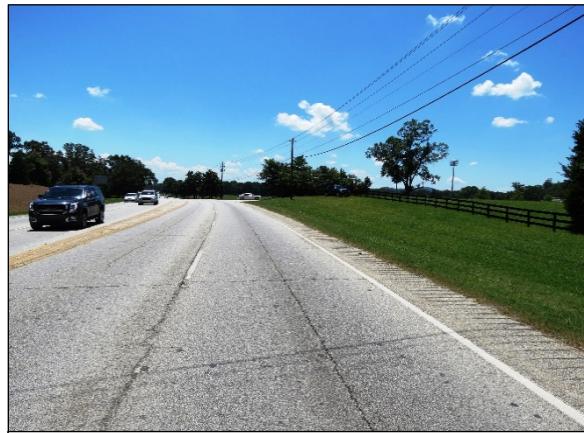
**Figure 2.** South-facing view depicting the roadway configuration and the ambulance's pre-crash trajectory.

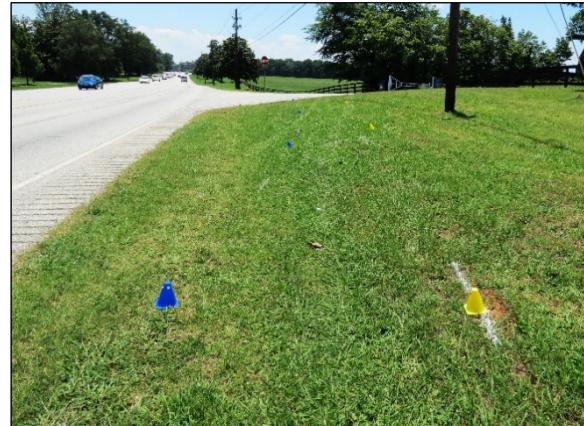
**Figure 3.** South-facing view of the ambulance's tire marks through the roadside.

**Figure 3** depicts the ambulance's tire marks through the roadside following the initial roadside departure, while **Figure 4** depicts the tire marks leading from the intersecting road toward the point of impact. In the images, evidence cones distinguish the right (yellow) and left (blue) tire marks.

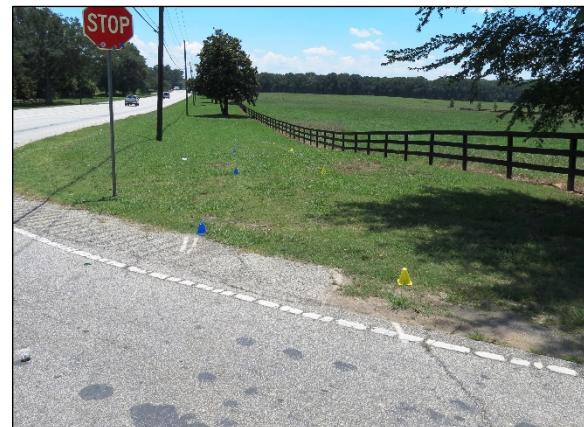
**Figure 4.** South-facing view of the ambulance's tire marks from the local road toward the point of impact.

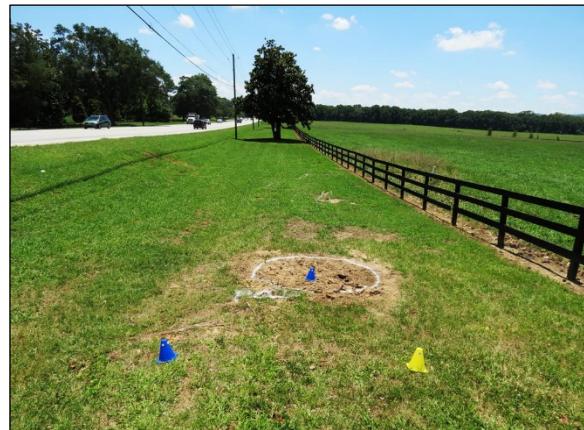
**Figure 5.** South-facing view of the location of the tree and focal impact for the Ford.

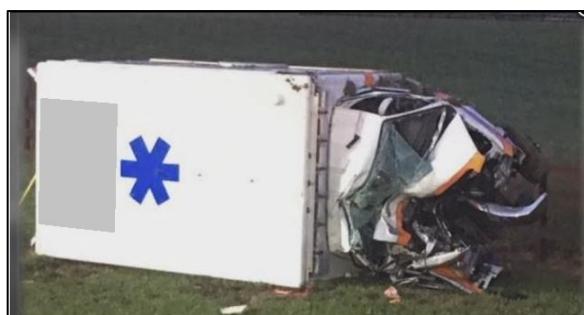
The vehicle rotated approximately 30 degrees clockwise and its left side tires began to furrow into the soft grass/soil surface of the roadside. Coupled with the dynamics from the tree impact, an instability was created by the lateral drag force on the left side tires with respect to the vehicle's center of mass. This tripped the ambulance into a left side leading rollover (Event 2). The vehicle rolled onto its roof and then onto its right side, completing 3-quarter turns over an estimated distance of 18.6 m (61.0 ft) from the initiation of roll to the center of mass' final rest position. During the rollover trajectory, the ambulance continued to rotate approximately 80-degrees clockwise about the vertical axis. The vehicle came to final rest on its right plane, facing in a northwesterly direction (**Figure 6**).

**Figure 6.** Image of the overturned ambulance at final rest from a southwest-facing perspective (obtained from an online news source).

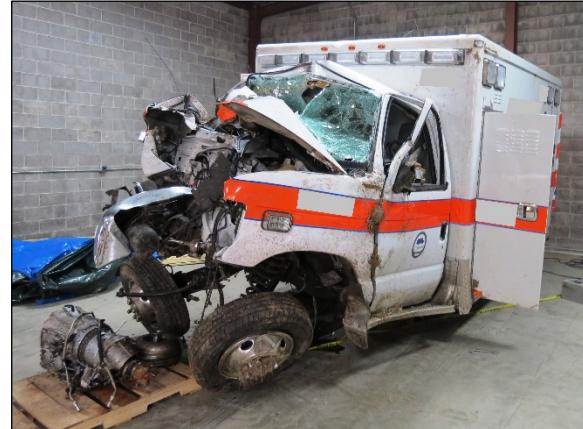
The Ford E-350 (**Figure 7**) was a cutaway chassis identified by the Vehicle Identification Number 1FDWE3FS2GDxxxxxx. It was manufactured as an incomplete vehicle in September 2015 and equipped with the manufacturer's "Ambulance Prep Package." An electric odometer reading could not be determined due to inoperability. The vehicle's powertrain consisted of a 6.8 liter, V-10, gasoline engine linked to a 4-speed, automatic transmission. The dual rear-wheel drive chassis was built on a 351 cm (138 in) wheelbase. The manufacturer's recommended tire size was LT225/75R16 front and rear, with cold tire pressures of 448 kPa (65 PSI) front and 414 kPa (60 PSI) rear. All tires were Michelin Defender LTX M/S of the recommended size and had ample tread. The force of the crash displaced and deformed the front axle and drive shaft. There was no damage to the rear tires or displacement of the rear axle.

**Figure 7.** Left front oblique view of the Ford Type III ambulance at the time of the SCI inspection.

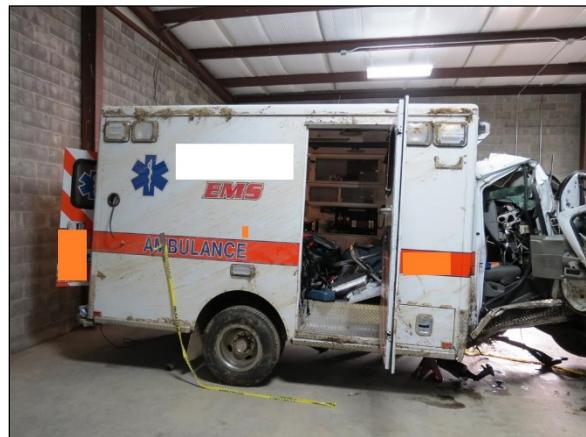
Exterior damage from the rollover (Event 2) was limited to minor deformation to the front header, with surface scratches and debris embedded in the joints of its construction. The header was dented immediately right of the longitudinal centerline from presumed contact with a tree branch during the initial impact. A 60 x 60 cm (24 x 24 in) area at the left rear corner of the roof was deformed less than 5 cm (2 in) as a result of ground contact during the rollover. The entire surface of the right plane was dirt-scuffed in a diagonal pattern, indicative of the rotation of the ambulance as it rolled onto its right side and slid to final rest. The CDC assigned to the ambulance for the rollover damage was 00RDAO2.

**Figure 10.** Left-side view of the AEV Type III patient compartment.

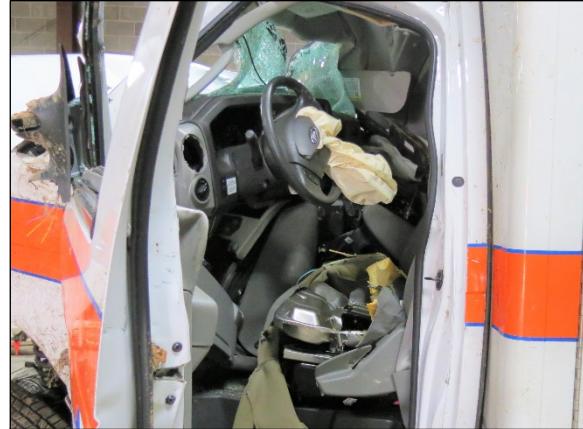
The cab of the ambulance sustained severe damage from the Event 1 tree impact that consisted of catastrophic intrusion into the front row right occupant space and moderate intrusion into the driver’s space. The left A-pillar was displaced rearward 10 cm (4.0 in), which had resulted in the rearward displacement of multiple components including: the instrument panel by approximately 15 cm (5.9 in), the steering column by 10 cm (3.9 in) and the windshield header by 10 cm (3.9 in).

Rearward displacement of the engine and transmission prior to their separation had displaced the engine cowling laterally to the left, which had compressed the toe pan approximately 15 cm (5.9 in). As a result of this intrusion, the SCI investigator observed that the accelerator pedal overlapped the brake pedal. **Figure 11** is an overall view of the intrusion and damage to the driver's area of the ambulance's cab.

**Figure 11.** Damage and intrusion to the driver's area of the ambulance cab.

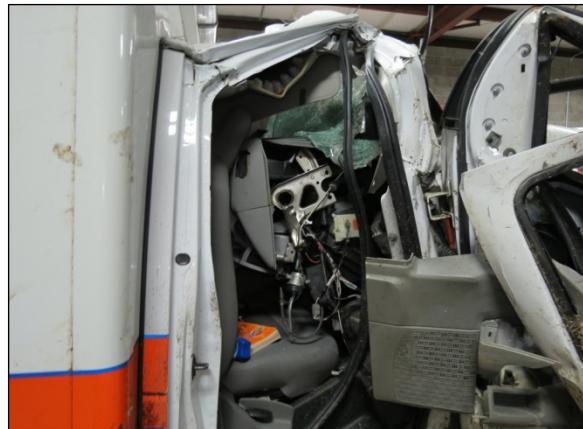
**Figure 12.** Catastrophic intrusion and deformation at the front row right position of the ambulance cab.

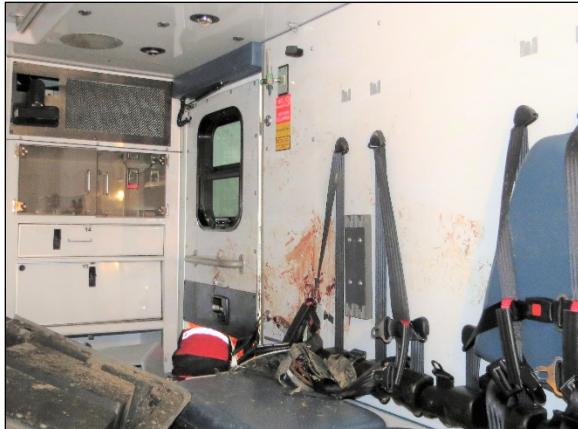
The SCI investigator observed significant blood evidence on the right wall of the patient compartment above the bench seat and on the interior surface of the right door. There was also blood on the ceiling of the interior at the forward aspect of the patient compartment. The blood evidence on the right wall and right door was attributable to the patient, and evidenced his post-crash final rest position in the overturned ambulance. Blood on the roof had droplets extending toward the right plane, indicative that the transfer had occurred post-crash while the vehicle was still overturned. Therefore, the blood on the ceiling likely was not associated with the occupants' crash-sequence kinematics. **Figure 13** depicts the blood on the right wall of the patient compartment. Further contact evidence in the patient compartment evidentiary of the patient's kinematics included separation of the bench seat webbing net and minor deflection of the cabinetry doors at the forward right aspect of the patient compartment (**Figure 14**).

**Figure 13.** Forward-facing view of the right wall of the patient compartment and the patient's blood evidence.

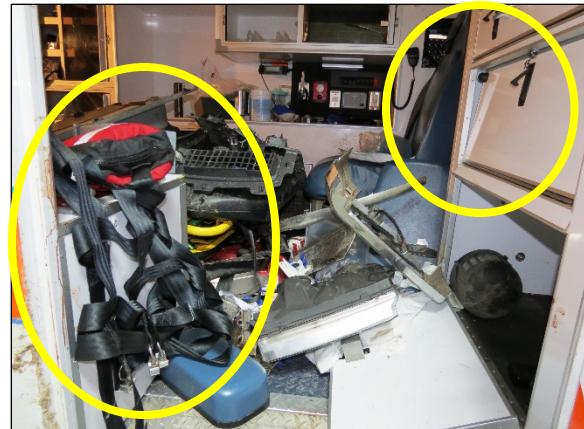
**Figure 14.** Left-facing view of the separated webbing net and deflected cabinet (highlighted by yellow circles).

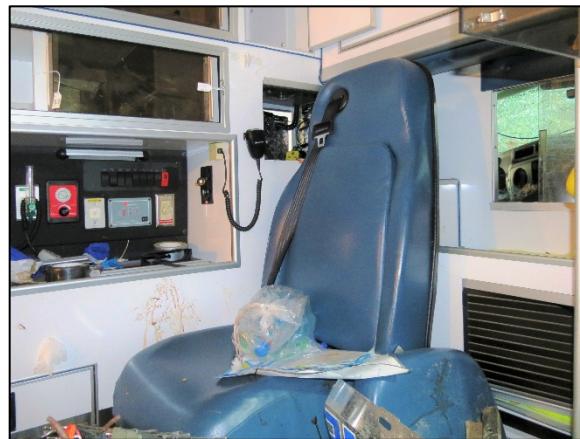
The male EMT's seating position and orientation for this crash enabled his body to ride down the frontal impact event crash forces by distributing his weight against the seat cushion and seat back of the rear-facing captain's chair (**Figure 15**). Due to the soft material comprising the seat, there was no discernable evidence of his kinematic loading or contact relative to the first crash event. It is likely that his head contacted the left wall of the patient compartment adjacent to his seated position during the rollover. However, the SCI investigator was unable to observe any evidence attributable to such contact during the limited visual inspection.

**Figure 15.** Left-facing view of the captain's chair in the patient compartment of the ambulance.

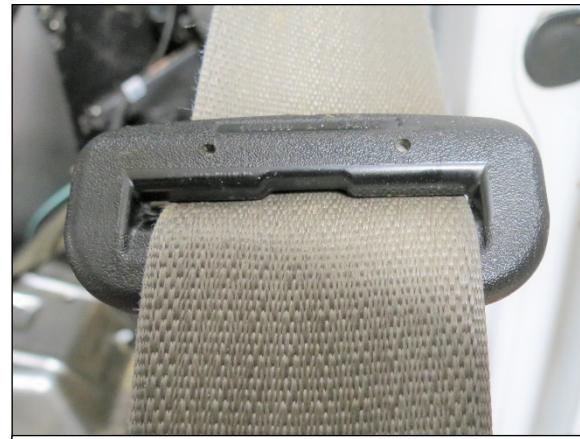
At the time of the SCI inspection, the driver's seat belt was observed to be stowed in the retractor and resting loosely against the left B-pillar. The webbing spooled freely from the retractor, and although it exhibited historical wear, there was no distinct evidence attributable to driver loading. However, examination of the latch plate revealed frictional abrasions of the polymer surface from the seat belt webbing in the belt path (**Figure 16**). It was apparent that the shortened buckle stalk was indicative of buckle pretensioner actuation. Based on the observations

**Figure 16.** Loading evidence in the belt path of the Ford's driver latch plate.

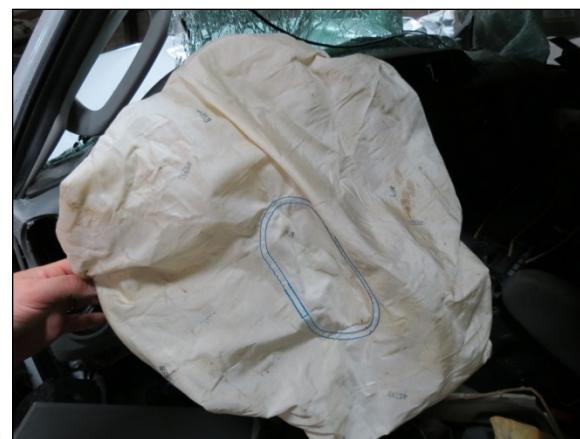
**Figure 17.** Deployed driver's frontal air bag in the Ford.

The driver's frontal air bag was concealed in the center hub of the two-spoke steering wheel with a tri-flap module cover. In its deflated state, the deployed air bag (**Figure 17**) was 58 cm (22.8 in) in overall diameter. It was internally tethered via a circular center stitch pattern. Venting was achieved by two 2.5 cm (1.0 in) vent ports located on the back side of the air bag at the 11 and 1 o'clock positions. A small area of blood evidence to the right of the air bag's center stitch pattern was indicative of probable post-crash occupant contact. There was no discernable damage to the deployed driver's air bag.

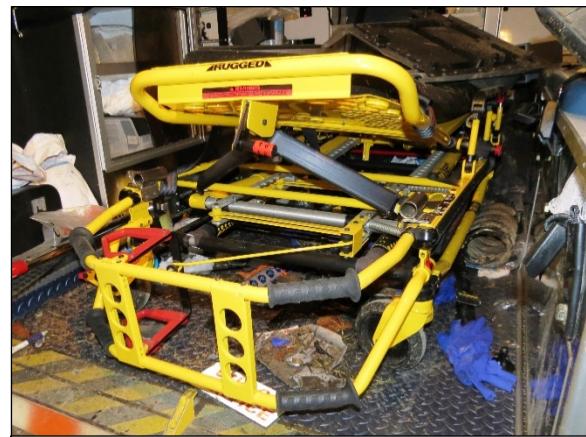
The patient cot sustained visible damage attributable to occupant loading in relation to the crash sequence. During the crash, the occupant responded toward the front crash force and the back of his torso compressed against the mattress platform and the back support. This translated a minor loading force into the cot's frame as the occupant slid forward along the mattress. As the occupant slid forward and his head and upper torso extended off of the head-end of the cot, his shoulders engaged the multi-point harness systems' straps.

**Figure 21.** Overall view of the visibly deformed wheeled ambulance cot from the rear of the ambulance at the time of the SCI inspection.

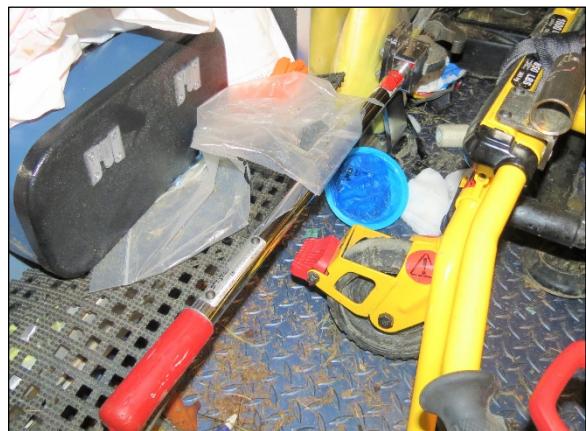
Based on the visual inspection, the antler bracket appeared to have remained engaged to its floor mount. The SCI investigator was unable to determine if the antler bracket was deformed as it was partially concealed by debris in the patient compartment. The rail clamp was in its opened position and appeared to be slightly angulated downward, indicative that it likely released during the crash as a result of forward loading by the locking pin as a result of forward compression by the occupant's loading of the cot. It was apparent that the system did not withstand the forces of the crash or retain the wheeled ambulance cot from unrestricted movement.

**Figure 22.** Rail clamp of the Stryker cot fastener system in the ambulance.
