On-Site Ambulance Crash Investigation  
Case Number DS15014  
Vehicle: 2007 GMC Yukon XL Ambulance  
Location: Colorado  
Crash Date: November 2015

## Technical Report Documentation Page

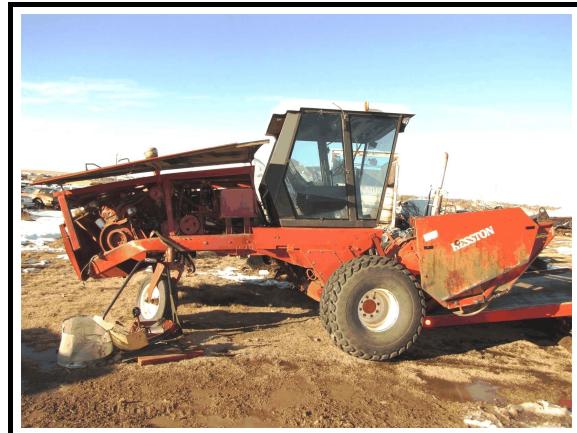
**Figure 2.** 1994 Hesston 8200 Swather

The other vehicle in the crash was a 1994 Hesston 8200 Swather (**Figure 2**). The Hesston was a cab

and header configured heavy farm implement that cuts hay or small grain crops and forms them into rows on the ground to dry. It was being driven northbound ahead of the GMC at a low speed by a 21-year-old male. For unknown reasons, the driver of the GMC did not brake in time and the front plane of the GMC impacted the back plane of the Hesston. Following the initial impact, the GMC departed the roadway on the left edge and overturned onto its roof. It came to rest in an upside down orientation on the roadside. The Hesston departed the roadway on the right edge and came to rest after impacting a highway sign.

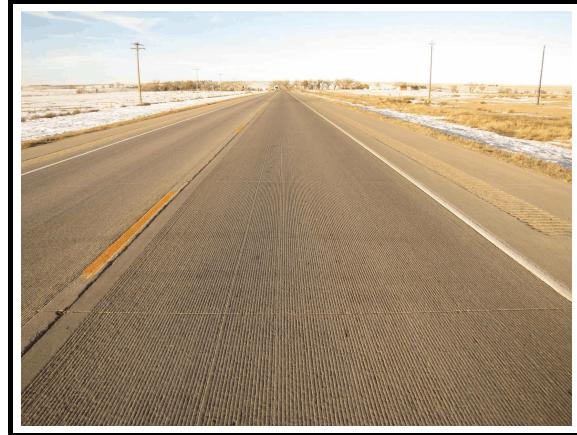
**Figure 3.** Crash site looking north

The crash occurred on an undivided two-lane north/south state highway in the state of Colorado (**Figure 3**). The roadway was configured with one northbound and one southbound travel lane with paved shoulders bordering each side. The travel lanes each measured 3.7 m (12.0 ft) in width and the paved shoulders each measured 2.9 m (9.5 ft) in width. The travel lanes were separated by a dashed yellow painted stripe and bordered by solid white painted fog lines. The roadway was paved with grooved concrete tining and the shoulders were paved with smooth concrete and configured with rumble strips. The roadway measured 13.1 m (43.0 ft) in total width. It was straight with a level profile. The posted speed limit was 105 km/h (65 mph).

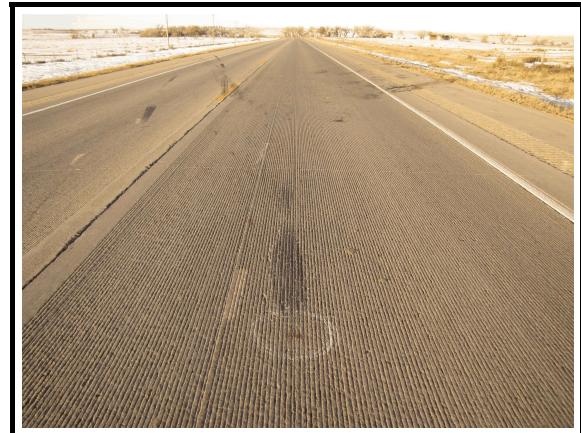
Following the initial impact, the GMC was displaced to the left and rotated counterclockwise. The vehicle crossed over the southbound lane, departed the left edge of the roadway and traveled onto unpaved ground. The right side tires furrowed into the ground causing sufficient opposing lateral forces to cause the right side leading trip rollover. The GMC rolled two quarter turns before coming to rest on its roof in an upside down orientation on the roadside facing southwest. The distance traveled from Event 1 to final rest was 42.7 m (140 ft) and the estimated roll distance was 8 m (26 ft).

**Figure 4.** Point of Impact, northbound lane

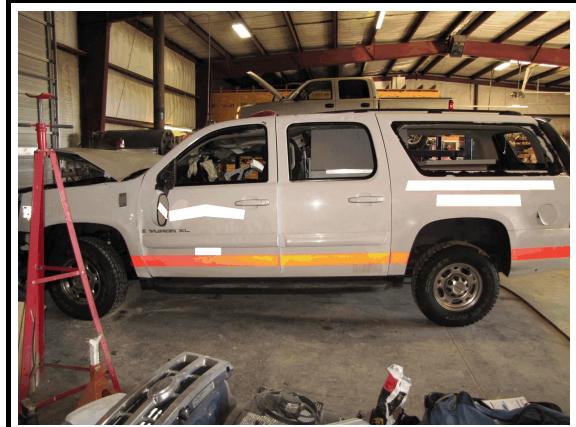
**Figure 5.** 2007 GMC Yukon Ambulance

The 2007 GMC Yukon XL (**Figure 5**) was manufactured in January 2007 and identified by the Vehicle Identification Number (VIN): 1GKGK26K07Rxxxxxx. The vehicle mileage was unknown. The vehicle interior and exterior was configured to be a transfer unit outfitted with equipment and

The GMC sustained moderate severity damage to the front and right planes caused during the impact with the Hesston in Event 1. Direct damage began at the front right bumper corner and extended 110.0 cm (43.3 in) to the left. The field L was distributed from bumper corner to bumper corner and measured 170.0 cm (66.9 in). Six crush measurements were taken at bumper level as follows (**Figure 6**):  $C_1 = 0 \text{ cm}$ ,  $C_2 = 0 \text{ cm}$ ,  $C_3 = 6.0 \text{ cm}$  (2.4 in),  $C_4 = 11.0 \text{ cm}$  (4.3 in),  $C_5 = 14.0 \text{ cm}$  (5.5 in),  $C_6 = 43.0 \text{ cm}$  (16.9 in). Maximum crush was located at  $C_6$  and the Collision Deformation Classification (CDC) for the GMC in Event 1 was 92FZEW2 which included frame shift of both rails to the left.

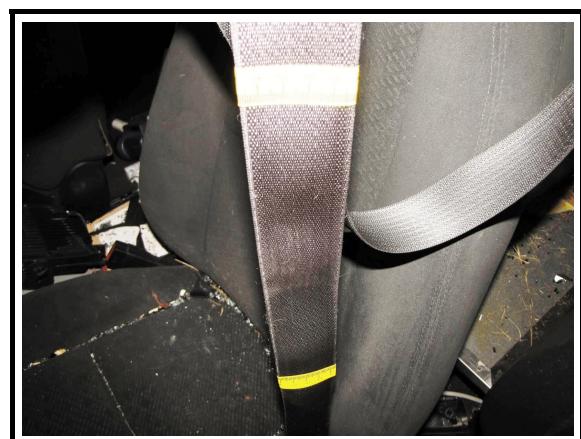
The GMC's interior was equipped with forward seating for three occupants and all seats were configured with three-point lap and shoulder safety belts. The front row belts were equipped with dual retractor/buckle pretensioners, sliding latch plates and adjustable D-rings. Both D-rings were adjusted to the full-up positions. The driver's lap and shoulder belt was used during the crash and revealed evidence of occupant loading on the webbing beginning 22.0 cm (8.7 in) above the stop button (**Figure 8**). During the crash, the driver's belt pretensioners actuated locking the webbing in the used position and reducing the buckle stalk to

**Figure 8.** Driver's safety belt loading evidence, 2007 GMC Yukon Ambulance

a length of 5.0 cm (2.0 in). The front right seat was unoccupied.

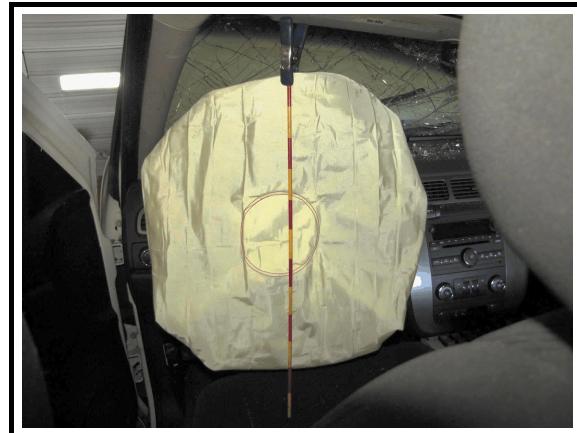
During the crash, the driver's frontal air bag deployed and both front row pretensioners actuated. The driver's frontal air bag deployed from the steering wheel hub (**Figure 9**). It was round in shape and measured 53.0 cm (20.1 in) in diameter. The air bag was configured with two vent ports on the upper aspect, and two internal tethers. It was not damaged and appeared to have deployed normally. The air bag exhibited slight and scattered blood deposits on the top and left aspects. The front right passenger air bag did not deploy during the crash.

**Figure 9.** Driver's deployed frontal air bag, 2007 GMC Yukon Ambulance

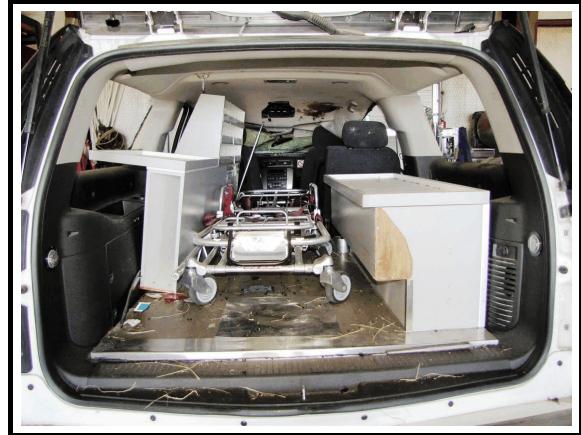
The patient compartment (**Figure 10**) was equipped with after-market cabinetry storage units located on the left wall, right wall and forward center console areas. These cabinets were constructed of plastic-laminate covered particle board. The left cabinet was the largest of the three units, extended to the roof and was configured with plexiglass shelving on the upper aspect. This cabinet covered the second row door side glass. It had broken away from its floor mounted hardware but remained near its original location inside the vehicle. The right cabinet was next largest in size and was primarily a large open box with hinged lid, probably used to store larger equipment. No oxygen tank was present and most of the medical supplies had been removed prior to the SCI inspection. This cabinet was still mounted in place to the floor. The forward center cabinet was the smallest unit of the three and fit between the front row seats. It was within arms reach of the second row right occupant and was used to hold the heart monitoring equipment needed by the paramedic and patient during patient transport. According to the driver of the GMC, the paramedic seated in the second row was possibly attending to the heart monitoring equipment at the time of the crash. This cabinet was fractured at the lower aspect and was found loose within the vehicle at the time of the inspection. It was probably damaged by contact with the paramedic during the crash.

**Figure 10.** Patient compartment, 2007  
GMC Yukon Ambulance

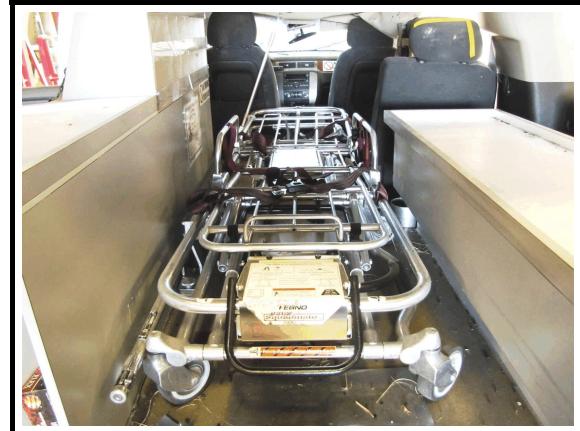
At the time of the SCI inspection, a Ferno Model 93ES Squadmate ambulance cot was secured in place along the left wall using a floor-mounted Ferno Model 175-3 Fastening System. The Squadmate cot was identified by Serial No. 06xxxxxx. The cot (**Figure 11**) measured 205 cm (81.0 in) in length, 59.0 cm (23.0 in) in width and maximum 77.0 cm (30.0 in) in height. It weighed 35.0 kg (77.0 lb) and had a 227.0 kg (500.0 lb) load limit. The cot was configured with swing-down side arms, eight-position (0 - 75%) back angles, three belt restraints and a mattress. At the time of the inspection, the mattress had been removed and was missing. The cot was equipped with a manual

restraint system consisting of three lap-type belts with locking latch plates. The webbing, latch plates and buckles were examined by the investigator and found to be functioning properly. No evidence of occupant loading on the belts was noted.

The 175-3 Fastening System consisted of a floor-mounted antler and rail configuration identified by the Serial No. 06xxxxxx. The antler bracket cradled the forward portion (location of the patient's head area) of the cot frame, while the vertically-oriented locking mechanism clamped around the cot frame rail. The aluminum antler and rail were mounted to an aftermarket floor constructed from composition board encased in aluminum trim. The mounting hardware used was detachable. Inspection of the fastening system with the cot in place revealed no discernable movement or play. The rail release mechanism functioned normally and no damage was present.

**Figure 11.** Ferno 93ES Squadmate Ambulance Cot, 2007 GMC Yukon Ambulance
