Risk Survey Report

Insured Name: Qatar Air Distribution Network QAD-NET Category Class: 3

Survey Date: 21-Sep-2023

Report no: QG-SR/2023/09/10958

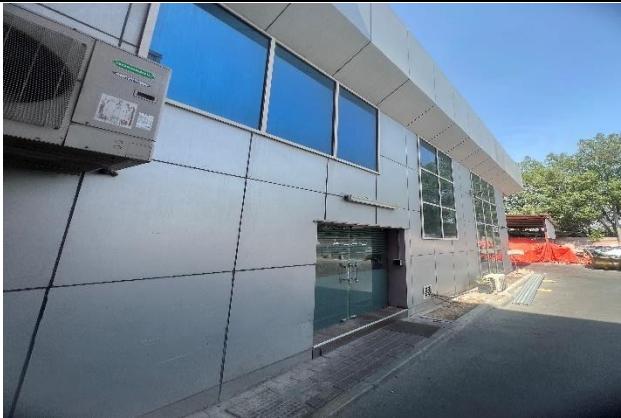
Office building

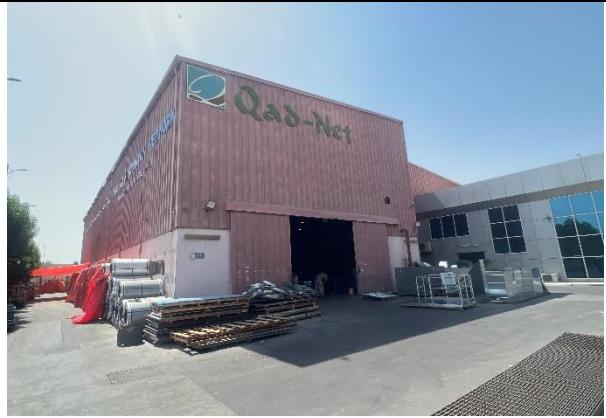
Entrance to factory

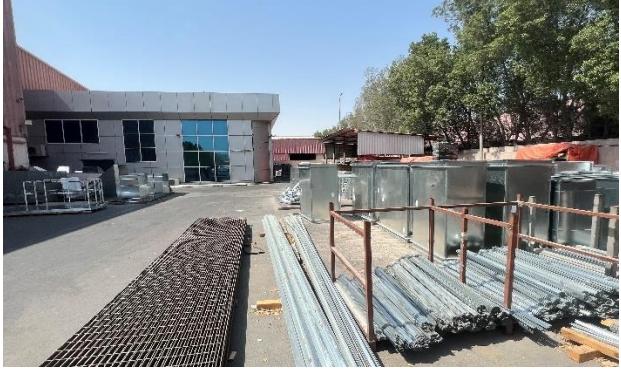
Some materials kept at the open yard

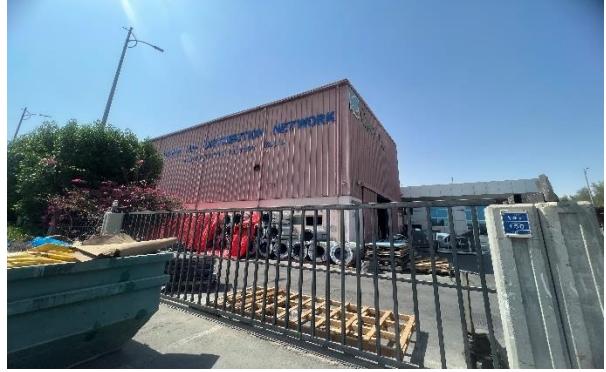
Factory building

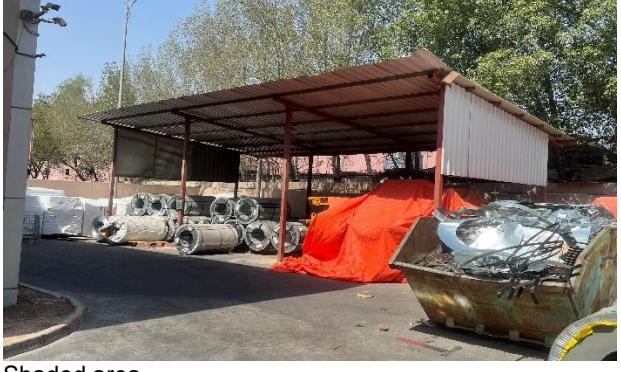
Shaded area

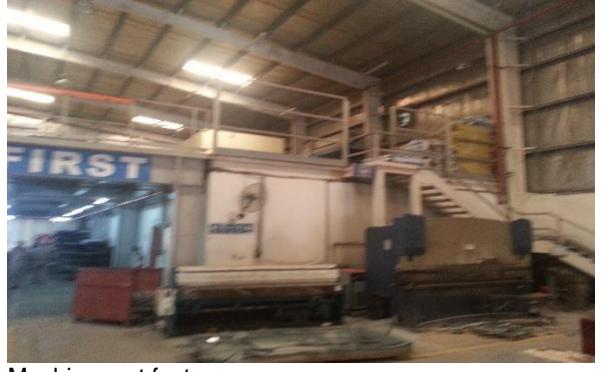
Machinery at factory

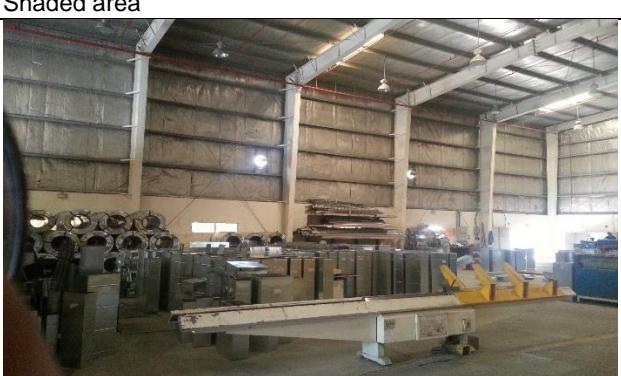
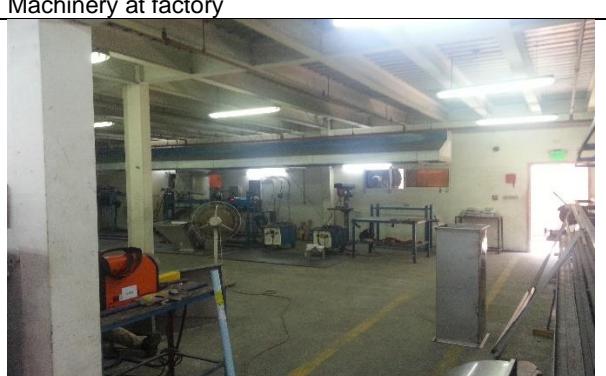
Access and spaces	Assembly of ducting

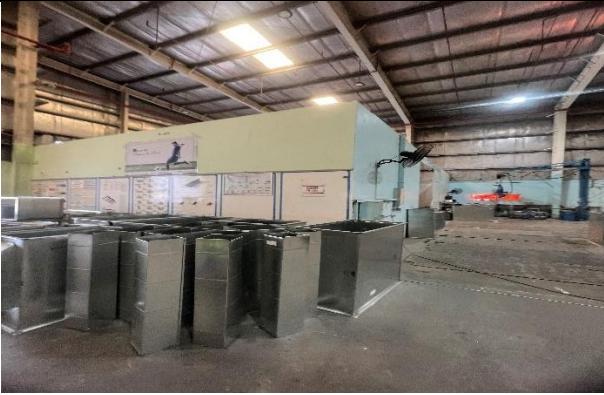
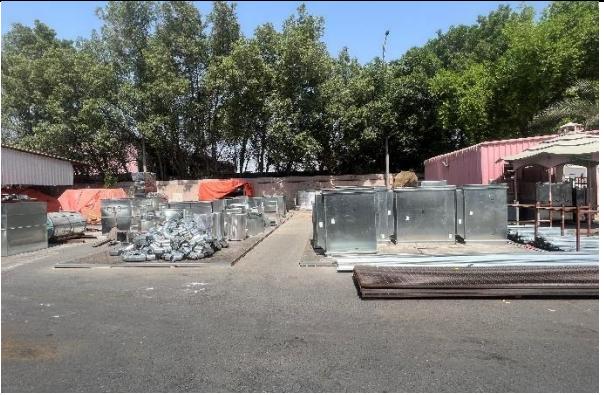
Ducting final product	Final Products for delivery

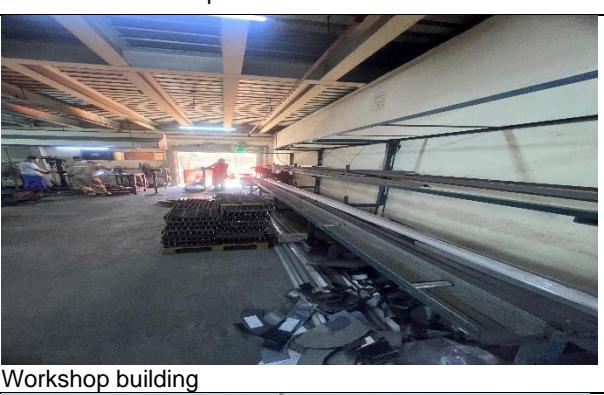
Drying of filters	Workshop building

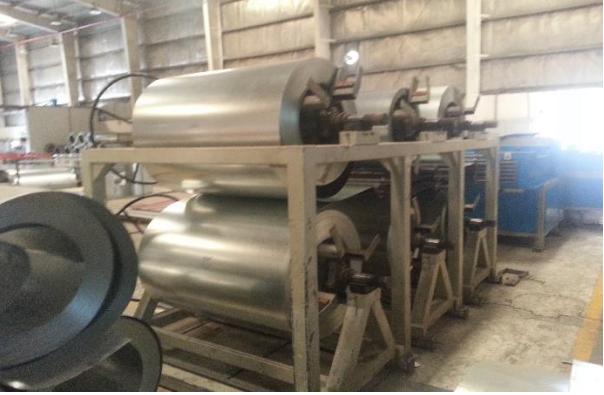
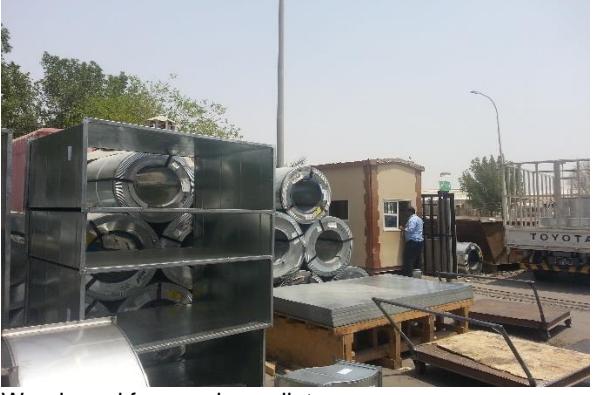
Metal sheet rolls	Wood used for wooden pallets
