Digital twin-based investigation of a building collapse accident

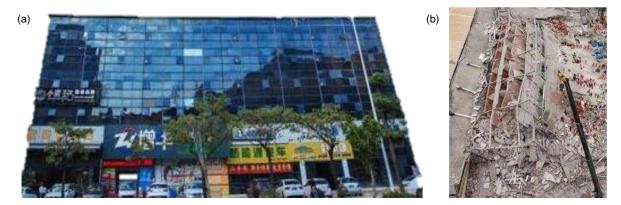
The adopted case is the collapse accident of a seven-story building (Figure 2(a)). The building collapsed after welding strengthening in 2020, and the debris is shown in Figure 2(b). The collapsed building was initially a conventional steel frame structure. However, the building underwent many functional changes over the years, and its structure changed correspondingly. Therefore, the complex retrofitting process and irregular internal structure led to complicated loading states and collapse accidents. The complex retrofitting process also makes it difficult to reveal the potential collapse mechanism using conventional analysis methods. The digital twin-based collapse investigation method can provide a comprehensive and accurate understanding of the building at each stage from construction to collapse. Therefore, to establish the digital twin model, we collected the necessary information about the building from construction to collapse. Based on this information, we established the corresponding digital twin models (see Section 3) and updated the models several times from the initial state to the critical state before collapse (see Section 4).

Figure 2. Hotel building before and after the collapse. (a) The hotel building before collapse (the hotel name is anonymous). (b) Ruin after the collapse.
