VISUAL INSPECTION SUMMARY REPORT

Optronics S.A. de C.V.

EQ R LINEA 2

File Name: S45194-132648930A1

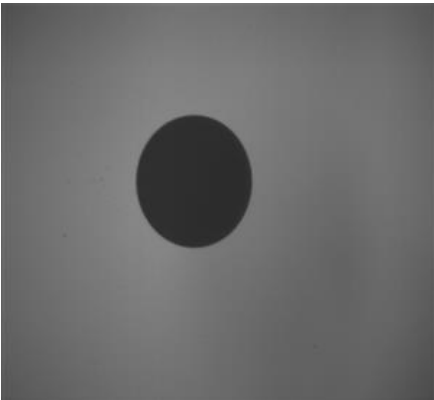
LOW Magnification

**\*\*PASS\*\***
