# VISUAL INSPECTION SUMMARY REPORT

Optronics S.A. de C.V.

File Name: S26940-192600013A

Serial Number: S26940-192600013

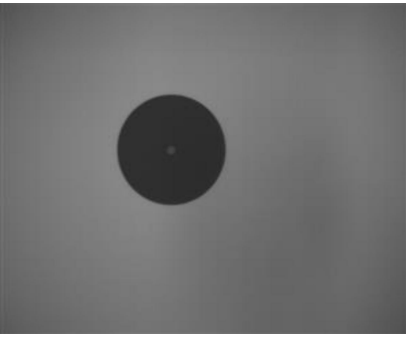
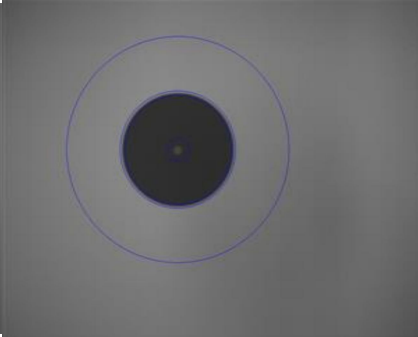
| Zone Name | Diameter | | Result | Defects | | Scratches | |
|---|---|---|---|---|---|---|---|
| Zone A | 0 | 25 | PASS | 0 | 0 | PASS | 0 |
| Zone B | 25 | 120 | PASS | 0 | 0 | PASS | 0 |
| Zone C | 120 | 130 | PASS | 0 | 0 | PASS | 0 |
| Zone D | 130 | 250 | PASS | 0 | 0 | PASS | 0 |
| Zone E | 250 | 1000 | PASS | 0 | 0 | PASS | 0 |
| Epoxy Gap: | PASS | Fiber Type: | Simplex | Core Size: | 9 | | |

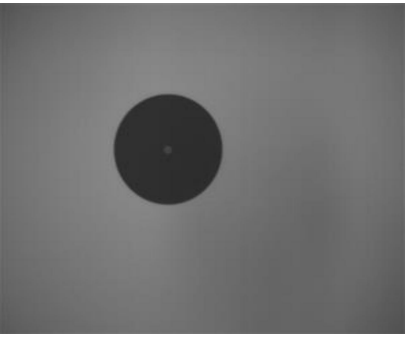
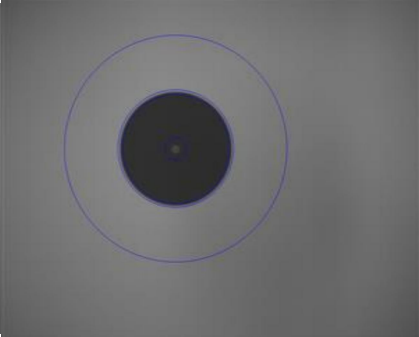
File Name: S26940-192600013B

| Zone Name | Diameter | | Result | Defects | | Scratches | |
|---|---|---|---|---|---|---|---|
| Zone A | 0 | 25 | PASS | 0 | 0 | PASS | 0 |
| Zone B | 25 | 120 | PASS | 0 | 0 | PASS | 0 |
| Zone C | 120 | 130 | PASS | 0 | 0 | PASS | 0 |
| Zone D | 130 | 250 | PASS | 0 | 0 | PASS | 0 |
| Zone E | 250 | 1000 | PASS | 0 | 0 | PASS | 0 |
| Epoxy Gap: | PASS | Fiber Type: | Simplex | Core Size: | 9 | | |

**\*\*PASS\*\***
