# VISUAL INSPECTION SUMMARY REPORT

Optronics S.A. de C.V.

EQ R LINEA 2

File Name: S26940-192600019A

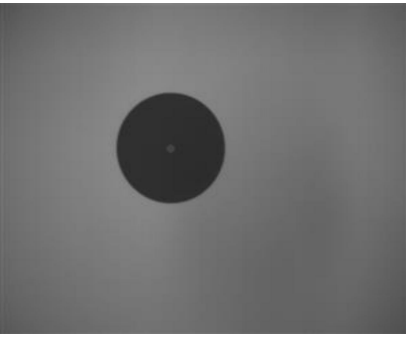
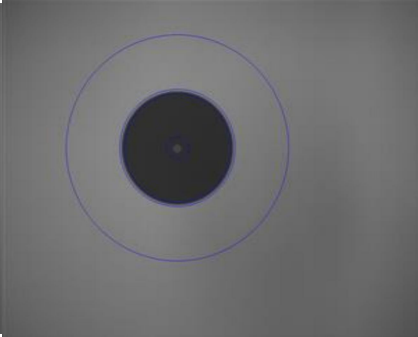
| Zone Name | Diameter | | Result | Defects | | Scratches | |
|---|---|---|---|---|---|---|---|
| LOW Magnification | | | | High Magnification | | | |

| Zone Name | Diameter | | Result | Defects | | Scratches | |
|---|---|---|---|---|---|---|---|
| Zone A | 0 | 25 | PASS | 0 | 0 | PASS | 0 |
| Zone B | 25 | 120 | PASS | 0 | 0 | PASS | 0 |
| Zone C | 120 | 130 | PASS | 0 | 0 | PASS | 0 |
| Zone D | 130 | 250 | PASS | 0 | 0 | PASS | 0 |
| Zone E | 250 | 1000 | PASS | 0 | 0 | PASS | 0 |
| Epoxy Gap: | PASS | Fiber Type: | Simplex | Core Size: | 9 | | |

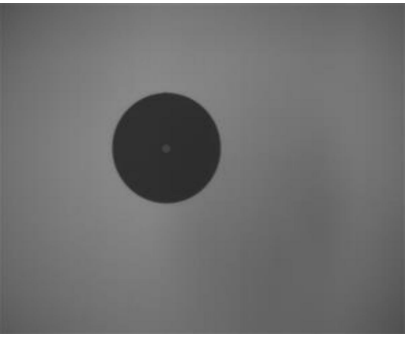
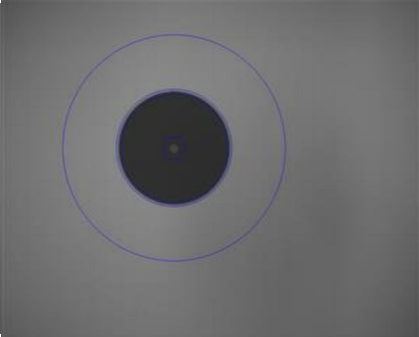
| Zone Name | Diameter | | Result | Defects | | Scratches | |
|---|---|---|---|---|---|---|---|
| LOW Magnification | | | | High Magnification | | | |

| Zone Name | Diameter | | Result | Defects | | Scratches | |
|---|---|---|---|---|---|---|---|
| Zone A | 0 | 25 | PASS | 0 | 0 | PASS | 0 |
| Zone B | 25 | 120 | PASS | 0 | 0 | PASS | 0 |
| Zone C | 120 | 130 | PASS | 0 | 0 | PASS | 0 |
| Zone D | 130 | 250 | PASS | 0 | 0 | PASS | 0 |
| Zone E | 250 | 1000 | PASS | 0 | 0 | PASS | 0 |
| Epoxy Gap: | PASS | Fiber Type: | Simplex | Core Size: | 9 | | |

**\*\*PASS\*\***
