# VISUAL INSPECTION SUMMARY REPORT

Optronics S.A. de C.V.

EQ R LINEA 2

File Name: S26940-192600011A

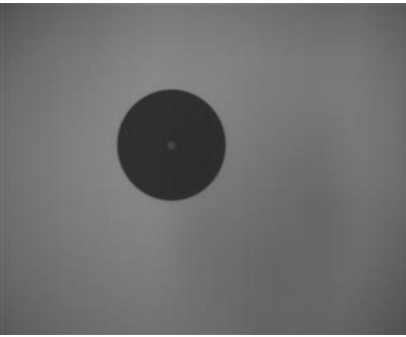
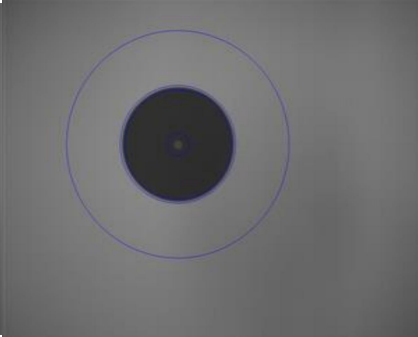
| Zone Name | Diameter | | Result | Defects | | Scratches | |
|---|---|---|---|---|---|---|---|
| Zone A | 0 | 25 | PASS | 0 | 0 | PASS | 0 |
| Zone B | 25 | 120 | PASS | 0 | 0 | PASS | 0 |
| Zone C | 120 | 130 | PASS | 0 | 0 | PASS | 0 |
| Zone D | 130 | 250 | PASS | 0 | 0 | PASS | 0 |
| Zone E | 250 | 1000 | PASS | 0 | 0 | PASS | 0 |
| Epoxy Gap: | PASS | Fiber Type: | Simplex | Core Size: | 9 | | |

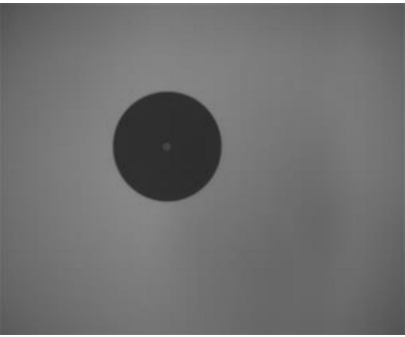
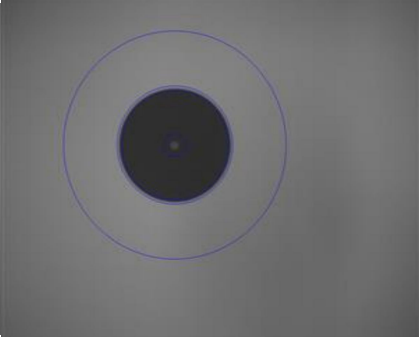
File Name: S26940-192600011B

| Zone Name | Diameter | | Result | Defects | | Scratches | |
|---|---|---|---|---|---|---|---|
| Zone A | 0 | 25 | PASS | 0 | 0 | PASS | 0 |
| Zone B | 25 | 120 | PASS | 0 | 0 | PASS | 0 |
| Zone C | 120 | 130 | PASS | 0 | 0 | PASS | 0 |
| Zone D | 130 | 250 | PASS | 0 | 0 | PASS | 0 |
| Zone E | 250 | 1000 | PASS | 0 | 0 | PASS | 0 |
| Epoxy Gap: | PASS | Fiber Type: | Simplex | Core Size: | 9 | | |

**\*\*PASS\*\***
