FIELD SERVICE REPORT

BONGKOT SOUTH

HOTGAS PATH INSPECTION

Aero Gas Turbine - Aero Gas Turbine

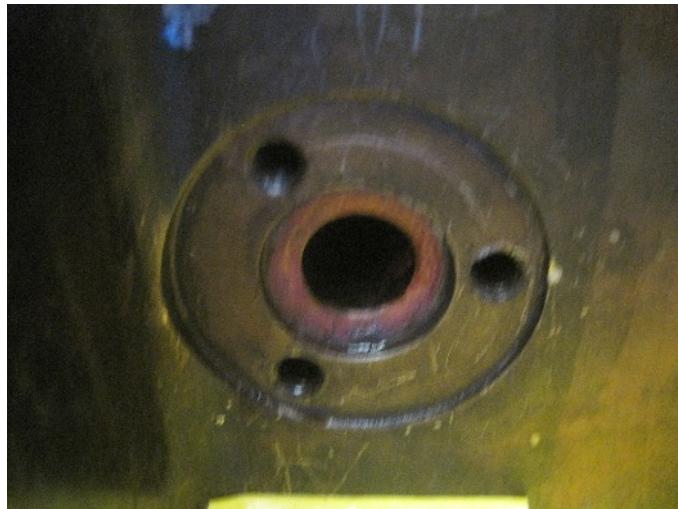
M port cover and Plug not installed. To install M port cover and plug at site.

M Port Plug and Cover to install

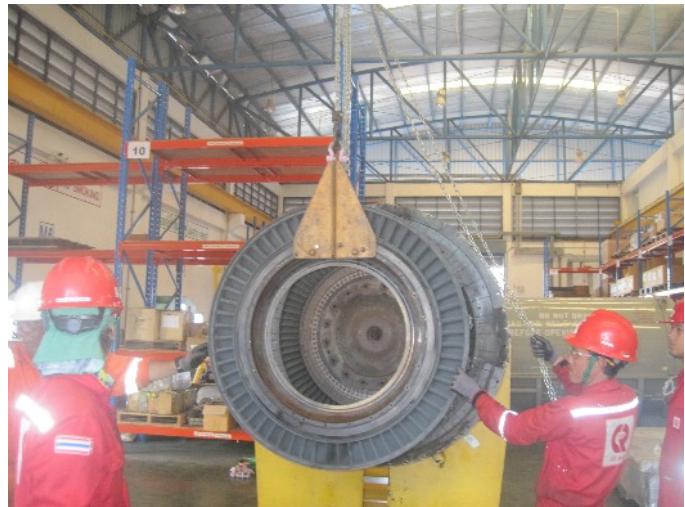
- Arrived at PTT Workshop Songhkla
- Kick off meeting with PTTEP Engineer
- Material Inspection and special tools available at site
- PT Container removed and transfer onto maintenance trolley
- Removal of Stage 1 Nozzle completed. Broken bolt was found at bonding baffle area, repair required to remove the broken bolt.
- Clearance check carried out as per SOM22777 on 2nd Stage Casing

Stage 1 Nozzle removal

- Dye Penetrant Test on Stage 1 Casing completed and found satisfactory.
- Dye Penetrant Test on Stage 2 Casing completed and found satisfactory.
- Dye Penetrant Test on old Stage 1 Bucket completed and found satisfactory.
- Repair on broken bolts on Stage 1 Nozzle and Stage 1 Casing completed
- Installation of new Stage 2 Bucket completed, dye penetrant test carried out on the twist lock and found satisfactory.
- Installation of old Stage 1 Bucket completed, dye penetrant test carried out on the twist lock and found satisfactory.

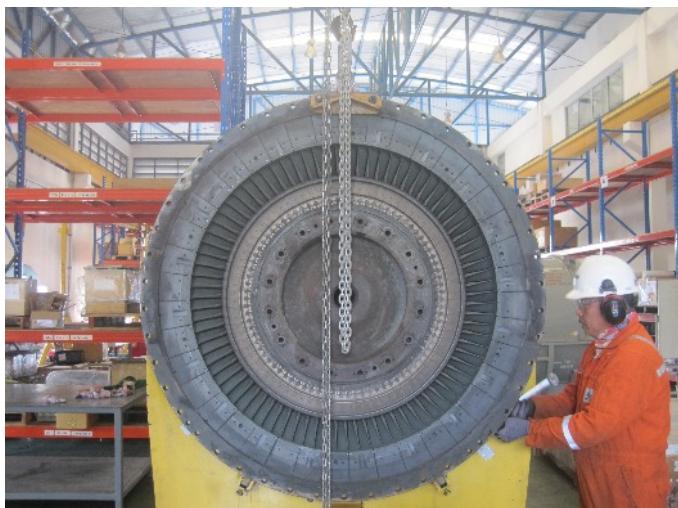
- Removal of Stage 1 Casing completed. Broken bolts was observed at M port cover.
- Removal of Stage 2 Nozzle completed and no abnormalities was observed
- Removal of Stage 2 Casing completed
- Removal of Stage 1 Bucket completed. Inspection carried out on main defects that can be detected on the rotor buckets are the following.
 1. Crack
 2. Dent
 3. Loss of material
 4. Corrosion

Stage 1 Casing removal

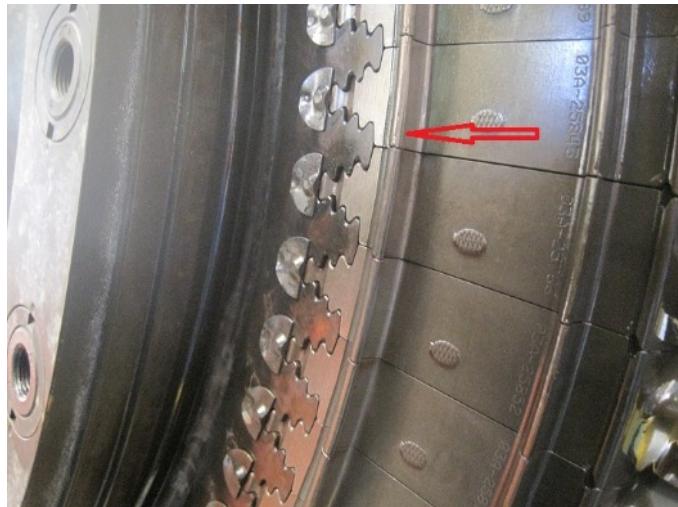
Findings: Forward Angelwings / Seal was wear and sign of rubbing.

Signed of rubbing on Stage 1 Bucket Forward Seal

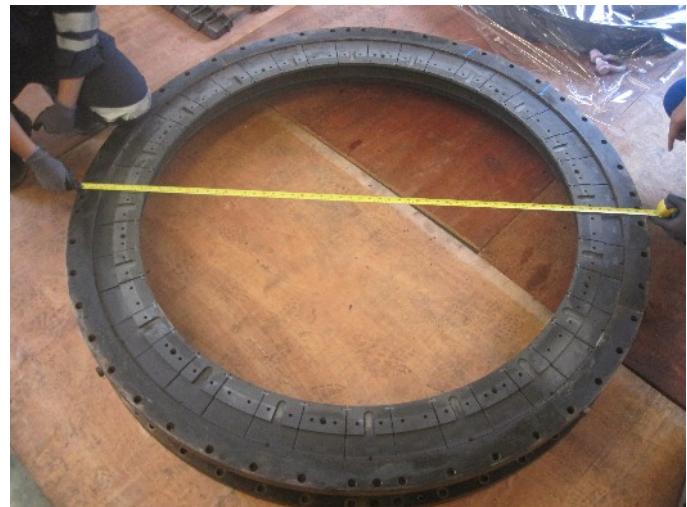
- 1st Stage Casing Dimensional check carried out and found within the tolerance.

Dimension = 1519 mm

Stage 1 Casing Dimensional Check

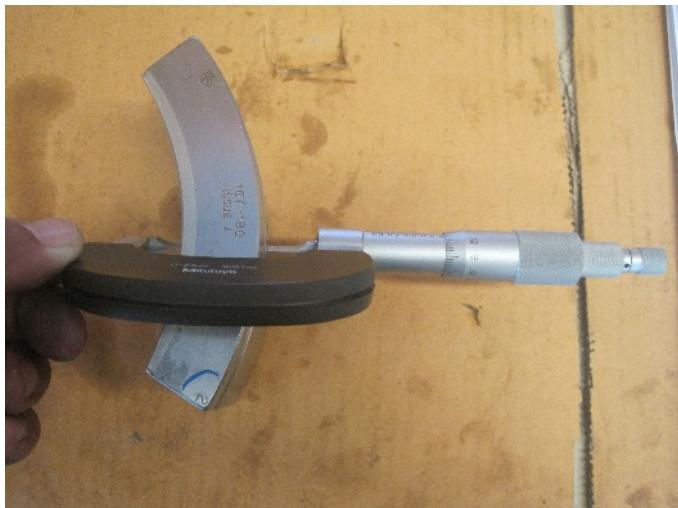
Journal Bearing Pad thickness average – 24.0 mm

- Radial clearance is 0.14 mm (limit specific 0.126/0.160 mm as per DRW SOM 22777)

#2 Journal Bearing Pad measurement

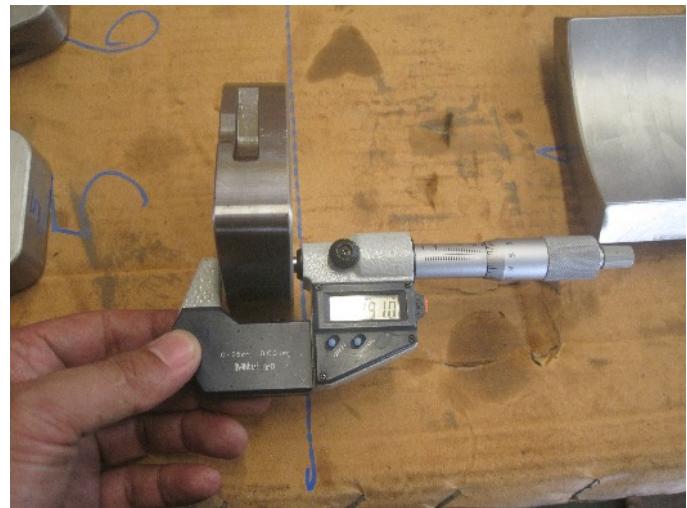
Active Thrust Bearing Pad measurement

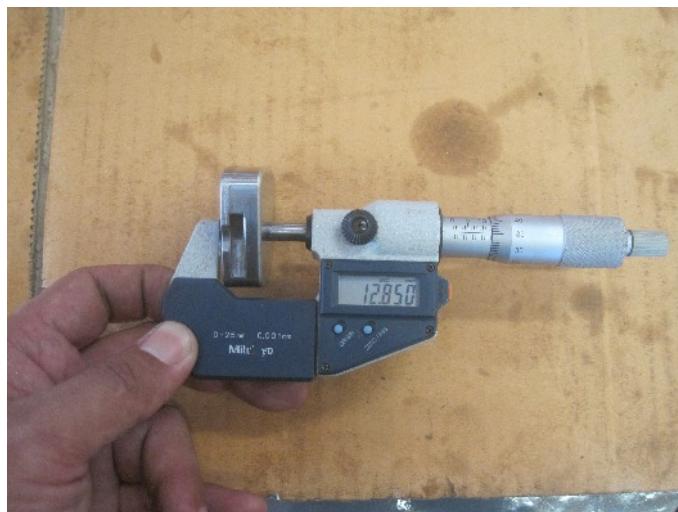
Inactive Thrust Bearing Pad measurement

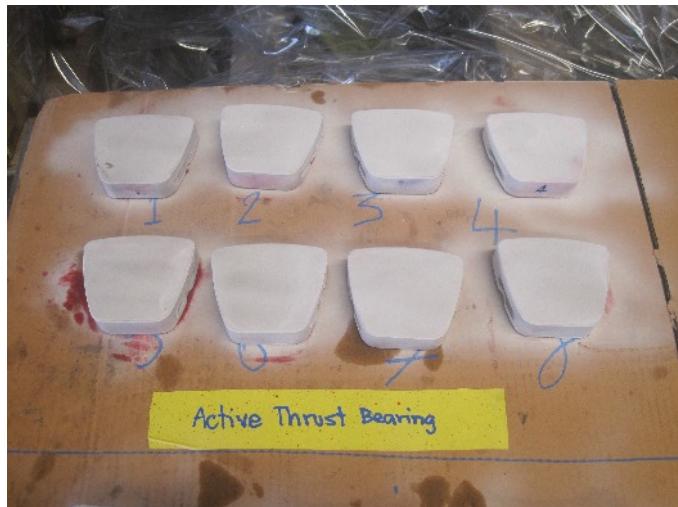
- Thrust Bearing Axial Clearance Check carried and found within the tolerance 0.66 mm
- Dye Penetrant Test and UT carried out on #2 Journal Bearing Pad and Thrust Bearing Pad and found satisfactory

Active Thrust Bearing Pad Dye Penetrant Test

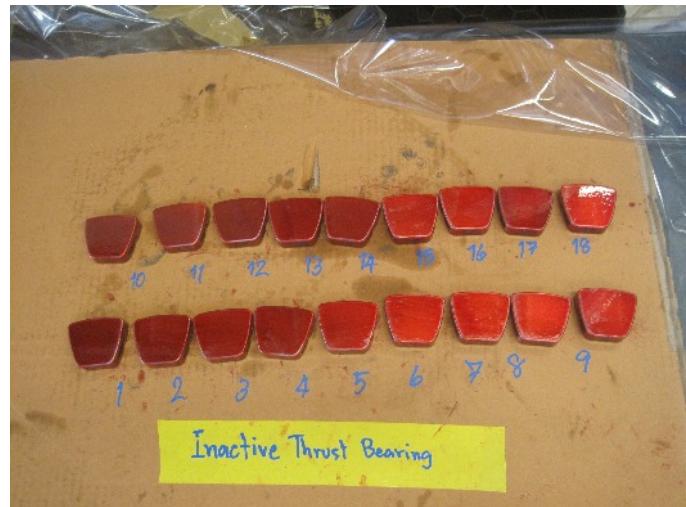
Inactive Thrust Bearing Pad Dye Penetrant Test

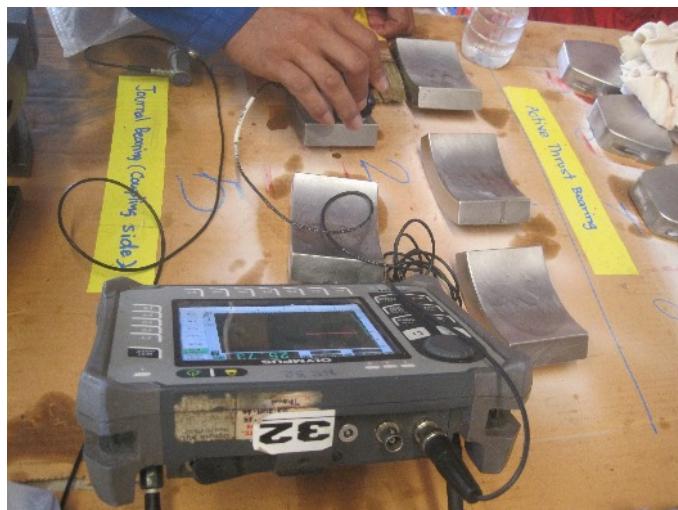
Bearing UT Test

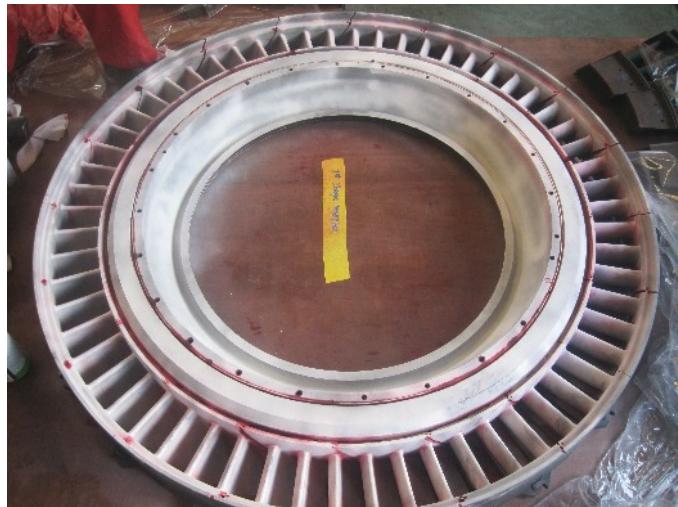
- Dye Penetrant Test on Stage 1 Nozzle completed and found satisfactory
- Dye Penetrant Test on Stage 1 and 2 Casing ongoing
- Air / Oil Seal clearance check carried out and found satisfactory.

Dye Penetrant Test on Stage 1 Nozzle

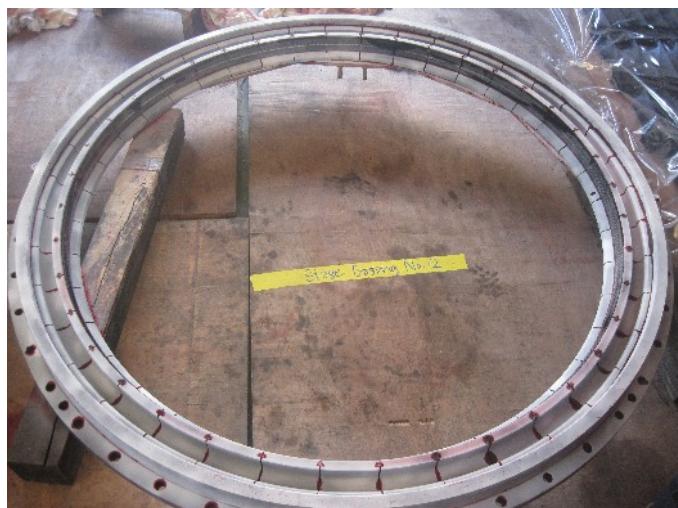
Dye Penetrant Test on Stage 2 Casing

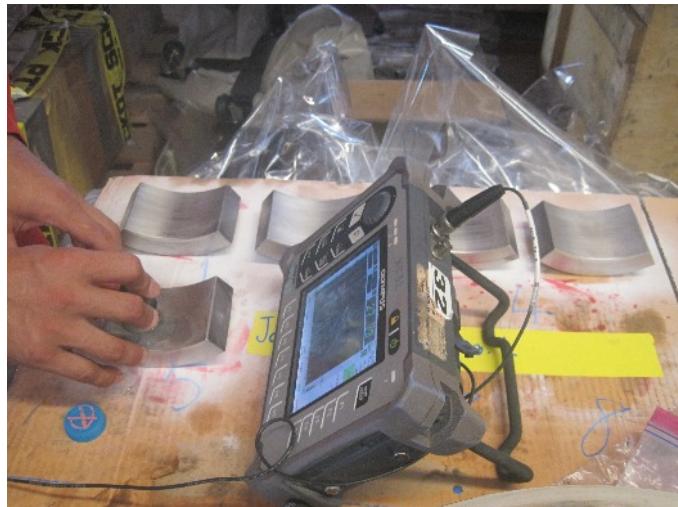
- #1 Journal bearing pad thickness measurement carried out.
Pad thickness = 24.05 mm
- Dye Penetrant Test and UT carried out on #1 Journal Bearing Pad and found satisfactory
- #1 Bearing installation completed
- Repair work on broken bolts on Stage 1 Nozzle ongoing
- Repair work on Stage 1 Casing broken bolt ongoing

UT Test on #1 Journal Bearing Pad

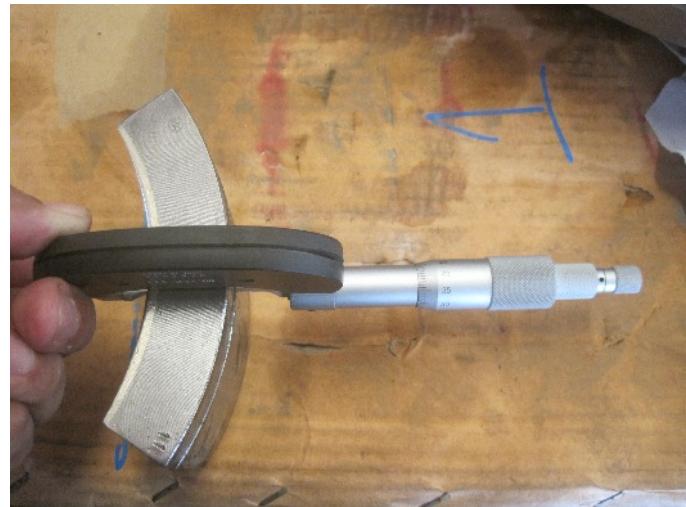
Dimensional Check on #1 Journal Bearing Pad

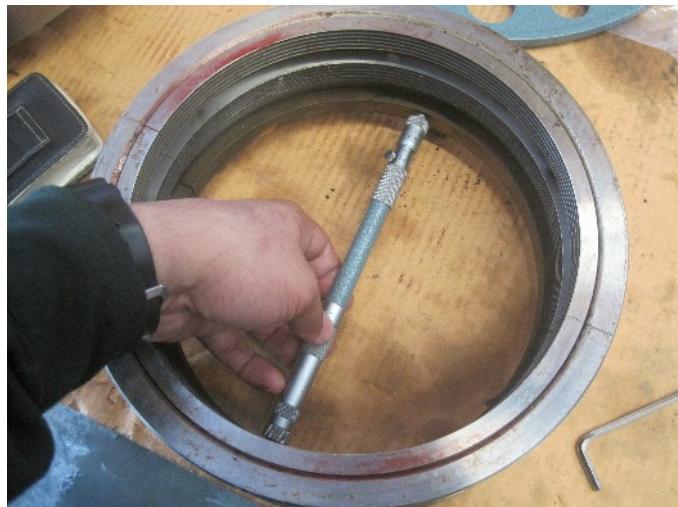
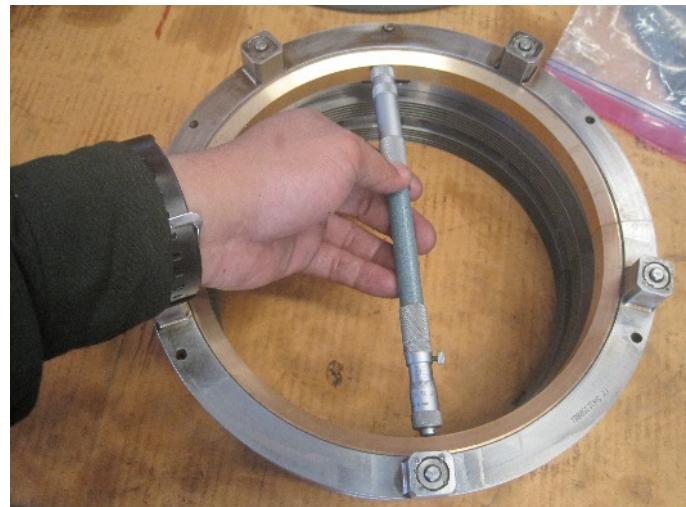
Dimension O = 221.12 – 219.95 = 1.16 / 2 = 0.58 mm

Dimension P = 220.52 – 219.75 = 0.77 / 2 = 0.38 mm

Air / Oil Seal measurement check

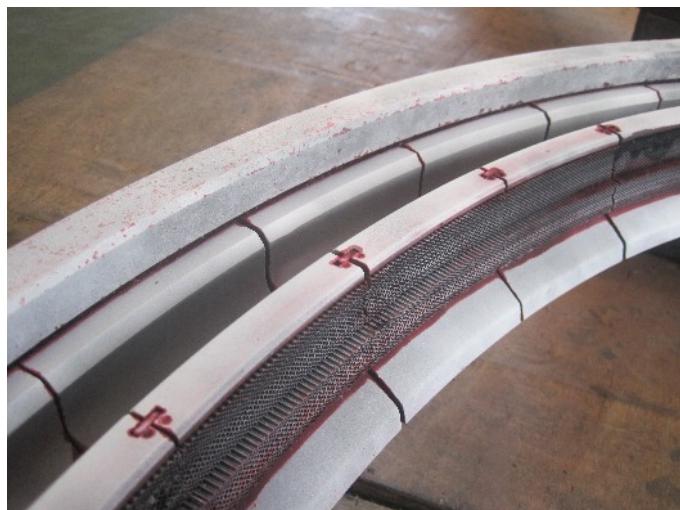
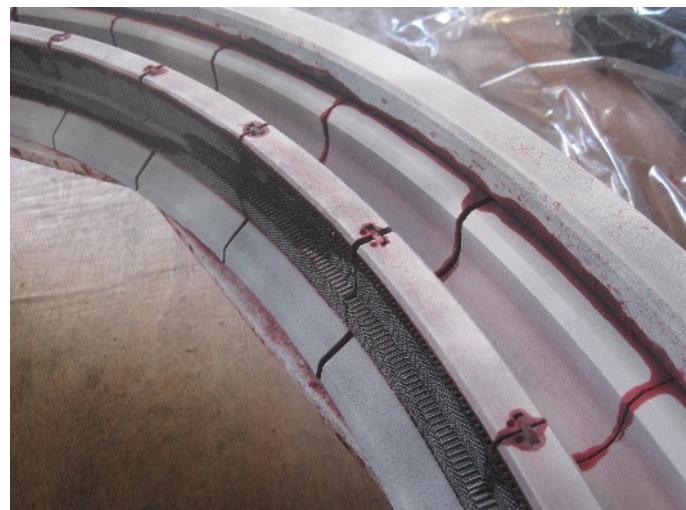
Stage 2 Casing Dye Penetrant Test

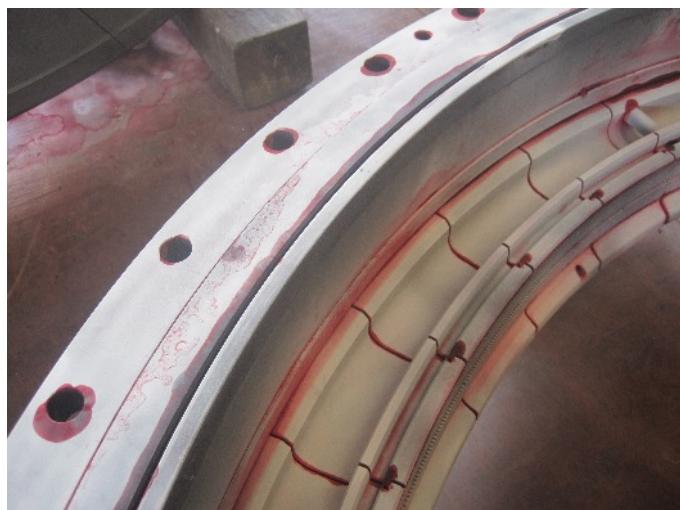
Stage 1 Casing Dye Penetrant Test

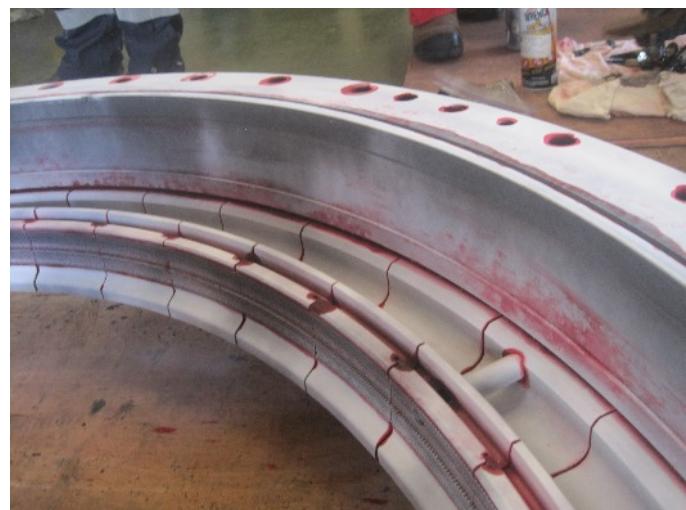
Stage 2 Casing Dye Penetrant Test

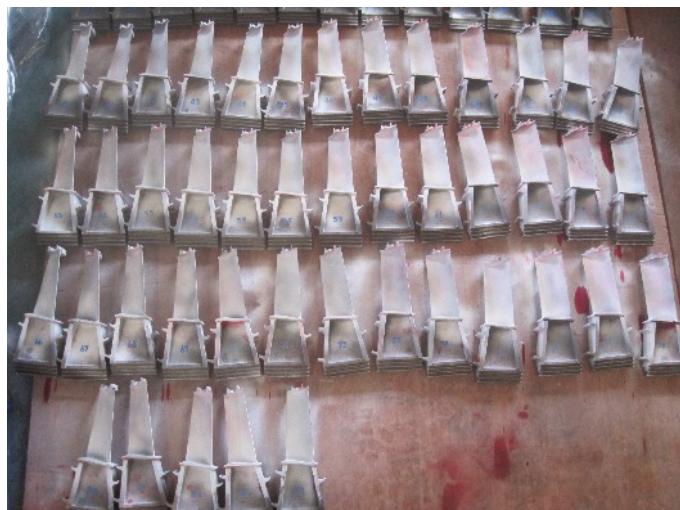
Stage 1 Bucket Dye Penetrant Test

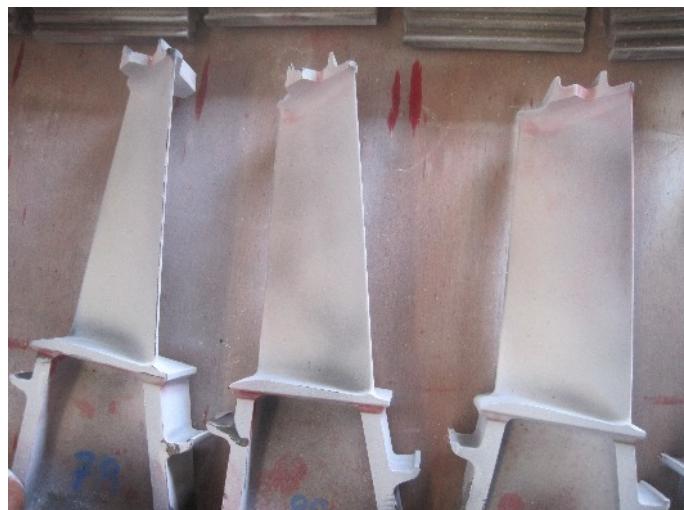
Stage 1 Bucket Dye Penetrant Test

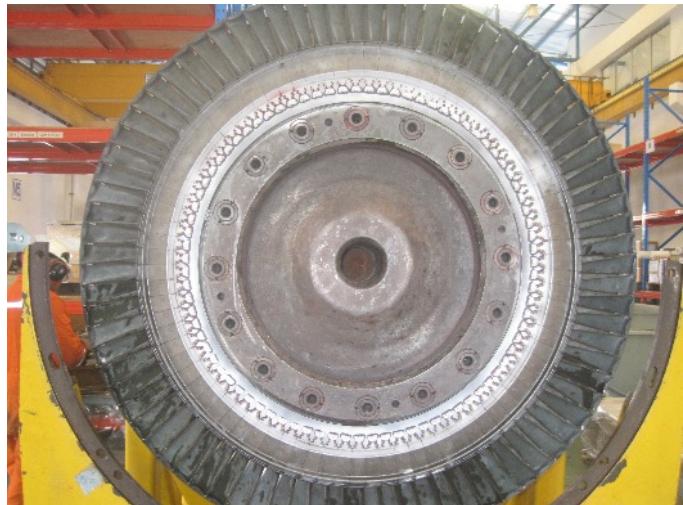
Old Stage 1 Bucket reinstalled

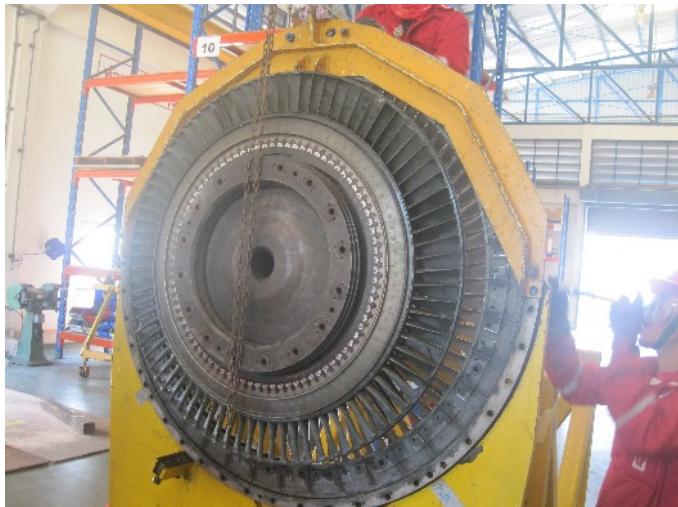
- Installation of Stage 2 Casing completed
- Installation of New Stage 2 Nozzle completed
- Clearance check carried out between Stage 2 Bucket and Stage 2 CasingShroud and found satisfactory

Stage 2 Casing installation

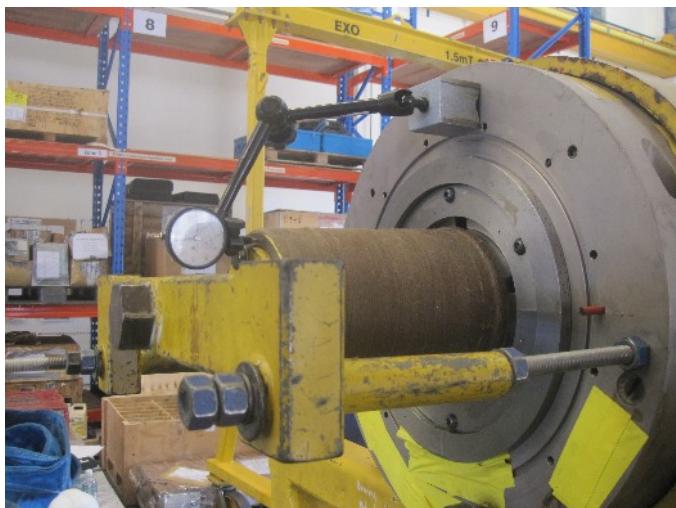
- Stage 1 Nozzle installation completed.
- Rotor Axial clearance check completed and found within the limit. Rotor position was set on center.

Dimension S = 0.60 mm

Rotor Axial Clearance Check

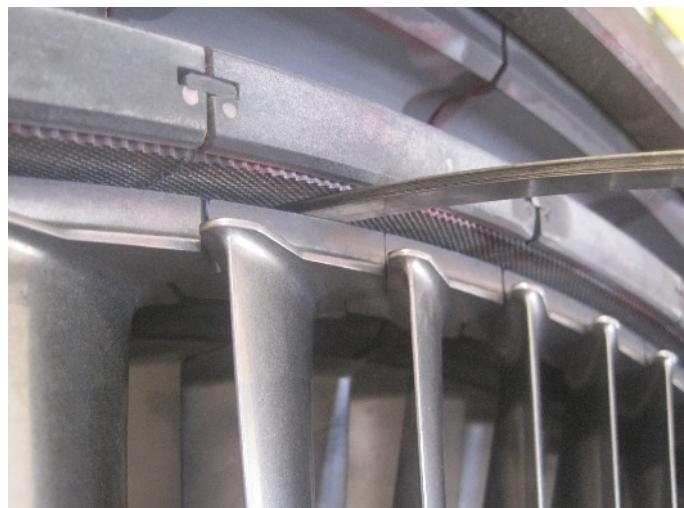
Clearance check
