GREATER BONGKOT SOUTH AUTONOMOUS SYSTEM

Greater Bongkot South Autonomous Initiation

- 2X-5210 Electro chlorination was selected to be implemented autonomous maintenance.
- This unit function is to generate hypochlorite from seawater. The hypochlorite is used for marine growth and bio fouling prevention in piping. Otherwise, line will be blocked.
- Hypochlorite is supplied to important unit such as fire water ring main, service water pump and fire water pump. Therefore, continuous injection of hypochlorite is very critical for plant.

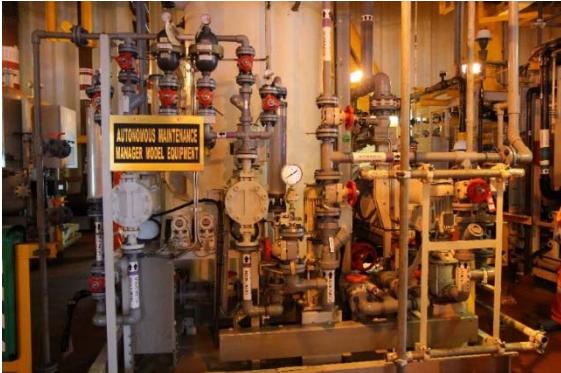
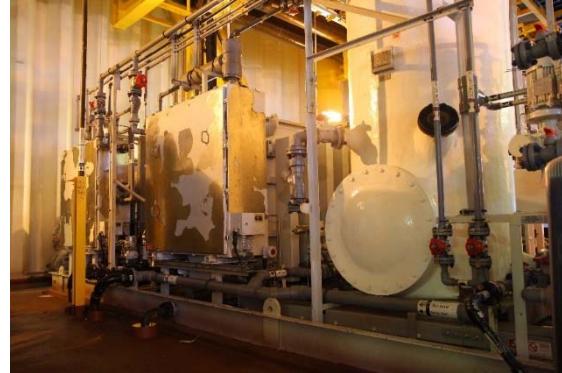
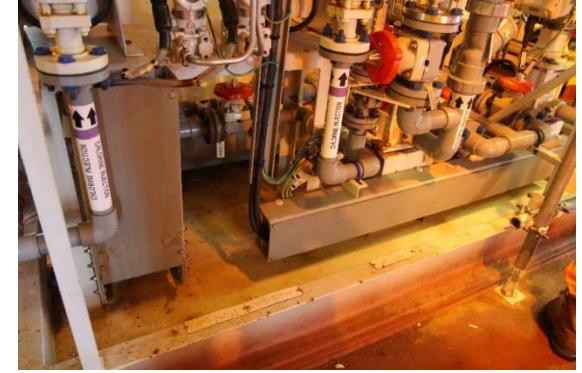
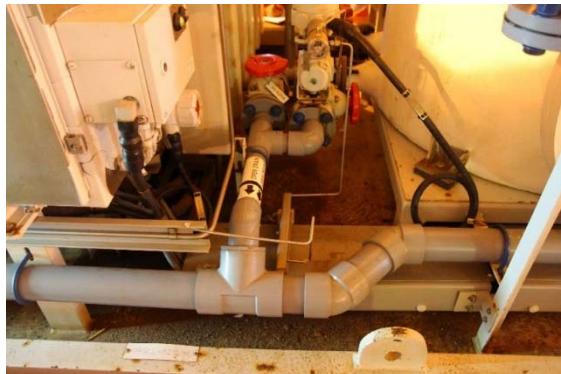
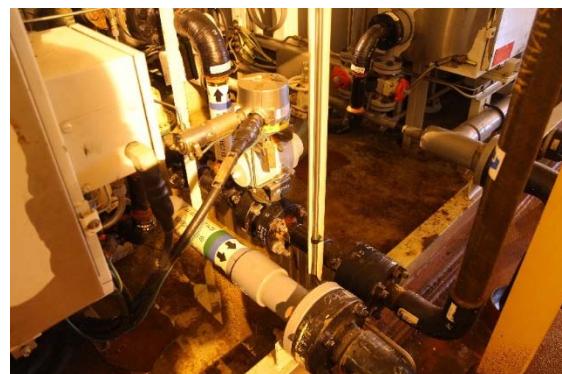
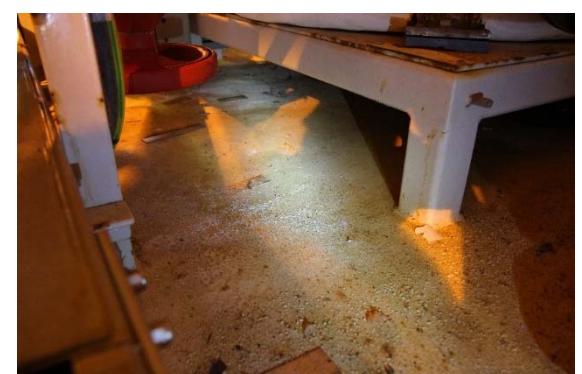
Before Cleaning

- Cumulative finding is 37 tags as Feb'2016.
- Example of finding
 - 2X-5210, Found cable tray damaged
 - 2LG-52157 cannot reading.
 - 2LG-52157 plug at drain line missing.
 - 2HV-52154B's body is rusty.
 - Many equipment is dirty and rusty.
 - etc.

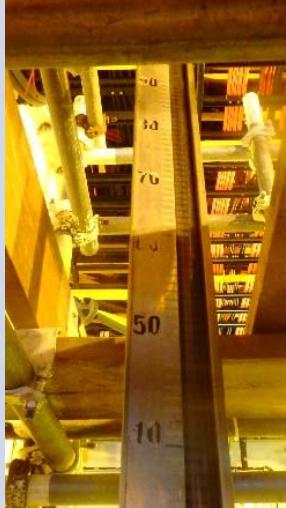
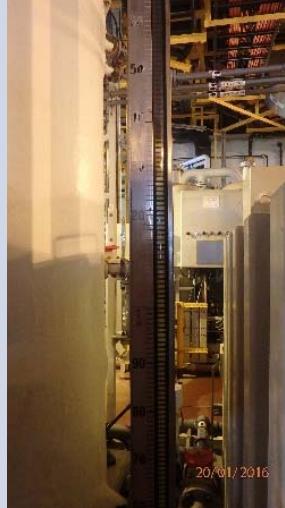
Cannot Reading	Clean float

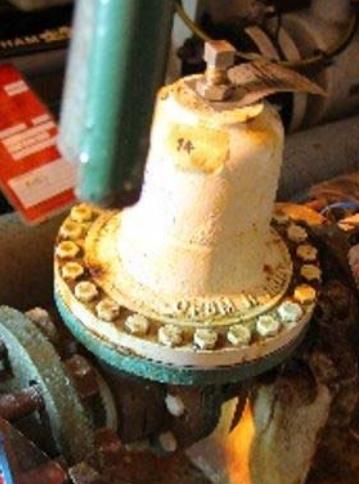
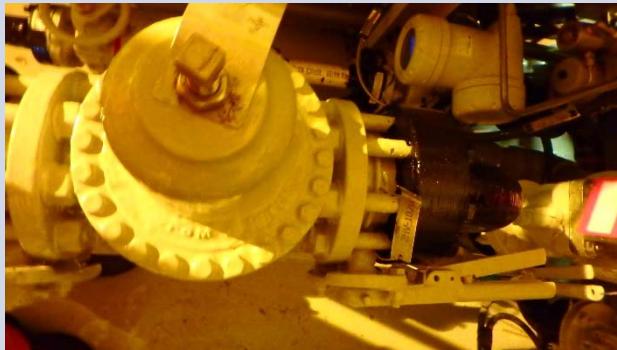
Rusty Valve Body

Remove scale and repair painting

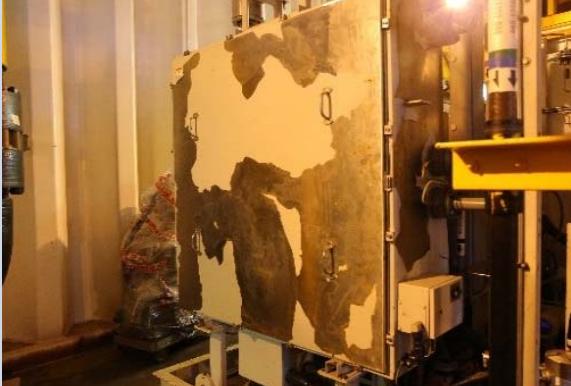
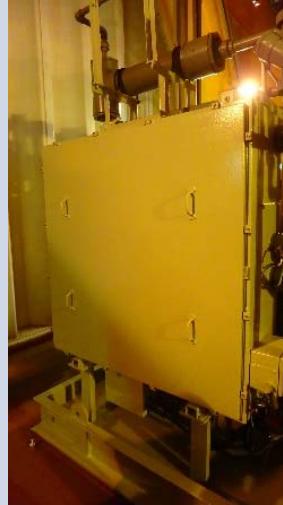
Painting damaged	Repair painting

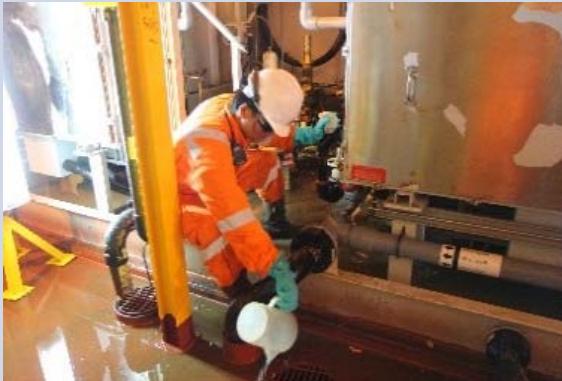
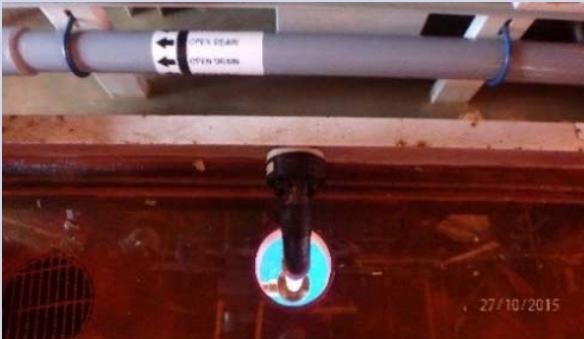
Drain line was plug.	Flushing by HP-Hose

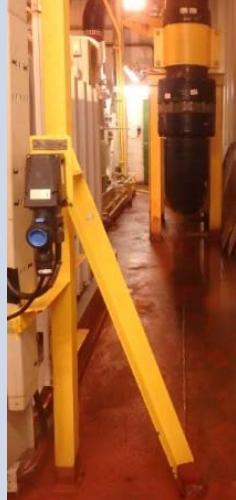
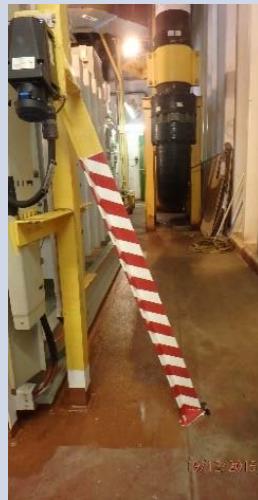
Obstruct walk way	Painting caution sign

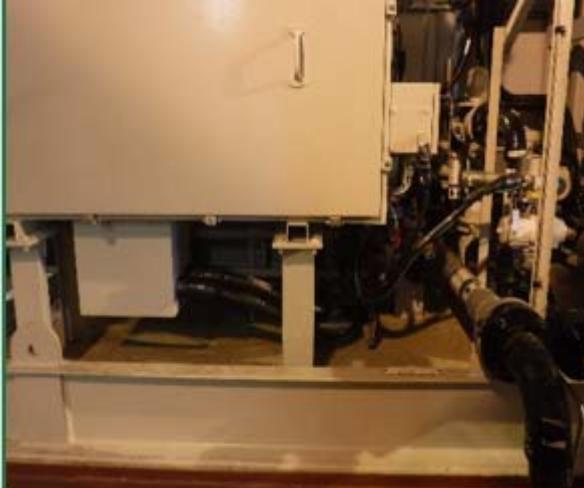
2X-5210, drip pan skid water flooding

Modify to install drain line

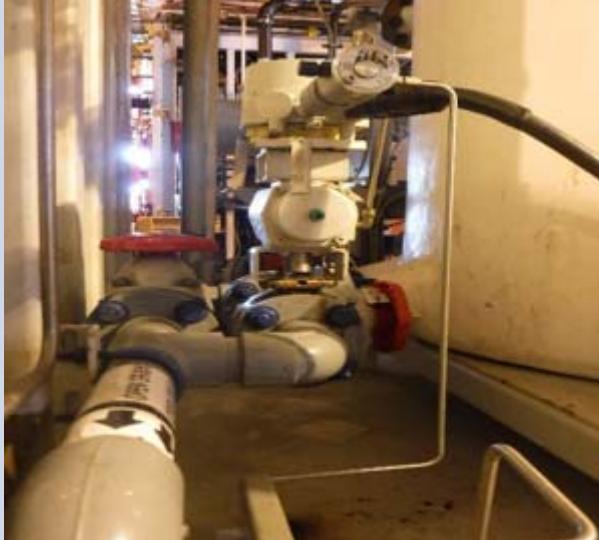
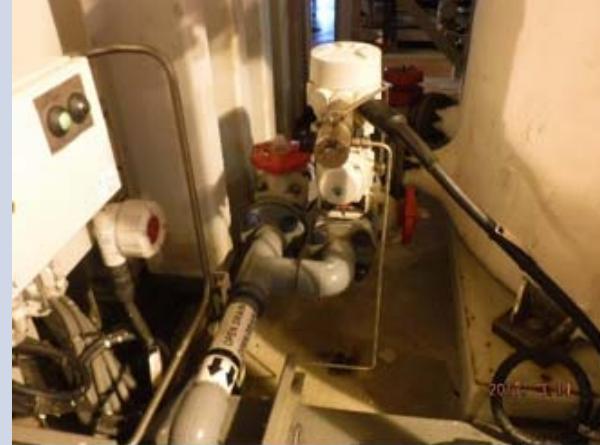
HV-52155 water leak at stem valve

Repaired to eliminate leak point

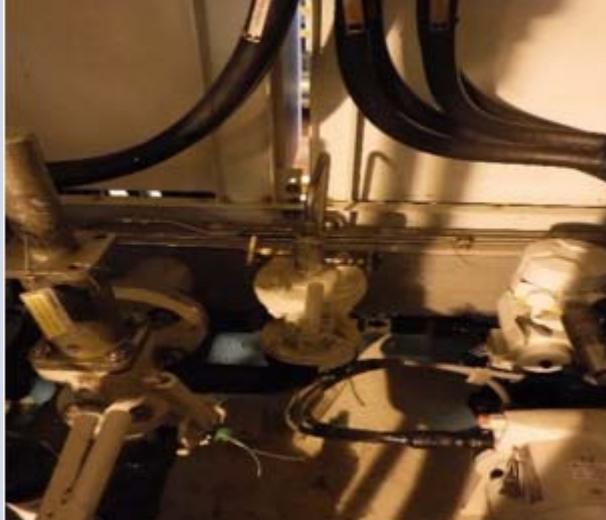
Water leaked at union tubing	Tightening union to stop leak

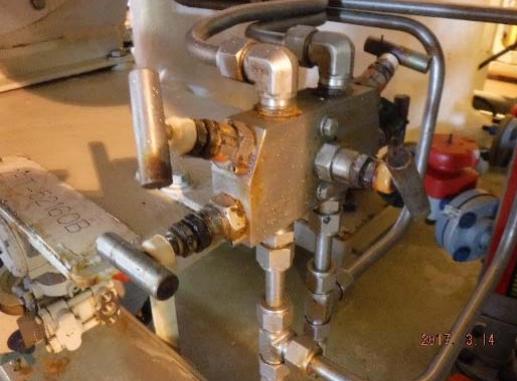
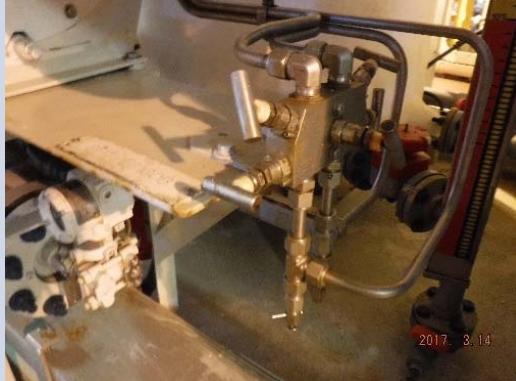
5 way of 2FIT-52160A was rusty	Cleaning

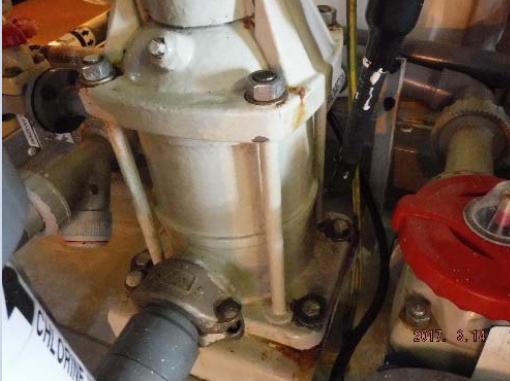
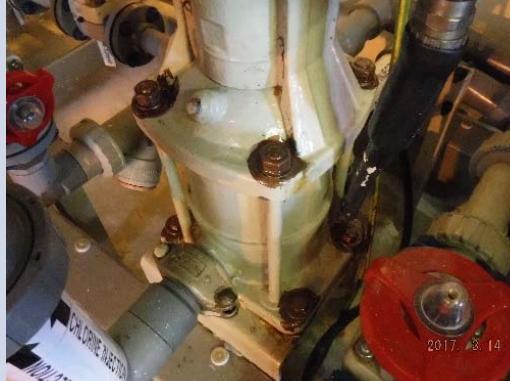
Support pump (2P-5210A) was rusty	Cleaning

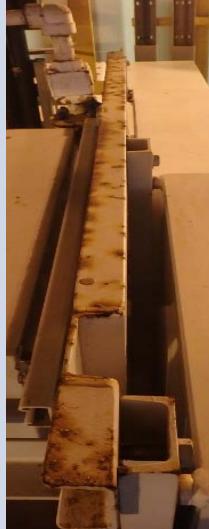
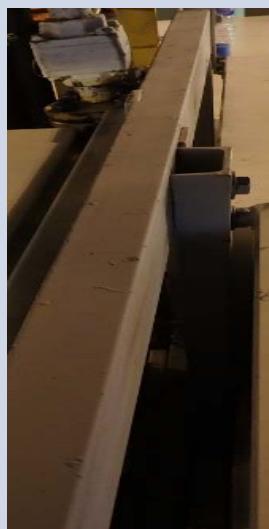
Structure above HMI was rusty	Cleaning and Repair painting

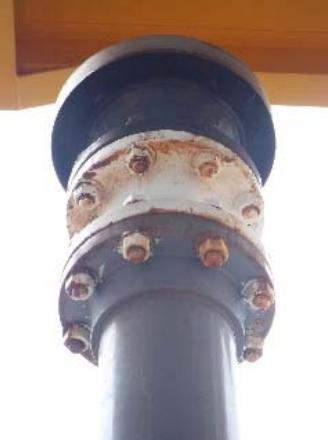
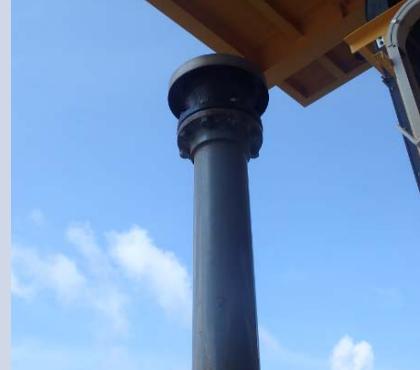
Found dirty at line 2FA-5251 cause had liquids blow out from flame arrester

Remove extension spool (CS) to prevent rusty

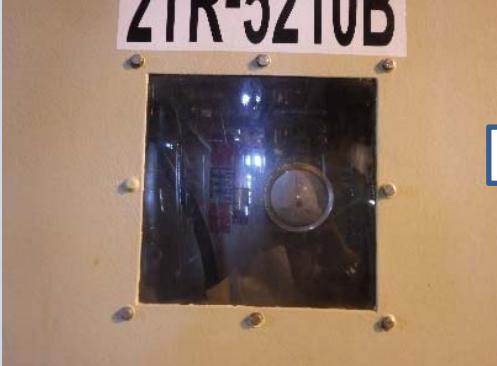
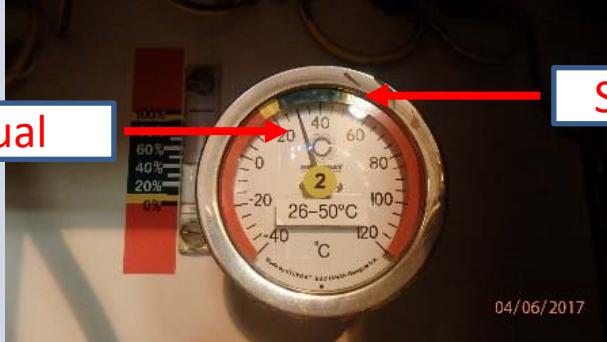
<p>Actual</p> <p>Set point</p> <p>Temp Gauge</p>
Require tag operation at temp gauge of 2TR-5210B.	Installed tag
