COLD BOX FOULING: NOV-15.

CONTENT OF PRESENTATION

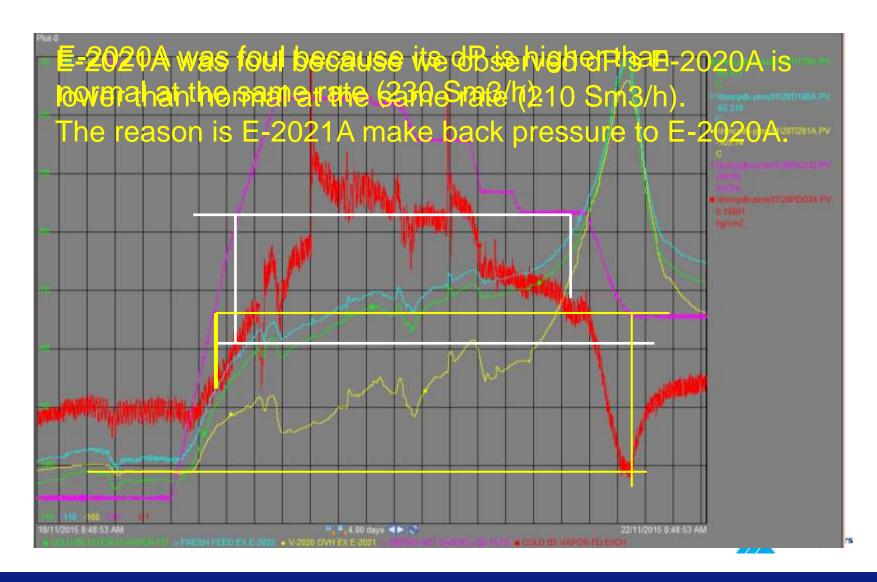
Cold box diagram

First fouling at E-2020A (vapor feed line)

Then move to fouling at E-2021A

E-2021A to V-2021(Behind V-2022)

No	Possible root cause	Information	Likelihood
1	Free water from pipe line of RED bed "C" (Dead pocket)	 Fouling in Cold box is occurred at E-2020A and E-2021A, Their upstream line is from vapor feed stream(Reactor and RED side). Fouling occurred after RED Bed"C" put on service. Operator observe free water come out from low point drain at RED"C". Main pipeline of RED"C" was define to be dead pocket because "No flow pass through" during reactor dry out. 	Most possible

GAP	Corrective Action	Ву	When	
Free water from RED (Dead pocket) cause fouling in cold box	Push more dry feed to cold box to remove the residual foulant.	Operation	22-30 Nov 2015	
Toding in cold box	Drain Low point drain of all RED bed to flare before put in service.	Operation	Daily basis	
GAP	Preventive Action	Ву	When	
Free water from RED (Dead pocket zone) cause fouling in cold box	1. Created WI to recognize operator to flushing and drain dead pocket line of RED after turnaround.	Nitikom	30 Nov 2015	
	2. Feasibility study to add drain line and bypass line of RED piping system.	Nitikom/Engin eering	Feb-2016	
	3. Feasibility study to add methanol injection unit to both vapor and combine feeds.	Nitikom/Engin eering	Feb-2016
