SUMMARY REPORT
ARTHIT PLATFORM
2014 ART Shutdown Valve Repair and Replacement

SUBJECT: Fix leak P-4635 (Sea Water Lift Pump)

REPORT NO: 20141217-ART-MAINT-00074

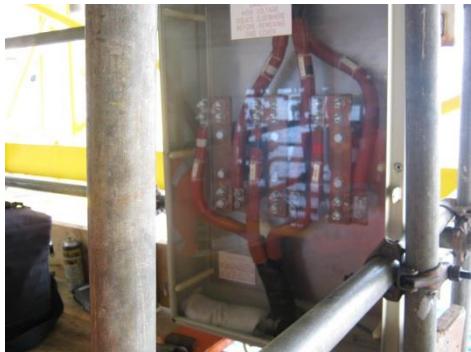
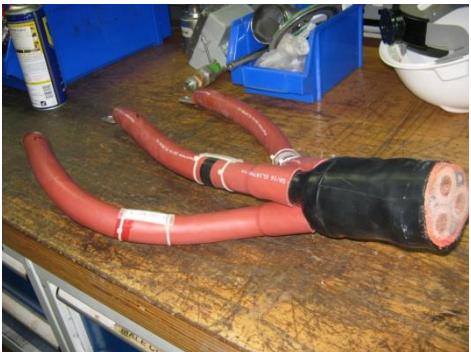
Date	Activities	Status
18-Sep-14	<u>Task</u> ➢ Disconnect power cable <i>Found that cable cannot removed, need to cut the cable</i> ➢ Perform mechanical isolation +remove elbow <i>The internal surface of elbow is still in good condition</i> <div style="display: flex; justify-content: space-around; margin-top: 10px;">

Fig.1-4: Disconnect power cable

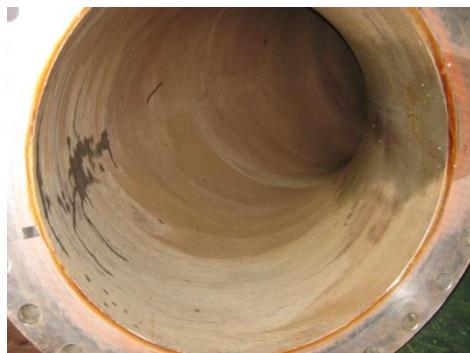
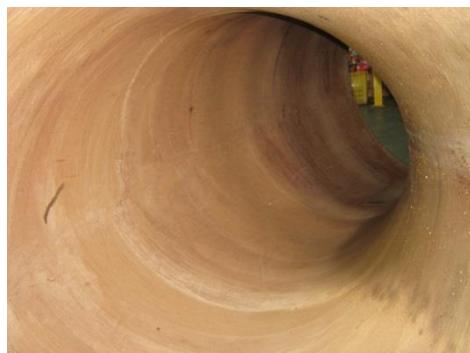
Fig.9-10: The condition for internal surface of elbow

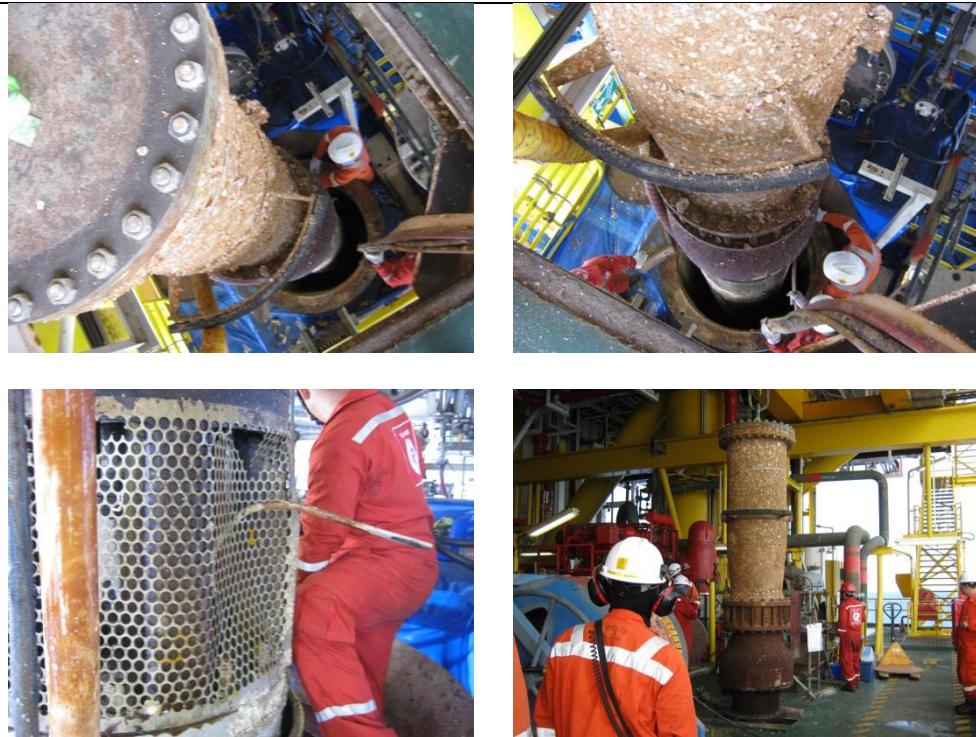
Fig.1-4: Remove compacted set of short piece, check valve and pump

<u>Task</u>	<u>Status</u>
20-Sep-14	<ul style="list-style-type: none">- Remove pump package<ul style="list-style-type: none">➤ Remove compacted set of short piece, check valve and pump➤ Dismantle compacted set of short piece, check valve and pump<ul style="list-style-type: none">• Short piece: in good condition• Check valve: spring broken, need to replace by repair kit• Pump: in good condition➤ Remove motor and laydown motor with motor support	Completed Completed Completed

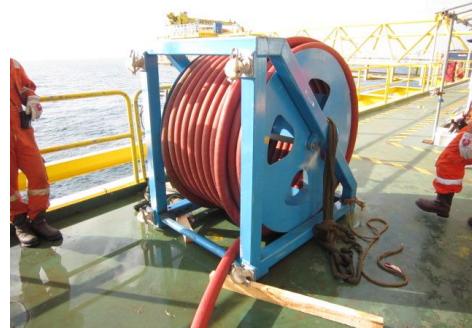
09-Dec-14	<u>Task</u>	<u>Status</u>
	<ul style="list-style-type: none">- Transfer new pump and motor to working area Found that power cable was incorrectly installed at the roller, need to be re-installed	In Progress

Fig.1-2: Wrong power cable installation at the roller

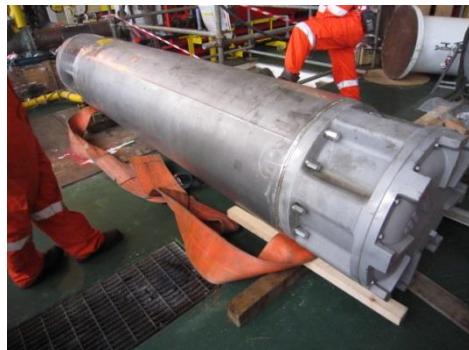
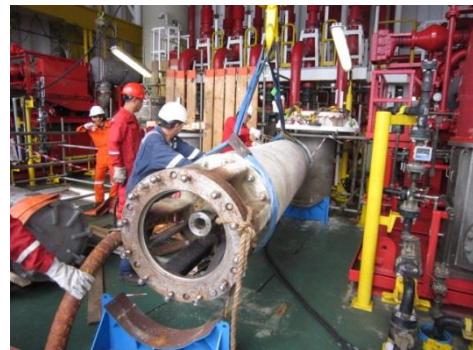
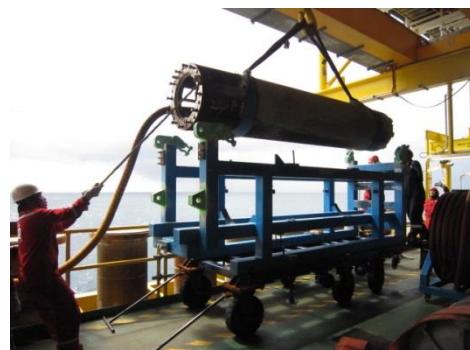
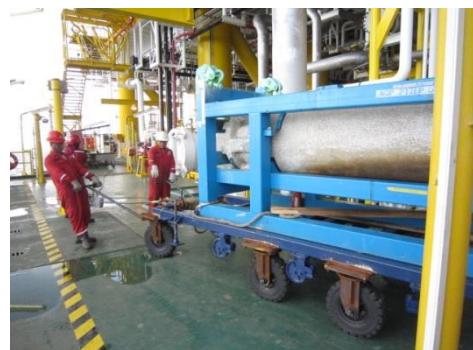
Fig.1-4: Move new motor to working area and old motor to temporary laydown area

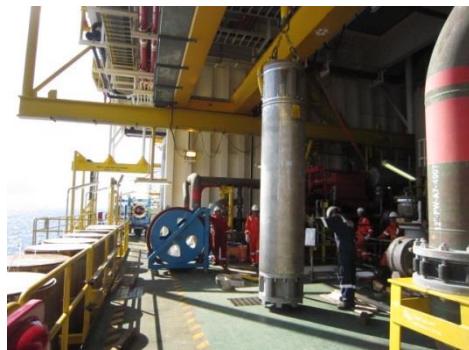
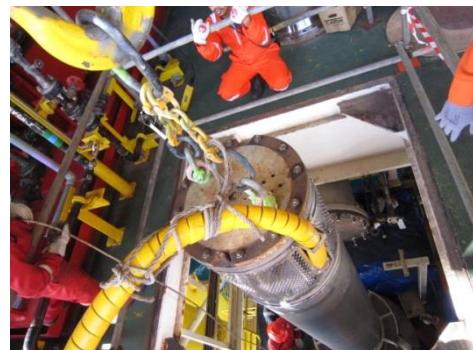
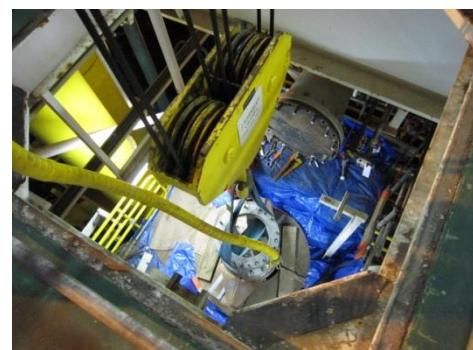
Fig.5-7: Install motor at caisson preparing for performing motor pressure test

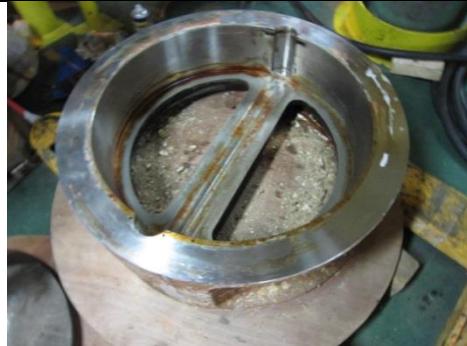
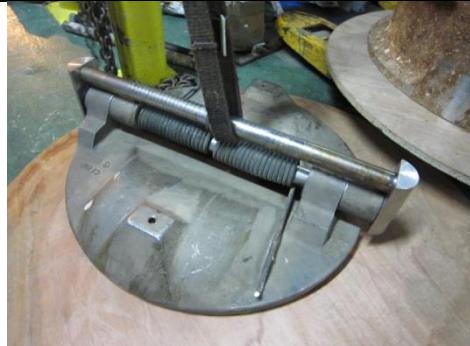
Fig.8-9: Overhaul discharge check valve

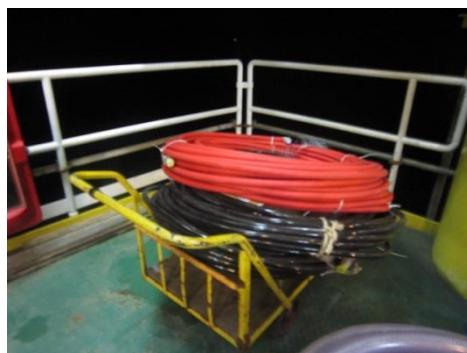
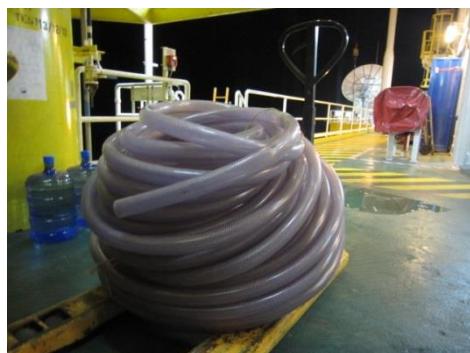
Fig.10-11: motor hoses arrived at ART

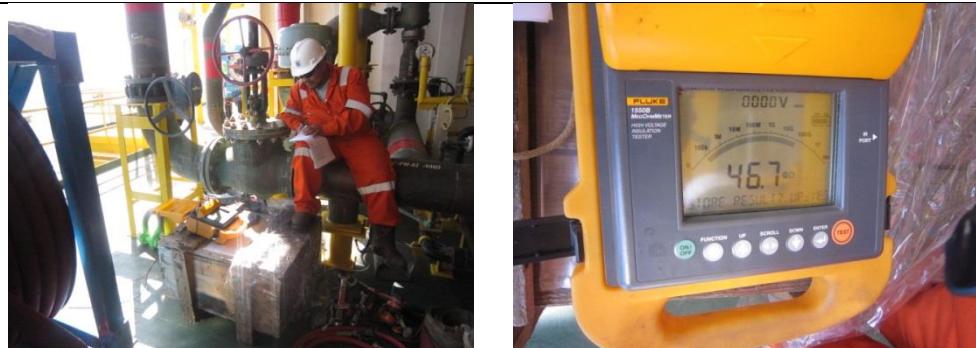
11-Dec-14	<u>Task</u>	<u>Status</u>
	<ul style="list-style-type: none"> - Perform motor pressure test/ megger test <ul style="list-style-type: none"> ➢ Perform insulation check at all phases with dry condition → Acceptable ➢ Perform megger test at U phase with wet condition → Acceptable ➢ Perform megger test at V phase under pressure 30 psig → Acceptable ➢ Perform megger test at V phase under pressure 65 psig → Acceptable - Check motor bearing torque inspection <ul style="list-style-type: none"> ➢ At holding pressure 65psig → The bearing torque is 407 N·m (Acceptable) - Install pump package 	Completed Completed In Progress

Fig.1-4: Perform motor pressure test/ megger test

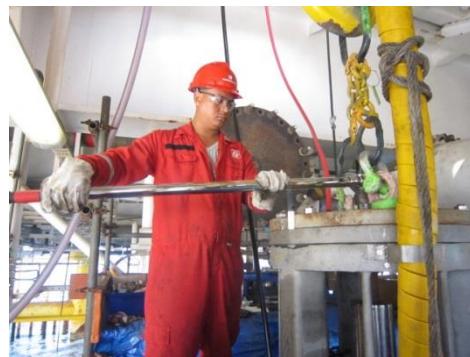
Fig.5-7: Check motor shaft torque under pressure at 65 psig

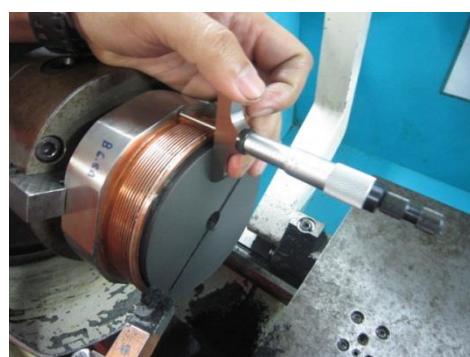
Fig.1: machine thrust nut at mechanic workshop to adjust axial displacement

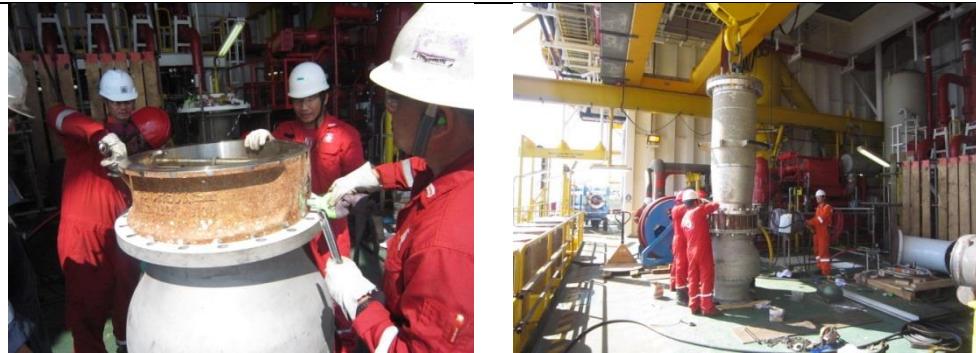
Fig.2-3: Install compacted set of short piece, check valve and pump

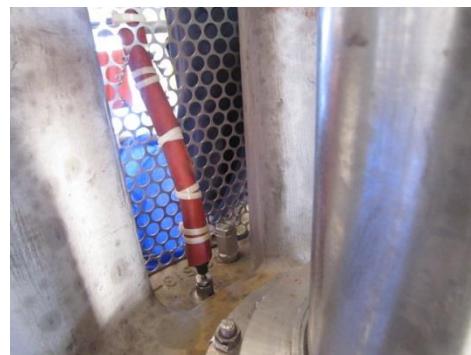
Fig.4: Install RTD cable

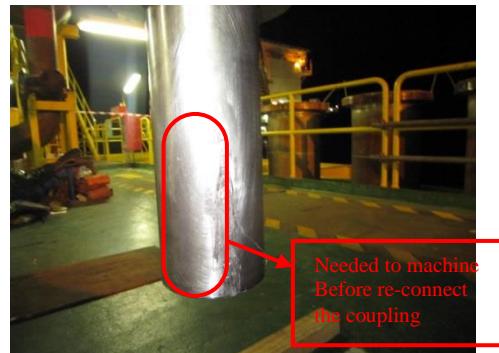
12-Dec-14	<u>Task</u>	<u>Status</u>
	<ul style="list-style-type: none">- Install pump package<ul style="list-style-type: none">➢ Check and adjust pump axial displacement → Acceptable➢ Install compacted set of short piece, check valve and pump➢ Install RTD cable➢ Connect pump and motor<ul style="list-style-type: none">• Found the pump shaft stuck inside the motor coupling After we removed the pump shaft, found the shaft was rubbed	In Progress

Fig.5: The rubbing at pump shaft

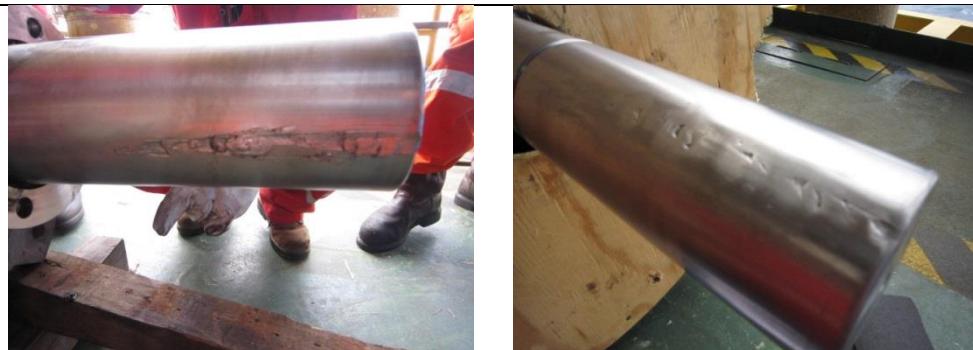
Fig.1-2: Shaft condition before machining (Left)
Shaft condition after machining (Right)

13-Dec-14	Task	Status
	<ul style="list-style-type: none"> - Install pump package <ul style="list-style-type: none"> ➢ Machine pump shaft → Completed ➢ Re-check dimension of pump shaft, shaft key, motor coupling → Completed ➢ Re-perform pressure test at 65 psig → Completed ➢ Re-connect coupling between pump and motor → Completed ➢ Re-check axial displacement → Acceptable ➢ Install check valve and short piece → Completed 	In-Progress

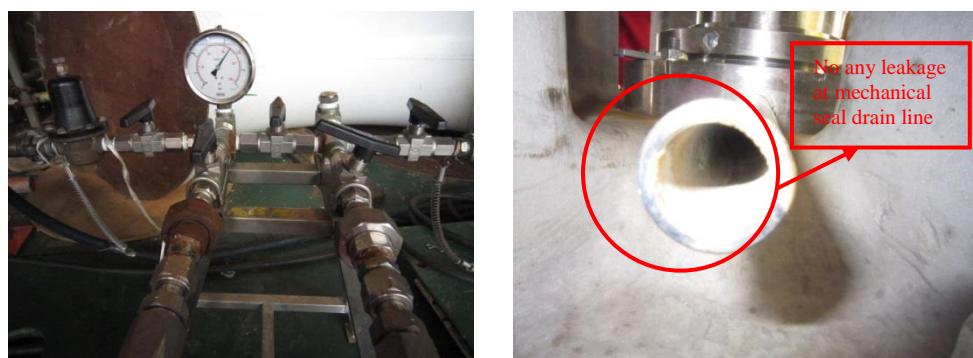
Fig.3-4: Re-perform pressure test at 65 psig

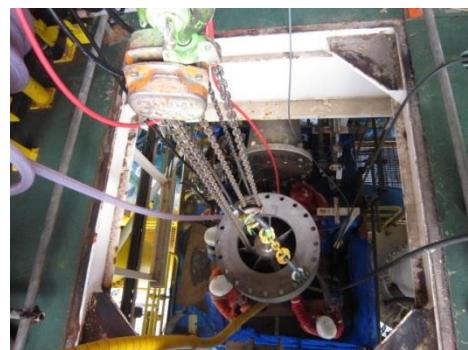
Fig.5: RE-connect coupling between pump and motor

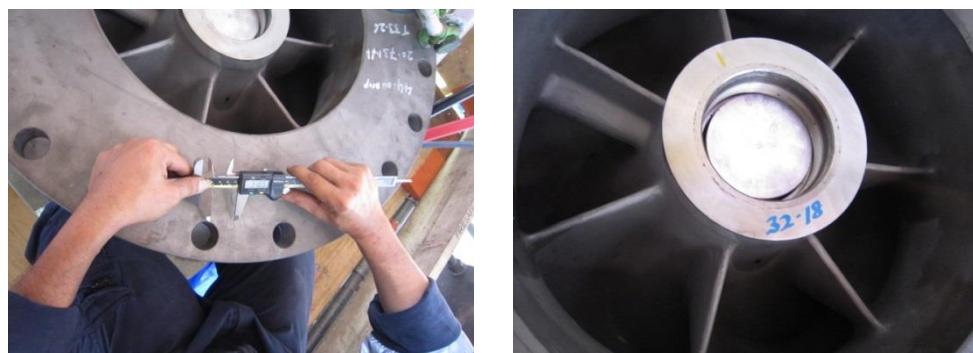
Fig.6-7: Re-check axial displacement

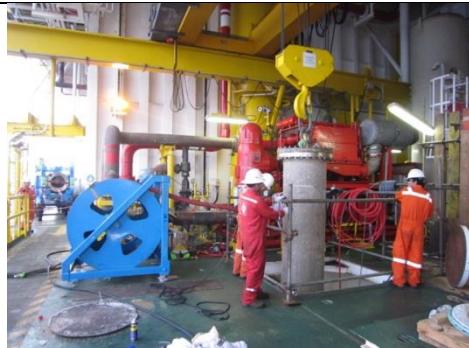
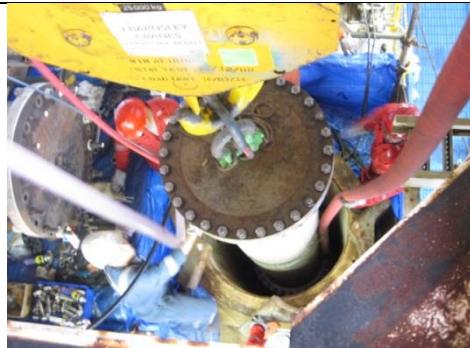
Fig.1-2: Install rising pipes

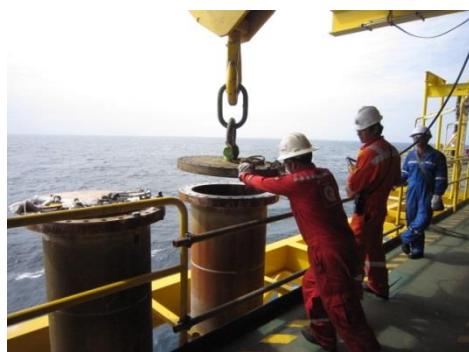
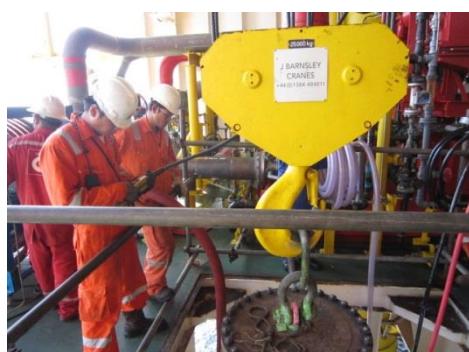
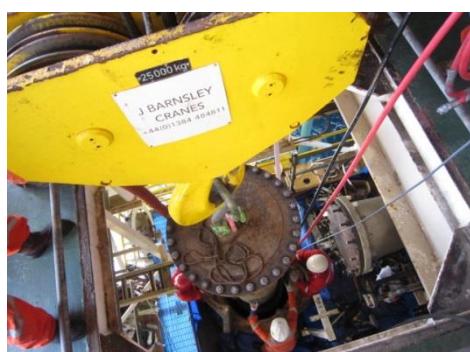
Fig.1-4: Install rising pipes

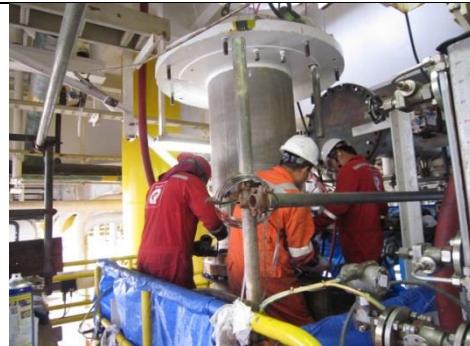
Fig.5-7: Install pump head

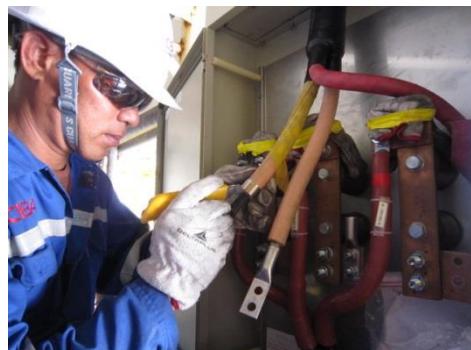
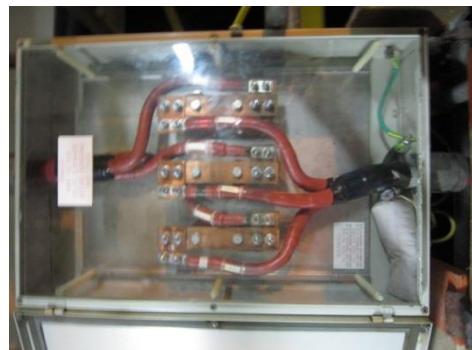
Fig.1-2: Install power cable connection

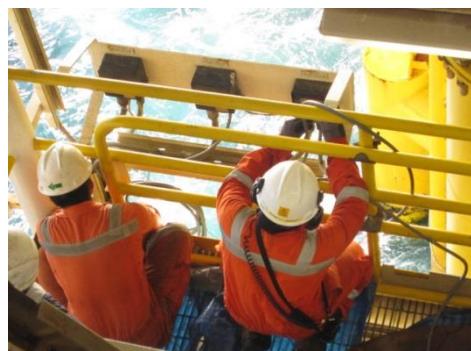
Fig.3-4: Install RTD cable connection

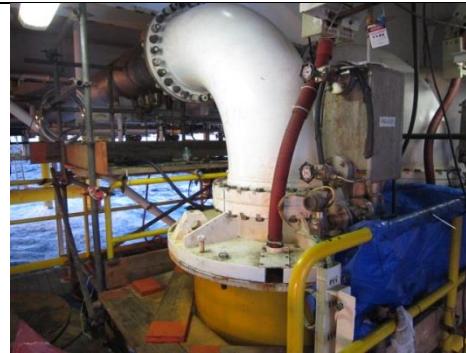
Fig.5-7: Perform mechanical de-isolation
